# Review of Damage in Welded Joints Caused by The Kobe Earthquake†

Kousuke HORIKAWA\* and Yoshihiro SAKINO\*\*

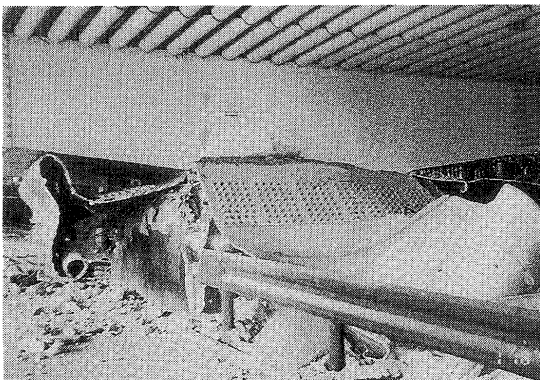
Only 2 steel piers completely collapsed and this number is much less than for RC piers. At first these piers cracked at a welded corner, and then these collapsed a few hours after the earthquake like peeling banana (Fig. 4). It is guessed that the cause of the collapse was due to an increase of dead load by collapse of neighboring

Fig. 4 Collapse of steel pier.<sup>6)</sup>

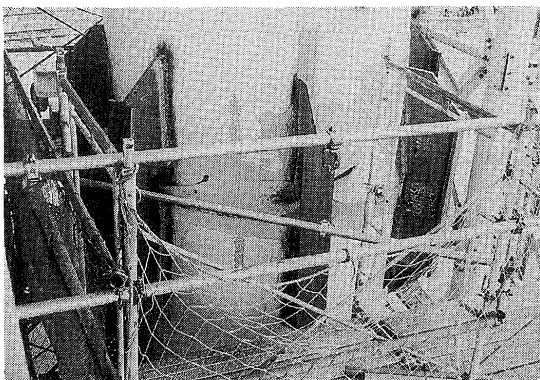
RC piers, but the exact causes are unknown. Other types of damage, local buckling, cracks due to local buckling in circular piers (Fig. 5), cracks due to low cycle fatigue at beam-column connections and brittle fractures of circular piers made with centrifugal casts (Fig. 6), were observed in piers. Cracks due to low cycle fatigue also may appear in welded connections between base-plate and pier, when encased concrete around these connections is destroyed in the future.

Fig. 5 Crack due to local buckling.<sup>6)</sup>

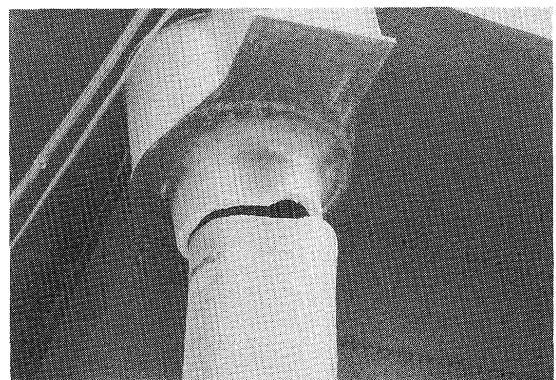
Fig. 6 Brittle fracture of circular pier made by centrifugal casting.

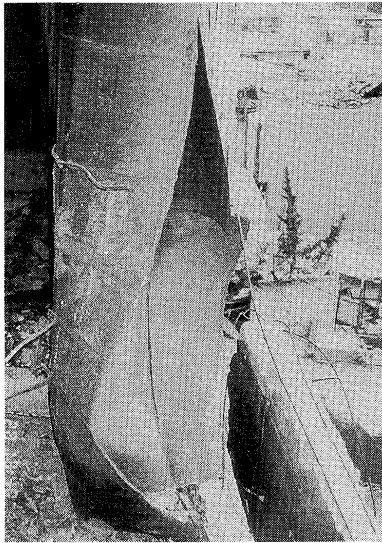
**Fig. 8** Fracture in corner part of square section column.<sup>6)</sup>

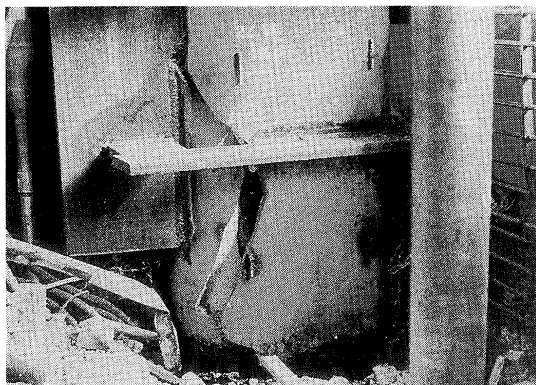
**Fig. 9** Brittle fracture in base metal of square section column.<sup>6)</sup>

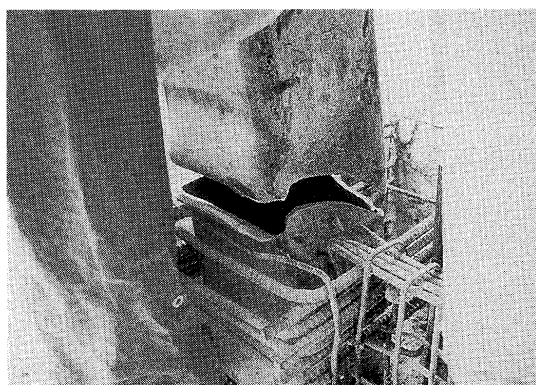
**Fig. 10** Flexural buckling and fracture due to local buckling in base of square section column.<sup>6)</sup>

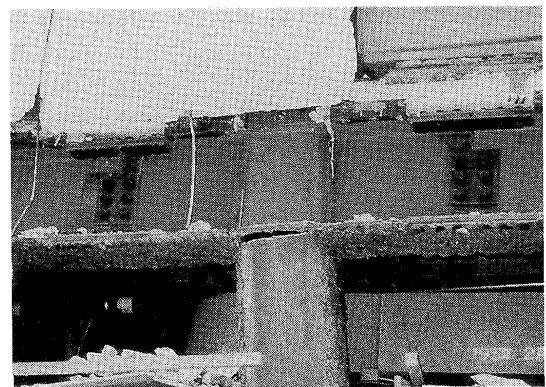
**Fig. 11** Crack and fracture probably caused by insufficiency of strength.<sup>6)</sup>

Cracks and fractures, probably caused by insufficiency of strength in the welded joint, were observed in the following locations (**Fig.11,12**).

- (a) In fillet weld joints, which had smaller sizes of throat depth than usual.
- (b) In old-type joints, in which discontinuous parts were not designed with enough care.
- (c) At short bead-lines in joints of small additions, which were not controlled carefully.

These were found in comparatively old buildings and were destroyed without residual deformation of the members. Most of these buildings hardly showed the energy absorption expected for steel structures, and were seriously damaged, or collapsed. As a result, quality control will become a serious problem for new buildings constructed in the future. A major problem is how to repair these low-strength buildings, of which there are still many in Japan.

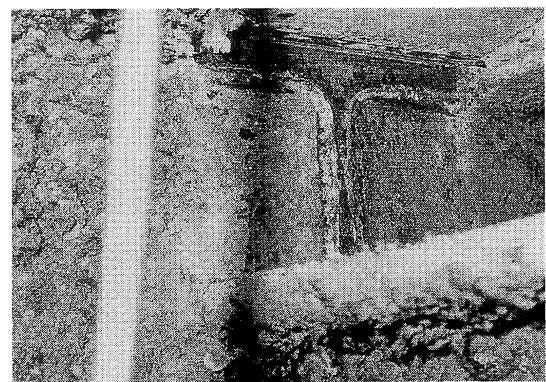
**Fig. 12** Fracture probably caused by insufficiency of strength.<sup>6)</sup>

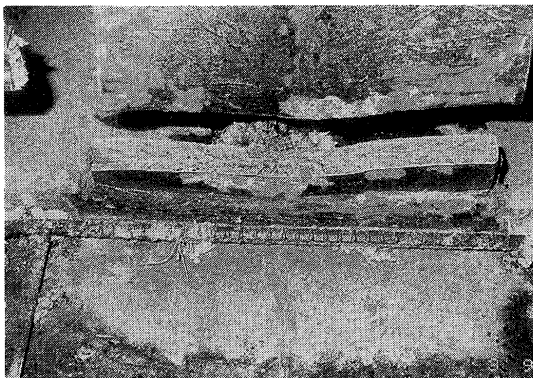
- (a) Brittle fractures in beam-flanges, started from the toe of the scallop in the web.(Fig.14).
- (b) Brittle fractures at heat-affected zones in the beam-flange or the diaphragm, started from the backing strip or the end tab (Fig.15).
- (c) Brittle fractures at heat-affected zones or base metal of the diaphragm in the column-diaphragm connections (Fig.16,17).

Fig.14 Brittle fracture in beam-flange.<sup>6)</sup>

It is ascertained by marks of local buckling, peeling of paint or mill scale and Luders's lines, that these fractured after large plastic deformation. In this observation, these are regarded as "the general yield brittle fracture", because these fractured at stress concentration points or discontinuous points of shape after absorption of seismic energy. As the fracture was may be caused by the hardness of metal, so it differ from "the low stress brittle fracture", which hardly absorbed seismic energy.

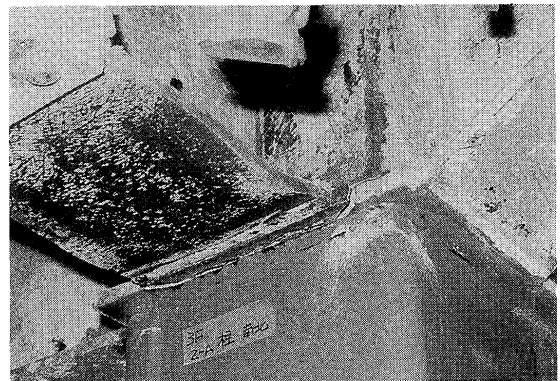
Fig.15 Brittle fracture at heat-affected zone in beam-diaphragm connection.<sup>6)</sup>

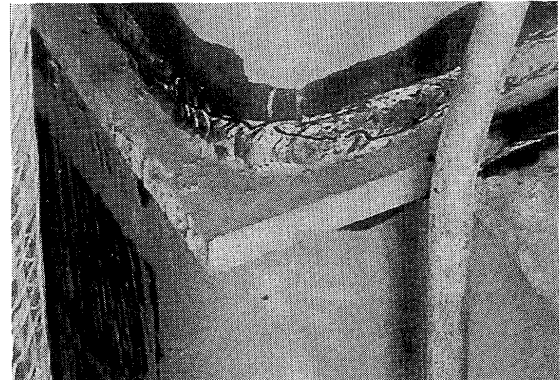
Fig.16 Crack at heat-affected zone of diaphragm in column-diaphragm connection.<sup>6)</sup>

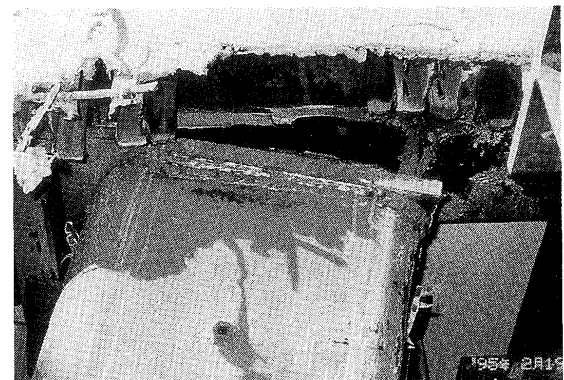
Fig.17 Fracture at base metal in column-diaphragm connection.<sup>6)</sup>

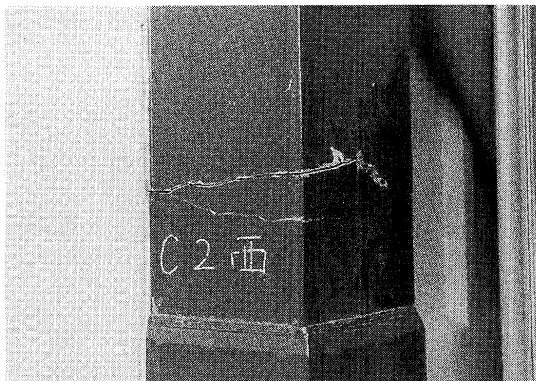
- (a) The upper points at a distance of 30~50cm from chord-chord welding connections (Fig.18). This type was found at 13 locations.
- (b) The points at which chord member, lateral member and diagonal member are connected by welding (Fig.19). This type was found at 7 locations.
- (c) In the chord-chord welding connections (Fig.20). This type was found at 37 locations.

It seems that (a) have no relations with welding, because these were fractured in the base metal. But the possibilities are pointed that the fillet welding of

**Fig.18** Fracture of base metal in chord member of mega-structure.<sup>6)</sup>

erection pieces and other additions become starting points for fractures.

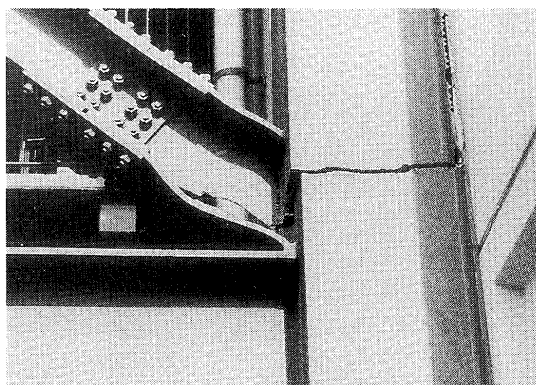
**Fig.19** Fracture at welded connection of chord-lateral-diagonal members on mega-structure<sup>6)</sup>

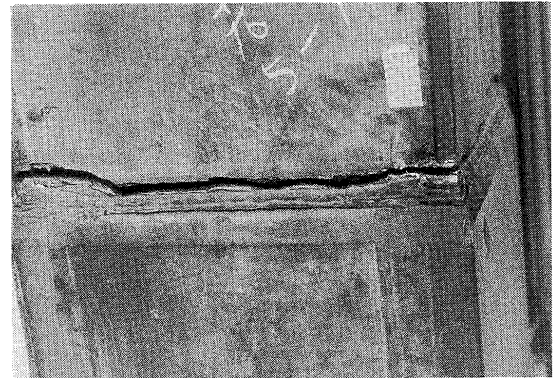
**Fig.20** Fracture at the welded connection of chord-cord member of mega-structure<sup>6)</sup>

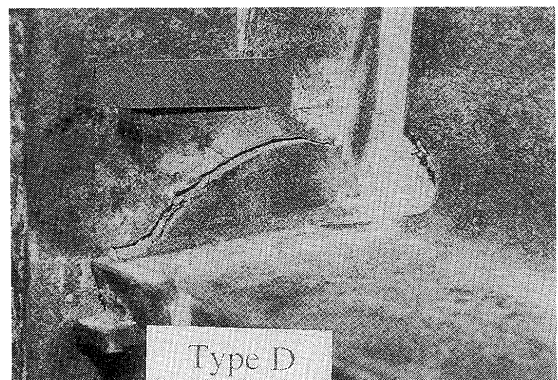
The Northridge Earthquake (magnitude of 6.8), which struck the Los Angeles area on January 17, 1994, just the same day one year before the Kobe Earthquake occurred, was an impulse type of epicentral earthquake, too. Also in the Northridge, brittle fractures were observed in many of the beam-column connections of steel buildings (Fig.21), called "Steel Moment Resisting Frame (SMRF)". Fig.22 shows the typical mode of cracking in the Northridge incident. But these fractures are differ from those in the Kobe.

**Fig.21** Brittle Fracture in beam-column connection due to the Northridge Earthquake.<sup>12)</sup>

In the Northridge, these connections were fractured without absorption of seismic energy by plastic deformation, against those in Kobe which were fractured with them, except mega-structures as mentioned above.

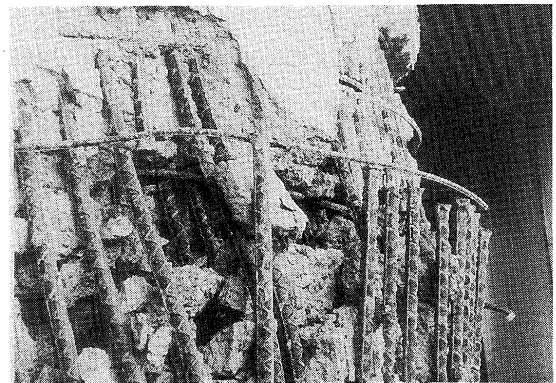
Fig.2.3 Damage of "the gas pressure welding connection".

Beyond the scope of this review, "gas pressure welding connections", the most popular method for joining reinforcing bars, also incurred heavy damage. The causes of these failures have also been studied (Fig.23).
