Title	Review of Damage in Welded Joints Caused by The Kobe Earthquake
Author(s)	Horikawa, Kohsuke; Sakino, Yoshihiro
Citation	Transactions of JWRI. 1995, 24(2), p. 1-10
Version Type	VoR
URL	https://doi.org/10.18910/10043
rights	
Note

Review of Damage in Welded Joints Caused by The Kobe Earthquake[†]

Kousuke HORIKAWA* and Yoshihiro SAKINO**

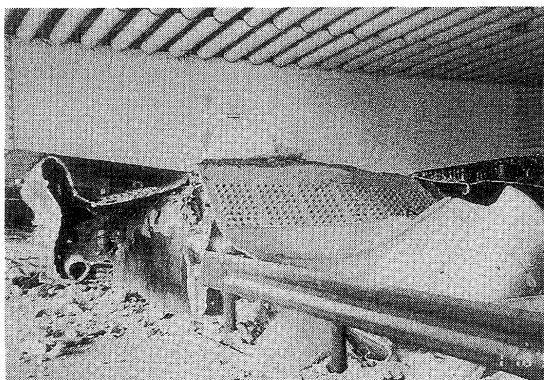
Only 2 steel piers completely collapsed and this number is much less than for RC piers. At first these piers cracked at a welded corner, and then these collapsed a few hours after the earthquake like peeling banana (Fig.4). It is guessed that the cause of the collapse was due to an increase of dead load by collapse of neighboring

Fig.4 Collapse of steel pier.⁶⁾

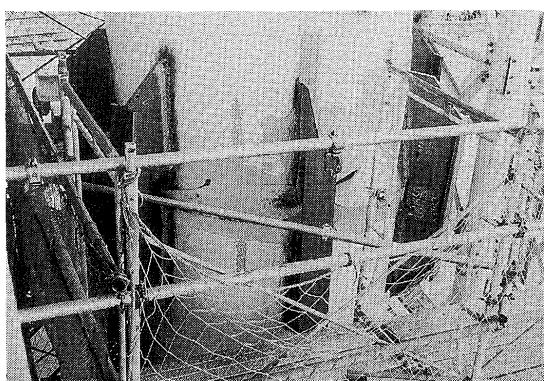
RC piers, but the exact causes are unknown. Other types of damage, local buckling, cracks due to local buckling in circular piers (Fig.5), cracks due to low cycle fatigue at beam-column connections and brittle fractures of circular piers made with centrifugal casts (Fig.6), were observed in piers. Cracks due to low cycle fatigue also may appear in welded connections between base-plate and pier, when encased concrete around these connections is destroyed in the future.

Fig.5 Crack due to local buckling.⁶⁾

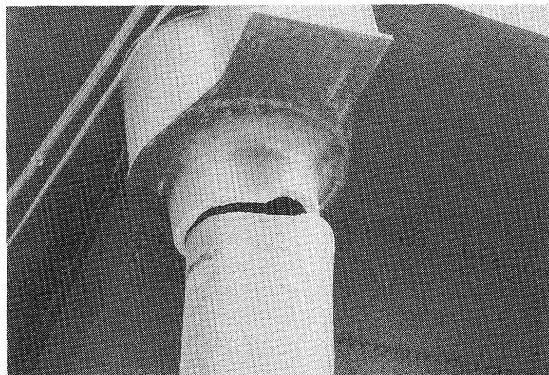
Fig.6 Brittle fracture of circular pier made by centrifugal casting.

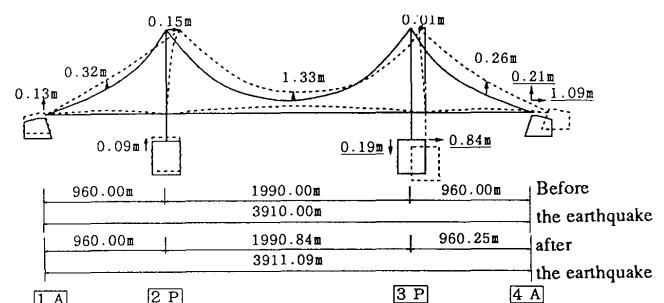
experienced due to the earthquake. After the earthquake, the relative displacements of the bridge were measured. As the result of the measurement, the Awaji Island side tower and anchorage moved about 1.3m relative to the Kobe side tower and anchorage. Then the center span length, originally 1,990m, was increased to 1,990.8m (Fig.7). But, it was fortunately found that the earthquake caused no critical damage to the bridge. The elongation of the span will be accomplished by adjusting the length of some panels of the stiffening girder.

Fig.7 The relative displacement of "Akashi-Kaikyo Bridge".⁹⁾

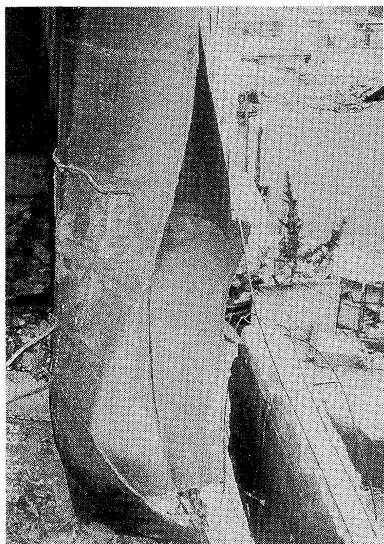
Fig. 8 Fracture in corner part of square section column.⁶⁾

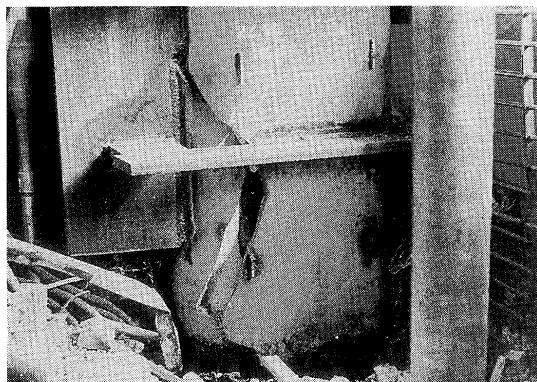
Fig. 9 Brittle fracture in base metal of square section column.⁶⁾

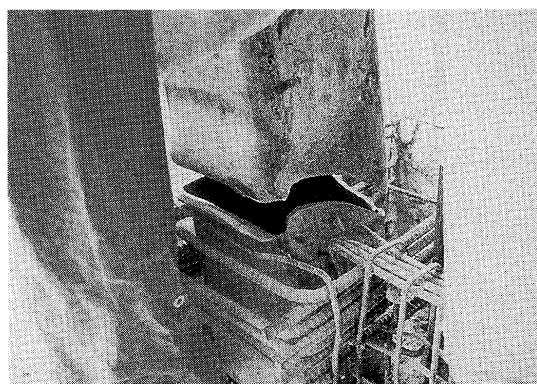
Fig. 10 Flexural buckling and fracture due to local buckling in base of square section column.⁶⁾

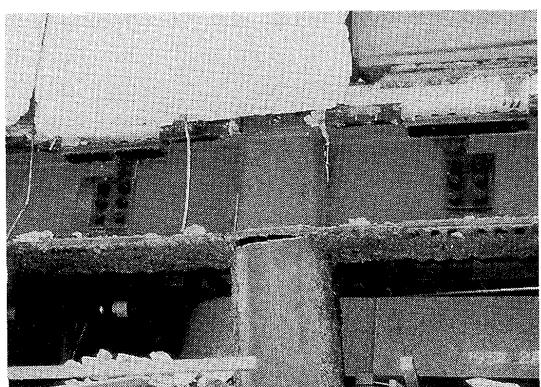
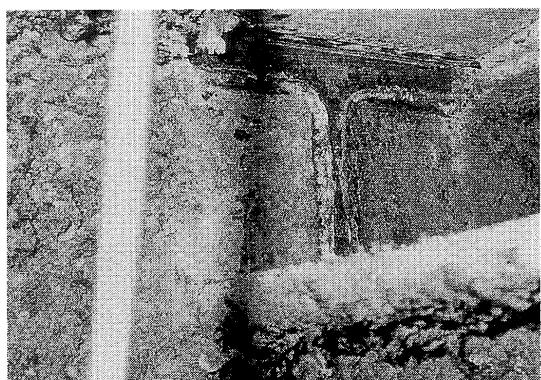
Fig. 11 Crack and fracture probably caused by insufficiency of strength.⁶⁾

Fig. 12 Fracture probably caused by insufficiency of strength.⁶⁾

Cracks and fractures, probably caused by insufficiency of strength in the welded joint, were observed in the following locations (Fig.11,12).

- (a) In fillet weld joints, which had smaller sizes of throat depth than usual.
- (b) In old-type joints, in which discontinuous parts were not designed with enough care.
- (c) At short bead-lines in joints of small additions, which were not controlled carefully.

These were found in comparatively old buildings and were destroyed without residual deformation of the members. Most of these buildings hardly showed the energy absorption expected for steel structures, and were seriously damaged, or collapsed. As a result, quality control will become a serious problem for new buildings constructed in the future. A major problem is how to repair these low-strength buildings, of which these are still many in Japan.

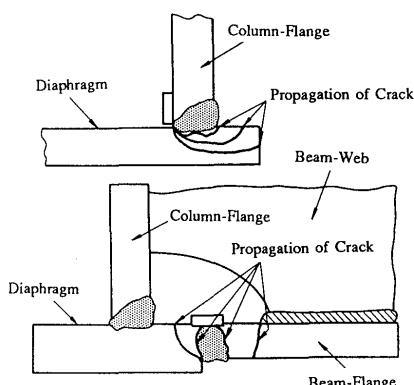
Brittle fractures were observed in beam-column connections, which were welded according to the present design standard. As Fig.13 shows diagrammatically, typical modes of fractures are divided as follows.

- Brittle fractures in beam-flanges, started from the toe of the scallop in the web.(Fig.14).
- Brittle fractures at heat-affected zones in the beam-flange or the diaphragm, started from the backing strip or the end tab (Fig.15).
- Brittle fractures at heat-affected zones or base metal of the diaphragm in the column-diaphragm connections (Fig.16,17).

Fig.13 Typical modes of fracture at the beam-column connection in the Kobe earthquake.¹⁾

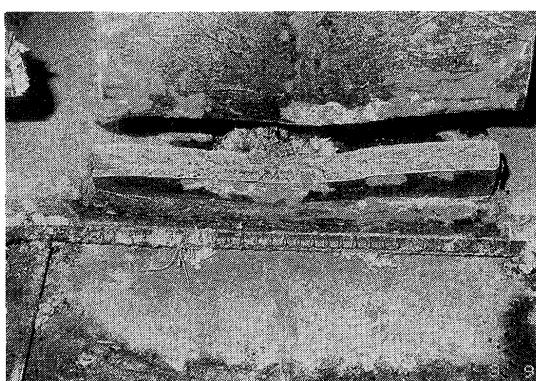
Fig.14 Brittle fracture in beam-flange.⁶⁾

It is ascertained by marks of local buckling, peeling of paint or mill scale and Luders's lines, that these fractured after large plastic deformation. In this observation, these are regarded as "the general yield brittle fracture", because these fractured at stress concentration points or discontinuous points of shape after absorption of seismic energy. As the fracture was may be caused by the hardness of metal, so it differ from "the low stress brittle fracture", which hardly absorbed seismic energy.

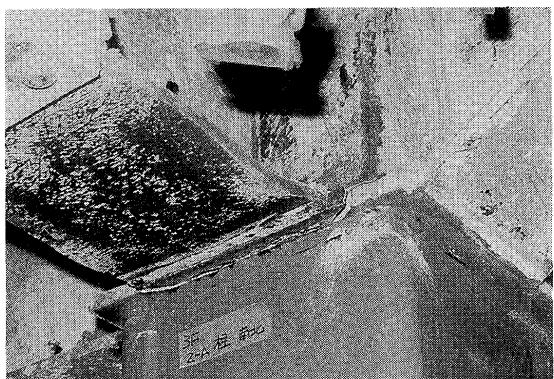
Fig.15 Brittle fracture at heat-affected zone in beam-diaphragm connection.⁶⁾

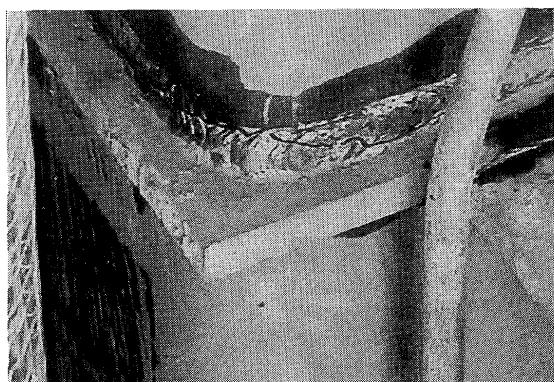
Fig.16 Crack at heat-affected zone of diaphragm in column-diaphragm connection.⁶⁾

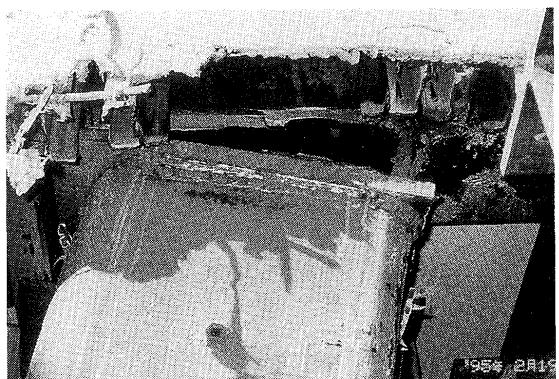
Fig.17 Fracture at base metal in column-diaphragm connection.⁶⁾

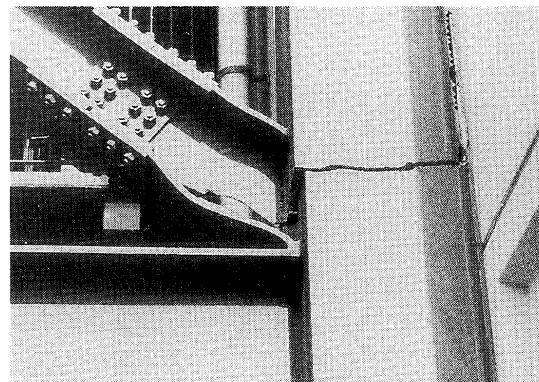
- (a) The upper points at a distance of 30~50cm from chord-chord welding connections (Fig.18). This type was found at 13 locations.
- (b) The points at which chord member, lateral member and diagonal member are connected by welding (Fig.19). This type was found at 7 locations.
- (c) In the chord-chord welding connections (Fig.20). This type was found at 37 locations.

Fig. 19 Fracture at welded connection of chord-lateral-diagonal members on mega-structure⁶⁾

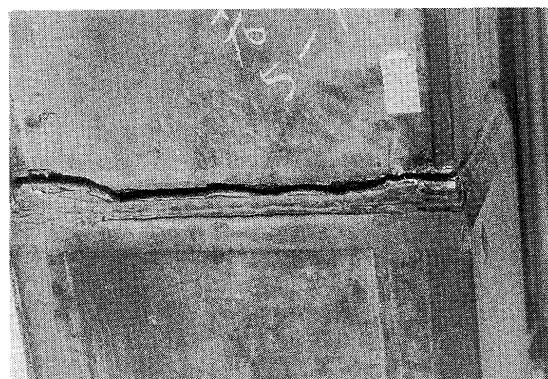
Fig. 20 Fracture at the welded connection of chord-cord member of mega-structure⁶⁾

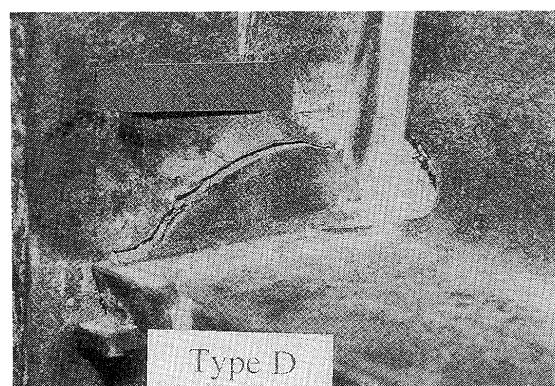
The Northridge Earthquake (magnitude of 6.8), which struck the Los Angeles area on January 17, 1994, just the same day one year before the Kobe Earthquake occurred, was an impulse type of epicentral earthquake, too. Also in the Northridge, brittle fractures were observed in many of the beam-column connections of steel buildings (Fig.21), called "Steel Moment Resisting Frame (SMRF)". Fig.22 shows the typical mode of cracking in the Northridge incident. But these fractures are differ from those in the Kobe.

Fig. 21 Brittle Fracture in beam-column connection due to the Northridge Earthquake.¹²⁾

In the Northridge, these connections were fractured without absorption of seismic energy by plastic deformation, against those in Kobe which were fractured with them, except mega-structures as mentioned above.

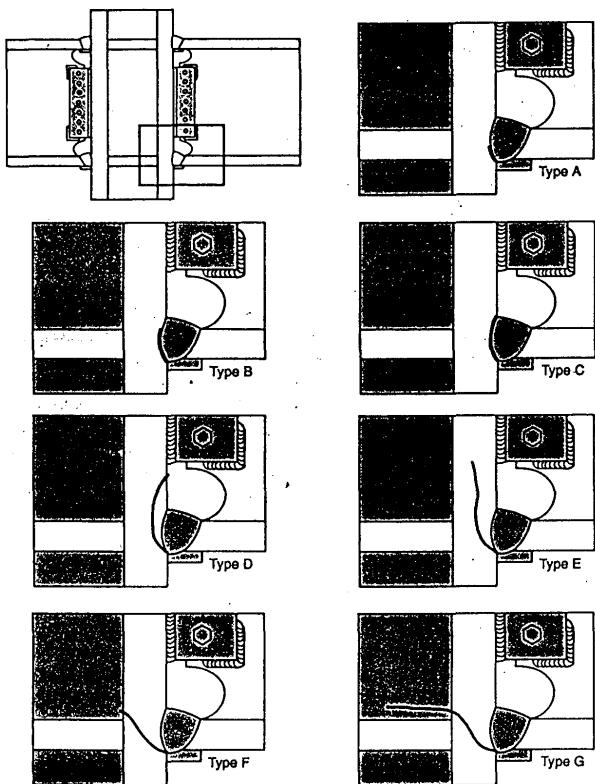
Fig.22 Typical modes of crack due to the Northridge Earthquake.¹⁴⁾

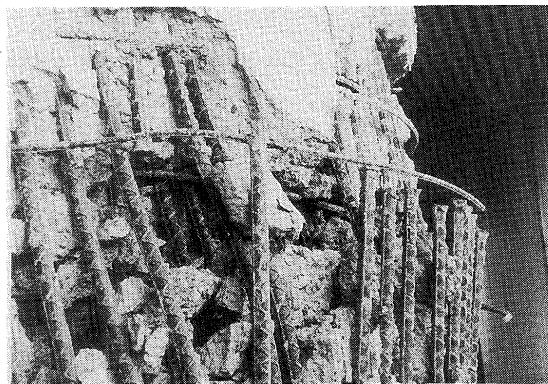
Fig.23 Damage of "the gas pressure welding connection".

Beyond the scope of this review, "gas pressure welding connections", the most popular method for joining reinforcing bars, also incurred heavy damage. The causes of these failures have also been studied (Fig.23).
