# Experimental Study on the Reshape of a Plate Girder under Loading

Kohsuke HORIKAWA\* and Hiroyuki SUZUKI\*\*

*This paper describes reshape works of a plate girder from uniform section to non-uniform section using gas cutting and welding under loading.*

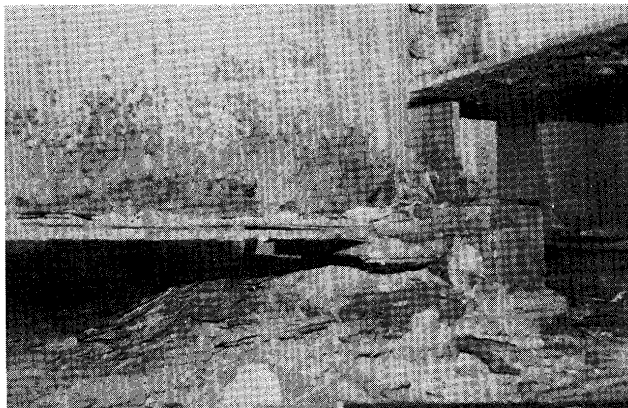
Corrosion is one type of failures in steel bridges in service and is apt to occur near expansion joint, bearing shoe and so on. In these parts, thickness of members decreases by rust. As an extreme case, there is an example that lost the fillet welds between web and lower flange, shown in Photo 1. Cause of this example was considered the leakage

Photo 1 An example of corrosion

of water with free lime because stalagmite existed on lower surface of slab and water dropped even on fine day.

In repair works of this bridge, following three procedures were considered.

1) Cutting off corroded part, then new member with T section is connected using H.T. bolts.

2) Cutting off corroded part, then new member with T section is connected using welding at site.

3) Cutting off corroded part, then only new lower flange is connected using welding at site. As a result, the plate girder is reshaped from uniform section to non-uniform section.

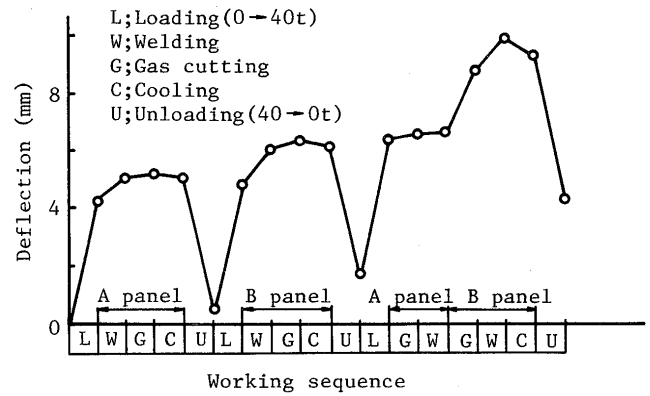
Fig. 4 Deflection at the center of span during works

In case of gas cutting after welding of lower flanges, increase of deflection at the center of span was 1mm at most though there was a difference by cut off length in it. Influence of gas cutting was a little in this increase. Moreover, increase by gas cutting disappeared with cooling and deflection before unloading was nearly equal to the deflection after welding.

In case of welding of lower flange after gas cutting, specimen was stable to end of works in A panel whose vertical stiffener was not cut off, and increase of deflection was only 0.2mm. In B panel whose vertical stiffener was cut off, load decreased from 40tons to 36tons at gas cutting of web and also decreased at welding of additional flange in inner panel beyond vertical stiffener. From these results, increase of deflection was 3.5mm. Therefore, it is known that vertical stiffener has a large contribution.

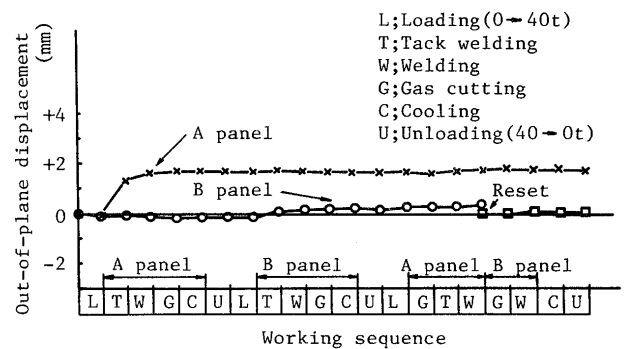
In Fig. 5, deformation in A panel increases rapidly during tack welding to A panel. This is considered that worker came into contact with displacement transducer

Fig. 5 Out-of-plane displacements in web during works

during welding or that specimen moved during stiffener fitting using hammer. Deformation in B panel has a discontinuity. This reason is that displacement transducer set at the center of B panel was moved to 275mm toward support for a possibility of obstruction in second works of B panel.

It is found from Fig. 5 that out-of-plane deformation in web was 0.5mm at most during all the work. There is little out-of-plane deformation even at gas cutting in B panel.

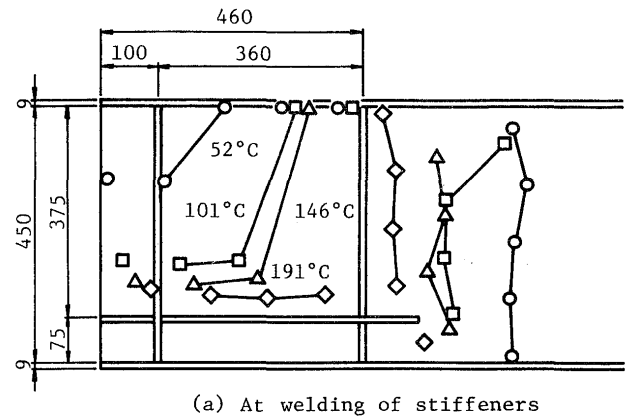
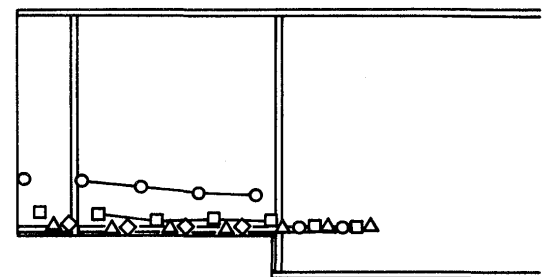
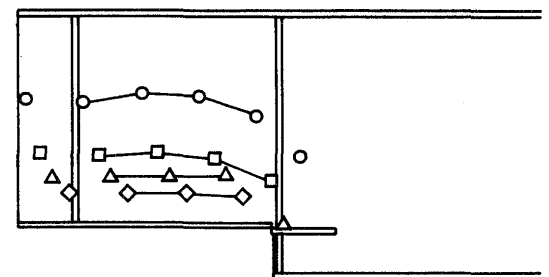
Isothermal lines at welding of stiffeners in panels surrounded with stiffeners and upper flange are convex curves toward the corner of horizontal and vertical stiffeners because temperature distribution at this time is the sum of heats by welding of horizontal and vertical stiffeners. Comparing welding of stiffeners with gas cutting, heated area by welding is wider than one by gas cutting. So, temperature distribution at welding of lower flange (Fig. 6 (c)) is the maximum temperature distribution by welding heat.

At gas cutting, the region over 101°C is 50mm at most. Also at welding, the region over 191°C is no more than 100mm. Therefore, as the region of decrease of yield point and Young's modulus is restricted within only vicinity of weld line, a loss of safety is considered to be little even though detailed considerations are omitted.

**Fig. 6** Maximum temperature distributions in web (A panel)

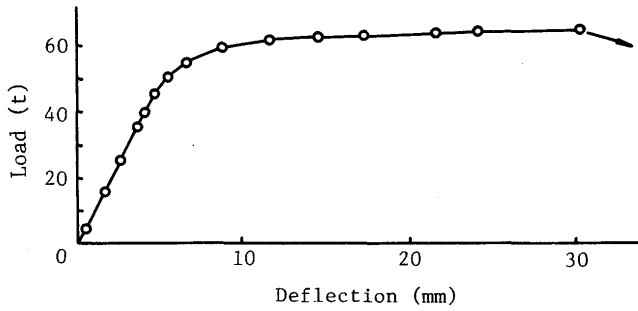
Figure 7 shows the change of bending rigidity near 50 tons. The reason of this change is considered general yield of girder, as stress on lower surface of lower flange at center of span was 350MPa at this time.

Fig. 7 Deflection at the center of span in loading test

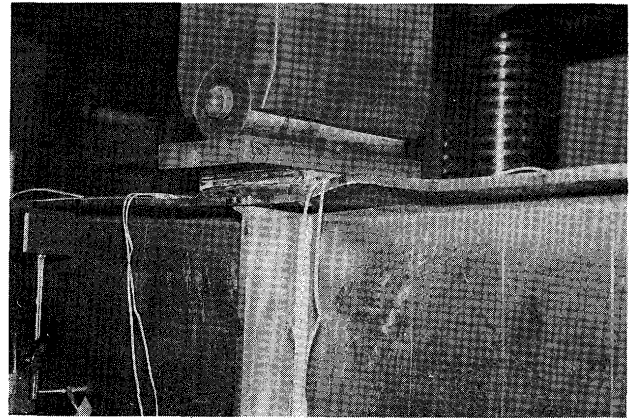
The ultimate strength of this specimen was 65tons. Collapse was occurred by local buckling of upper flange near both sides of bearing plate at loading point shown in Photo 2.

Out-of-plane deformations in web don't occur till the maximum load. Shearing stress at the maximum load was 82MPa on the average of both surfaces. So, increase of out-of-plane deformation near the maximum load in Fig. 8 is considered as caused by local buckling.

Photo 2 Local buckling of upper flange

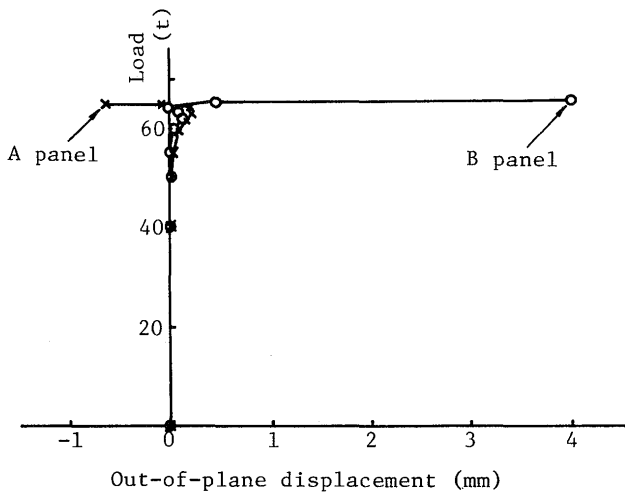
Fig. 8 Out-of-plane displacements in web in loading test

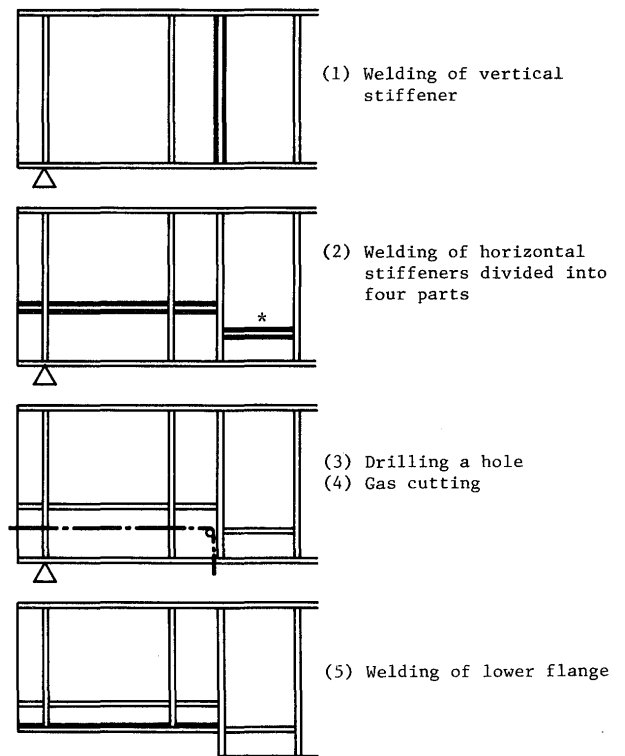
Fig. 11 Recommended procedures for bridge in service

- (1) At first, welding of vertical stiffeners
- (2) Secondly, welding of horizontal stiffeners

When, it is desirable that the stiffeners marked by \* in Fig. 11 is welded on the same line as lower flange of (5) and welded to next vertical stiffener.

- (3) Then drilling a hole
- (4) And gas cutting
- (5) Finally, welding of lower flange
