Title	Microbiologically Influenced Corrosion (MIC) of Stainless Steel Weldments on the Pipe Line in the Sewage Treatment Plant(Materials, Metallurgy & Weldability)
Author(s)	Kikuchi, Yasushi; Matsuda, Fukuhisa; Tomoto, Kenji et al.
Citation	Transactions of JWRI. 1995, 24(1), p. 63-67
Version Type	VoR
URL	<a href="https://doi.org/10.18910/7825">https://doi.org/10.18910/7825</a>
rights	
Note

# Microbiologically Influenced Corrosion (MIC) of Stainless Steel Weldments on the Pipe Line in the Sewage Treatment Plant†

Leaking was found from several welded joints on a 3mm wall thickness, 304 stainless steel pipe line system. This pipe line system is one of the important components in an activated carbon waste water treatment plant. The failures in weld joints occurred within two months from the start up of the plant.

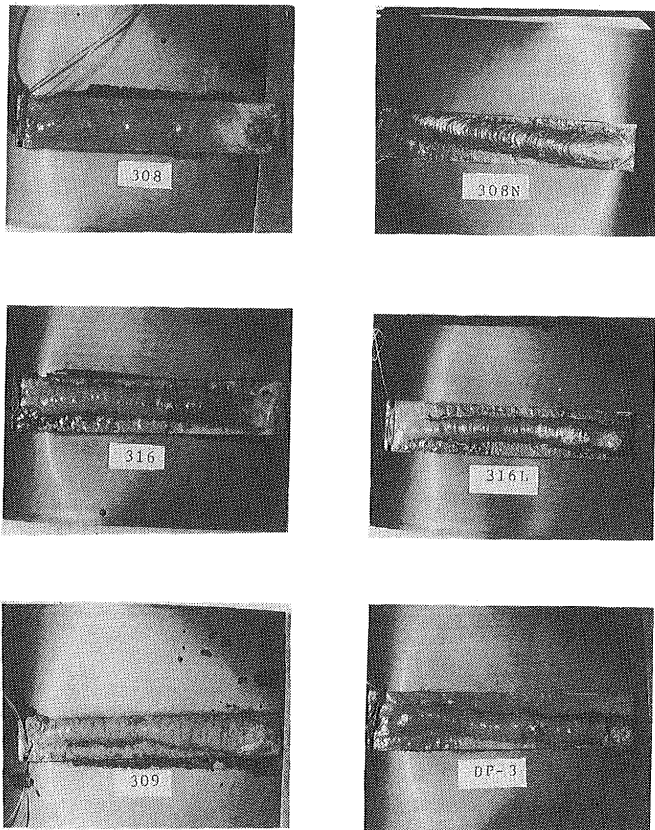
It is known that a turbercle is sometimes observed at a local corrosion site by MIC, so turbercles and local corrosion have an intimate relationship. After about 10 days, on the surface of coupon the turbercles were developed. Their growth occurred gradually as a function of time. Under these experimental conditions, the turbercles did not change to a solid substance. It is assumed that the soft turbercles will be agglomerated into a solid substance after long time exposure.

The surface appearances of coupon after 62 days of exposure are shown in Figure 2. The arrow indicates to the turbercle.

Fig. 2 Surface appearances of coupon after 62 days exposure test turbercle by arrow

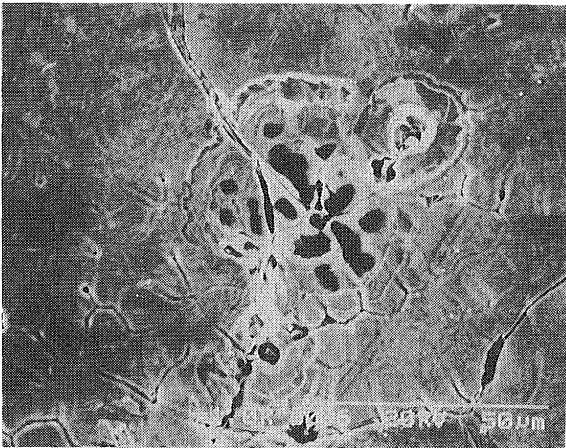
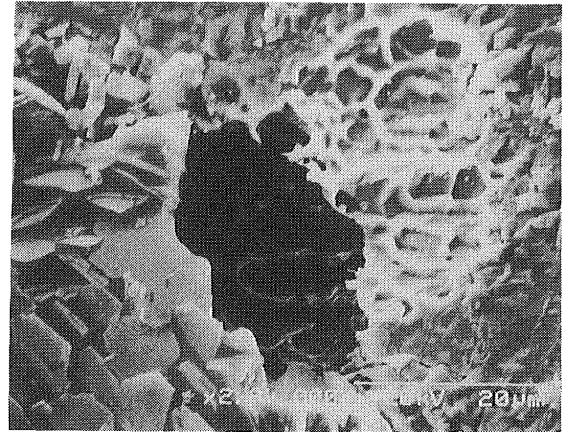
Figure 3 shows the result of 308N(nitrogen content about 0.2%) weld metal. As shown in (A), at the crater area, a lot of corrosion sites were occurring as pitting corrosion. The circular groove observed is also corrosion site. A large corrosion site is formed as shown in (B). 308N weld metal contains about 0.2% nitrogen, but many pits developed.

**Fig. 3** Pitting Corrosion of 308N weld metal  
(A) many small pit (B) large pit

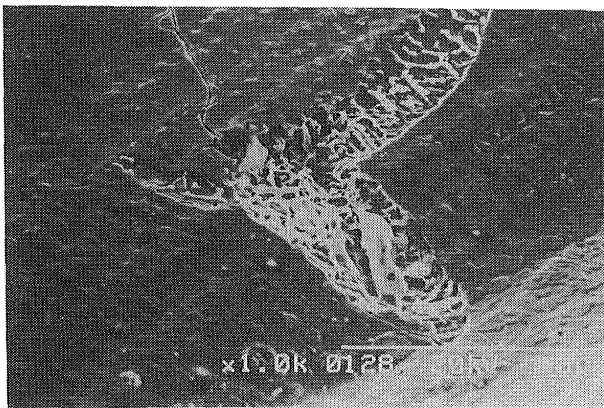
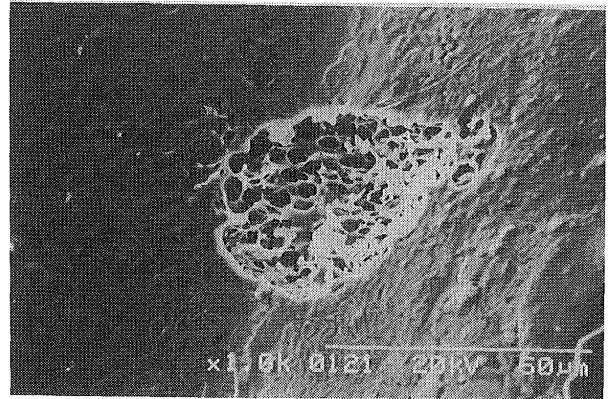
The results of 316L weld metal are shown in Figure 4.(A)(B) and (C). The different shape of pits can be seen as (A) and (B). (C) is a highlight of (B). As shown in (C), the morphology of the remaining structure is dendritic, and in this instance the austenitic phase in the weld metal has been preferentially corroded leaving the ferritic dendritic skeleton un-attacked<sup>3)</sup>. The skeleton structure was analyzed by EDX, and a high Cr content in the skeleton was found. So, it is concluded that this is ferrite phase. The turbercles were also developed on the surface of weld metals for other four samples, but there was no observable pitting of MIC. The 62 days exposure test results are summarized in Table 2. The size variations of turbercles were grouped by eye in the three categories, as maximum (⊙), moderate (○) and minimum (△). In short exposure examinations, the development of turbercles does not correlate with MIC of stainless steel weld metal. So, long exposure times were planned. The 308 and 316L weld metal samples were used. Reproducibility was checked by using 316L samples. The fixed bacteria in the corroded area were inspected by SEM.

**Fig. 4** Pitting corrosion of 316L weld metal  
(A) early stage corrosion (B) skeleton un-attacked  
(C) high magnification of (B)

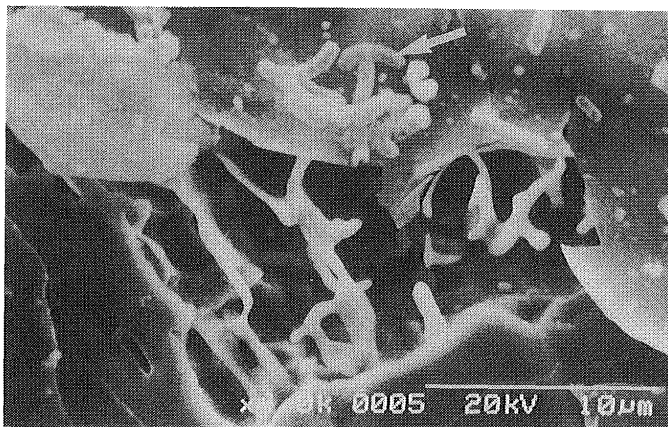
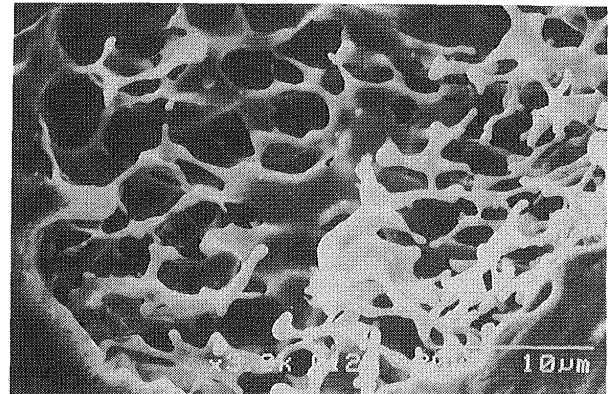
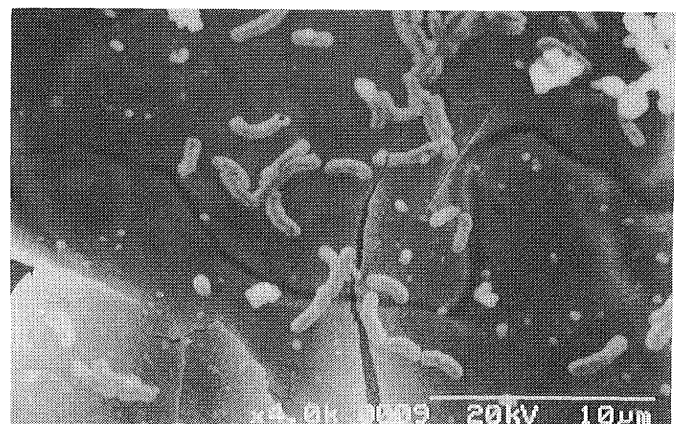
**Fig. 5** Bacterial and Pit of 308 weld metal , 240 days exposure test, (A) at Pit (B) at Crater

The test results on 308 weld metal are shown in Figure 5. MIC has been developed in 308 weld metal by long time exposure. As shown in (A) a dendritic skeleton structure is observed. On the other hand, bacteria are shown by an arrow in the same photograph. Bacteria are attached on the coupon surface around pits. As shown in (B), many bacteria are attached on the crater surface. The same corroded skeleton structure was obtained in 316L sample as in the results of 62day exposure tests.
