# Some Problems of the Weldability of High Strength Thick Plate Steels Subjected to Electron Beam Welding<sup>†</sup>

Stanislaw PIWOWAR\* Yoshiaki ARATA\*\* Hiroji NAKAGAWA\*\*\* and Michio TOMIE\*\*\*\*

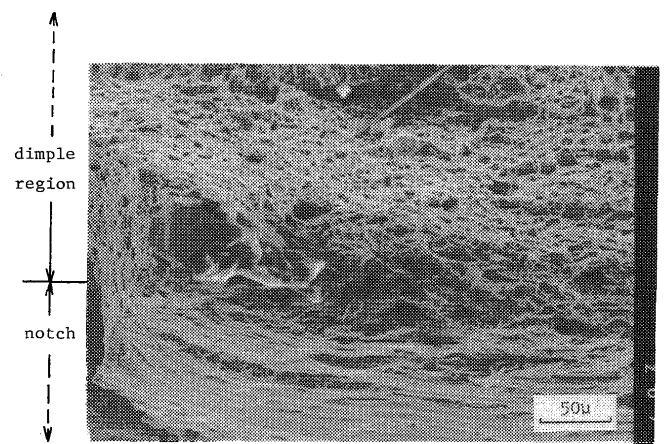
**Fig. 1** Wide dimple region at the vicinity of the bottom of the notch in the positive specimen (B1)

visible a wide dimple region and in **Fig. 2** and **4** are shown relatively big unit crack paths going along the full surface. However, the path in **Fig. 4** is generally somewhat larger than in **Fig. 2**. In **Fig. 3**, the dimple region is very narrow.

The analyses of Fig. 1 and 2 show that the wide dimple region does not relate to a small unit crack path. It means that the propagation of the fracture going out from the high ductility region went after that to the brittle path of the weld structure, which means that the beginning of the fracture started in the ductile deposited metal and then went to the brittle bonding line and went straight along it to the end. Confirmation of this explanation is very exactly seen in Fig. 5 and 6, where in Fig. 5 the crack is very much more developed compared with the very straight line of the fracture in Fig. 6.

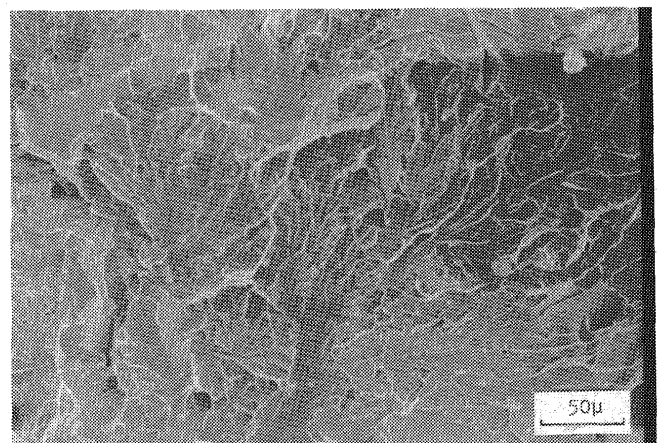
**Fig. 2** Example of unit crack path at the cleavage fracture surface in the positive specimen (B1)

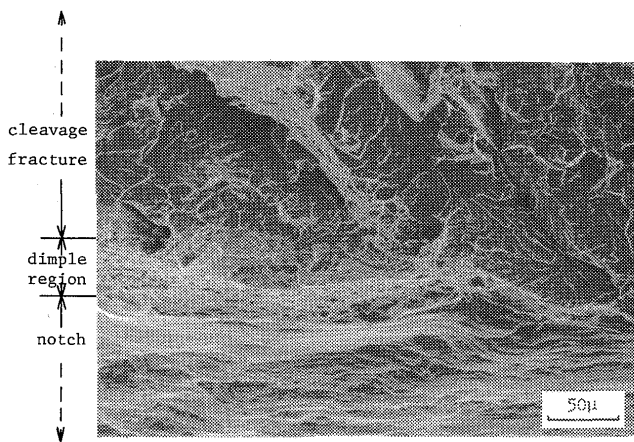
**Fig. 3** Very narrow dimple region at the vicinity of the bottom of the notch in the negative specimen (B2)

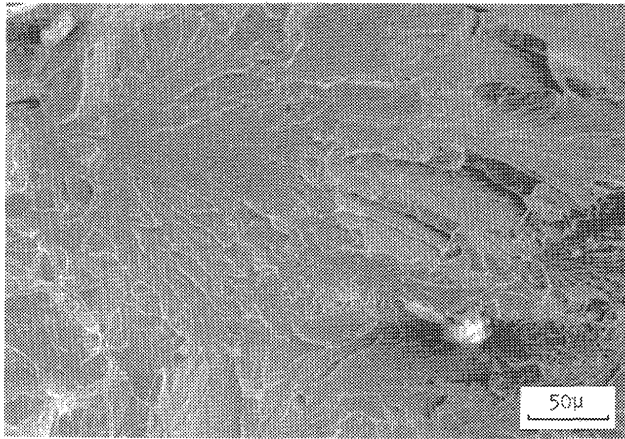
**Fig. 4** Example of unit crack path at the cleavage fracture surface in the negative specimen (B2)

The observation of the large unit crack path in both specimens suggests the possibility of low ductility connected with the microstructure.

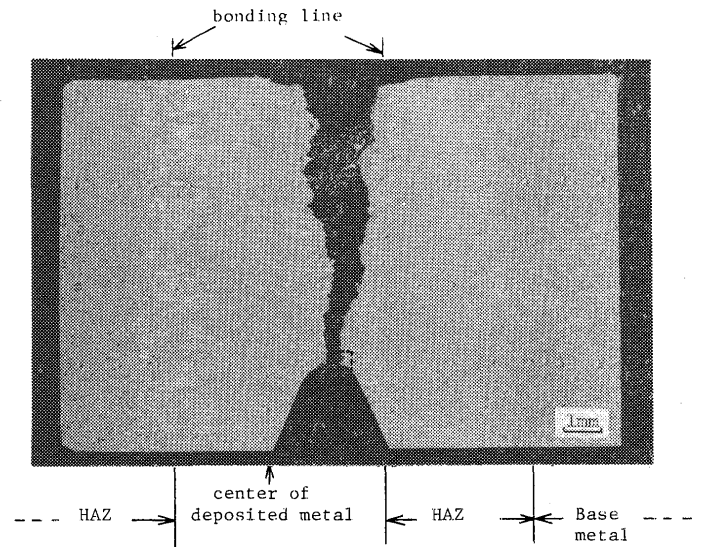
The Fig. 5 and 6 show the kind of fractures in the B1 and B2 specimens as well as size and measures of the related zones of the welded joints. The very first observation of both the macrostructures shows highly developed prior austenite grain size in the bonding line.

**Fig. 5** Macroscopic view of fracture path in the positive specimen (B1), showing developed fracture line partially following the deposited metal.

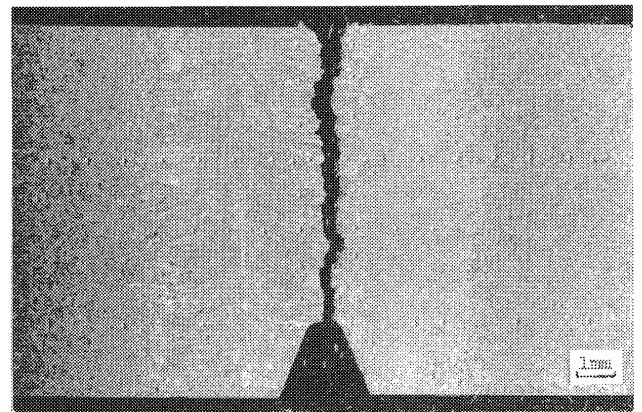
**Fig. 6** Macroscopic view of fracture path in the negative specimen (B2), showing almost straight fracture line going exclusively through the bonding line.

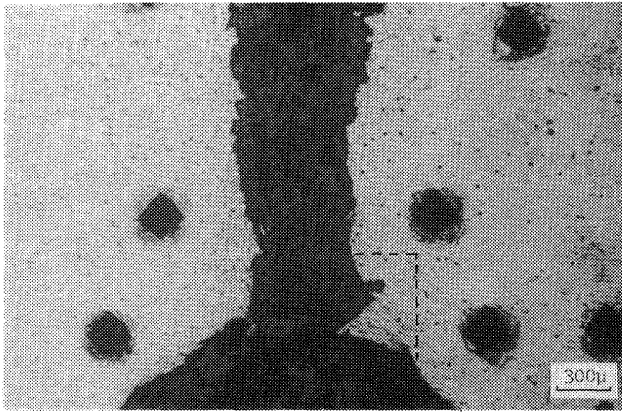
The more exact pictures of the starting of fractures are shown in Fig. 7 and 8. Related to Fig. 7, is the microstructure shown in Fig. 9. The arrow shows very deformed structure on the bottom of the notch, where the fracture started. Figure 10 doesn't show any deformation on the edge of fracture, which means that the fracture went exactly through the brittle region of the bonding line. This figure shows the typical structure of the deposited metal.

**Fig. 7** Detail of the bottom of the notch showing the initiation of the fracture in the deposited metal in the positive specimen (B1)

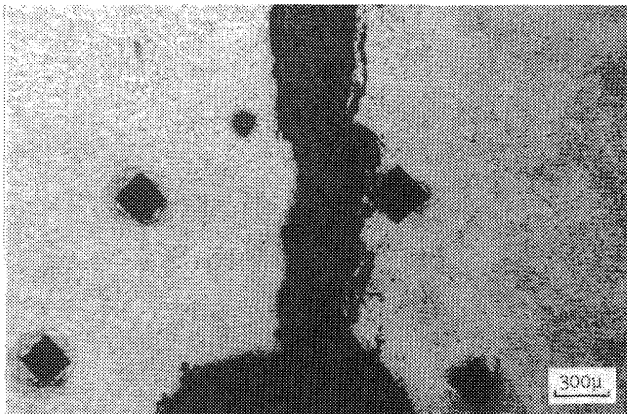
**Fig. 8** Detail of the bottom of the notch showing the initiation of the fracture in the bonding line in the negative specimen (B2).

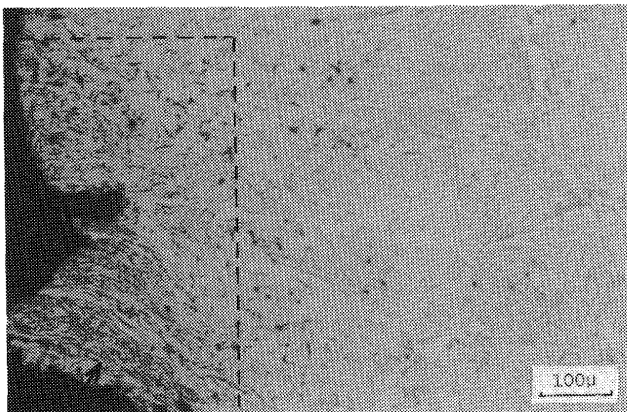
**Fig. 9** Microstructure (specimen B1) in the vicinity of the initiation crack region. The arrow shows in high magnification the deformed deposited metal where the crack started. The figure generally shows the structure of the bonding line which is large proeutectoid ferrite, ferrite side plate and upper bainite.

(The microstructure proves the assumption that initial austenite grain size was large and the cooling rate was relatively low.)

The microstructure analyses on the bonding line of Fig. 9 shows large proeutectoid ferrite, ferrite side plate and upper bainite. These structures occur during welding with high heat input by different methods of welding. Since in our case the welding conditions applied for the welding of the 50mm thick plate didn't give any negative result, it means that the shape of welds were correct, as well as no defects occurred. So we must acknowledge that these welding conditions were properly chosen, but they caused the negative structure as shown in Fig. 9.

Negative result of the impact test could be theoretically changed when using higher preheating temperature or PWHT. As we have mentioned in the beginning of this report, the applied preheating temperature 260°C is the intermediate temperature between 100°C and Ms transformation temperature. Both the high preheating temperature and PWHT are however almost impossible to apply from the practical point of view. In such a case there are only two possibilities of avoiding negative results of impact value in the bonding line. The first one is the complete change of the material used for the welded tubes in the pillars of elevated highways, and the second one is the attempt to improve actually used material. In this case the main idea should concern the reduction of carbon and nitrogen content as well as alloying this material with B, Ti and perhaps REM.

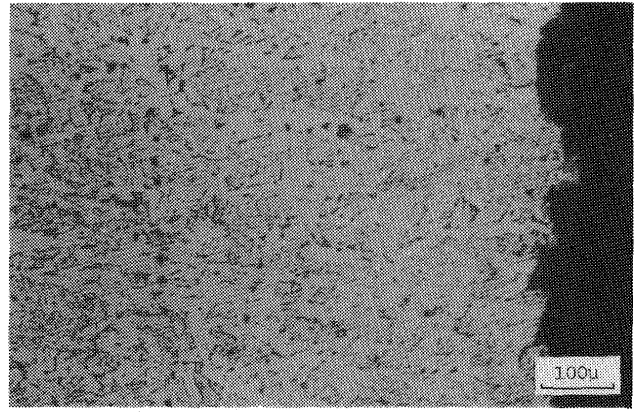
**Fig. 10** Microstructure of the deposited metal in the negative specimen (B2). There is no deformation on the fracture edge, and the microstructure consists of relatively fine ferrite and pearlite and partly of bainite.

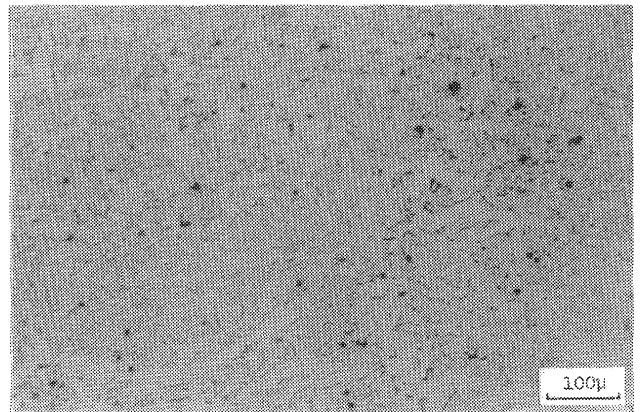
Figure 11 shows the deposited metal in the middle of the weld joint and Fig. 12 shows the structure of the base metal.

**Fig. 11** Microstructure in the center of the deposited metal shows relatively fine ferrite and pearlite and some bainite. There are some inclusions which probably were connected with higher oxygen content in filler wire and influenced positively the fine structure.

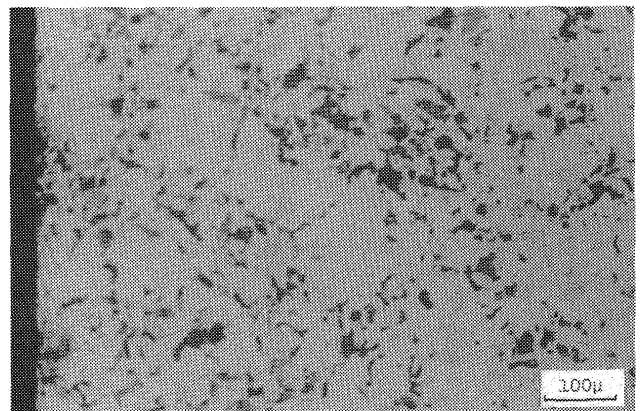
**Fig. 12** Typical microstructure of base metal showing ferrite and pearlite.

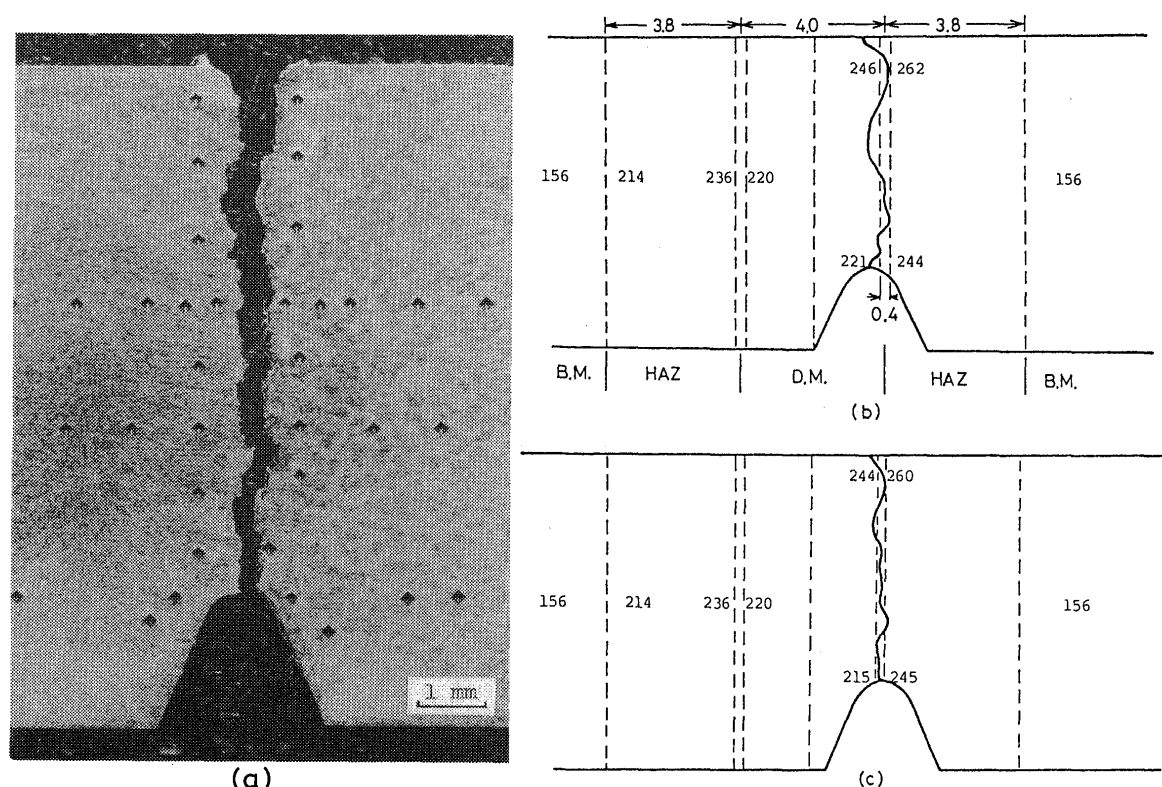
Fig. 13 Hardness distribution and sizes of weld zones in both specimens.

strip where the hardness is highest. These were our findings, but we could not find a proper explanation for why the hardness changes from its minimum at the bottom of the notch and reaches its maximum on the top of the specimen.

Deeper analysis of the above shown results lets us come to the conclusion that the impact test value of the "positive specimen" was a result of improper cutting of the notch in this specimen. As Fig. 13 (b) shows the crack initiated outside of the bonding line and then partially followed this line giving as a result a relatively high impact value and it is necessary to say that this result could not be acknowledged as a proper one. On the contrary, the "negative specimen" (Fig. 13c) shows the very straight way of the fracture going

thoroughly through the strip of the bonding line. This result which is 1.6kgf·m we must acknowledge as a proper one. If so, we should find explanation why so very low ductility occurs after welding in the allegedly sufficiently high ductile researched material.

- (a) The kind of measurement
- (b) Hardness value in positive specimen (B1)
- (c) Hardness value in negative specimen (B2)
