# SEM Dynamic Observation of Hydrogen-Induced Cold Cracking in Weld Metal of 80 kg/mm<sup>2</sup> Class Steel<sup>†</sup>

Fukuhisa MATSUDA\*, Hiroji NAKAGAWA\*\* and Takeshi MATSUMOTO\*\*\*

Dynamic direct observation of hydrogen-induced cold cracking in scanning electron microscope is tried for weld metal of 80 kg/mm<sup>2</sup> class steel. Welded joint made with TIG-arc welding in argon-hydrogen mixing shielding gas is sliced and polished as soon as possible to minimize loss of diffusible hydrogen, and then bended with a restraint device. The specimen set to the restraint device is put into a scanning electron microscope, and crack initiation and propagation are observed and recorded with a video tape recorder. Results show close connection among degree of plastic deformation, slip bands, martensite laths and cracking mode.

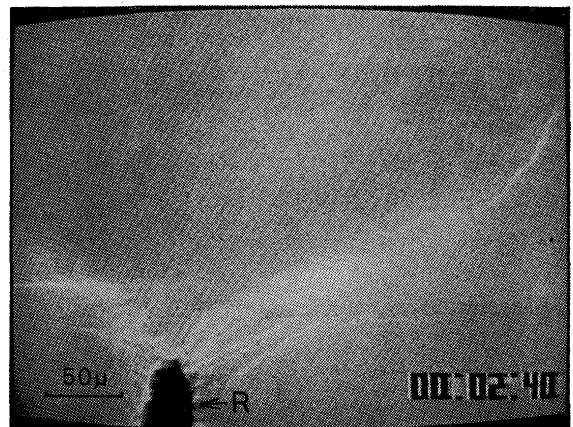
Fig. 5 Examples of stage I and stage II

(a) intense plastic strain region developed from root (stage I)

(b) crack initiation from root (stage II)

Figure 5 (a) and (b) give examples of stages I and II, respectively, where the six letters at lower site in the video picture show the time after the start of bending in a manner as XX(hr) XX(min) XX(sec). Many bright stripes are considered to be large slip bands, and the outline of the whole bright stripes, namely the intense plastic strain region developed in two direction from the tip of root gap R as expected from theory of plasticity. Each slip band, however, was generally parallel to laths of martensite according to metallographic investigation of etched microstructure after the observation. In Fig. 5 (b) initiation of a microcrack C was observed.
