Title	Studies on Repair Welding in Japan
Author(s)	Horikawa, Kohsuke; Suzuki, Hiroyuki
Citation	Transactions of JWRI. 1985, 14(2), p. 375-383
Version Type	VoR
URL	<a href="https://doi.org/10.18910/11350">https://doi.org/10.18910/11350</a>
rights	
Note

# Studies on Repair Welding in Japan†

Kohsuke HORIKAWA\* and Hiroyuki SUZUKI\*\*

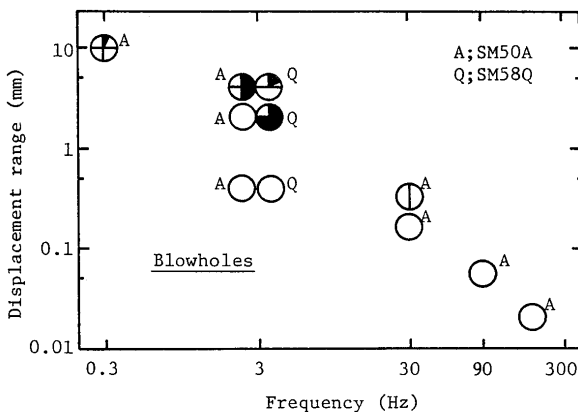
Fig. 7 Results of radiographic inspection on fillet weld by vertical up welding under out-of-plane vibration

Vibrations of bridges in service condition were measured and bead appearance and internal defects of joints welded under vibration were studied by I. Suzuki et al.<sup>13)</sup> Three bridges were measured as shown in Fig. 5. Vibrating conditions in experiments were decided from results of measurements. Frequencies were 0.3 ~ 300 Hz and displacement ranges were  $V_s$ ,  $5 \times V_s$  and  $10 \times V_s$ , where  $V_s$  was the measured maximum displacement range in each frequency. Vertical up and down welding were performed under in-plane or out-of-plane vibrations with above conditions. Results are shown in Figs. 6 to 8. It is obvious from these figures that many undercuts occur at 3 Hz in vertical up welding, that in-plane vibrations have influence on bead appearance more than out-of-plane vibration and that blowholes do not occur within  $5 \times V_s$  to harm the quality. Internal defects were blowholes, lack of joint penetration, lack of fusion and so on. Therefore, it is concluded that welding can be performed under vibration of bridges in service condition in case within  $5 \times V_s$  by paying considerable cares. Vertical down welding was better procedure under in-plane vibration than vertical up welding because it showed good results in bead appearance and blowholes even under  $10 \times V_s$  in-plane vibration.
