INVESTIGATION AND RESEARCH OF LANDSLIDE GEOHAZARD IN NORTH-WESTERN PART OF VIETNAM FOR THE SUSTAINABLE DEVELOPMENT OF THE TERRITORY

Nguyen Van Can and Dao Van Think

Northern Geological Mapping Division

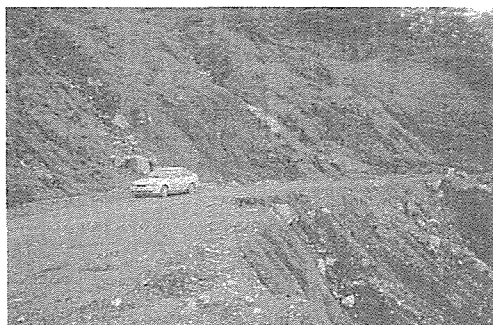
Reason: by road making; rain; thick weathering crust; steep slope of relief; strongly broken up rocks; active fault (Dien Bien-Lai Chau fault); underground water (there is one water out-crop near the foot of main body with the water recharge = 0,02l/s). Landslide is in thick layer of broken up. The vegetation is thinly populated.

Type of sliding: fast sliding on one plain surface. Material of main body is: broken up rocks, soil of weathering crust (silt, clay with dark brown, red-brownish color), soil layer (0,2-0,5m) and vegetation layer. The original rocks are yellowish gray, dark gray clayish shale of Lai Chau formation. Rocks were under-gene mechanic weathering and strongly broken up. The striking and dipping of rocks: 260-270<60. Main body has the shape of semicircle with length of 80m; width of 150m; high of 40m; depth of 3m; main scarp of 5m. Area of main body is ~ 9430m²; the volume of main body is ~ 28.290m³;

Damages: Destroyed 200m of 12 road and caused traffic jams for many days.

This is a typical multi-time landslide occurring in fine-grained terrigene sediments with sliding direction coinciding with rock dipping.

Pic.No2. The landslide point in South of Huổi Lềng, Mường Lay district, Dien Bien province.

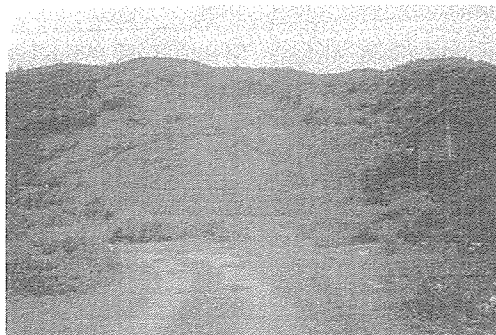
Reason: rain; thick weathering crust; deep slope; active fault (Dien Bien-Lai Chau fault). Landslide is in thick weathering crust (>5m). From strongly broken up rocks of Lai Chau formation. The striking of rocks is: 270<35. The vegetation is thinly populated.

Type of sliding: fast sliding on one plain surface. Material of main body is: broken up rocks from dark gray shale of Lai Chau formation, soil of weathering crust, soil layer and vegetation layer. Main body has the shape of semicircle with length of 50m; width of 100m; high of 15m; depth of 5m (according to electrical sounding the depth of weakened zone is >50m); main scarp of 10m. Area of main body is ~ 3925m²; the volume of main body is ~ 19.625m³;

Damages: Destroyed one part of forest with the area of 3925m².

This is the typical old landslide occurring in terrigenous sediments with the sliding direction against to rock dipping.

**Pic.No 3. The landslide point near Culture House at old Lai Châu town,
(now Mường Lay town ,Dien Bien province).
(taken by Đào Văn Thịnh, 2001)**
