# INVESTIGATION AND RESEARCH OF LANDSLIDE GEOHAZARD IN NORTH-WESTERN PART OF VIETNAM FOR THE SUSTAINABLE DEVELOPMENT OF THE TERRITORY

Nguyen Van Can and Dao Van Think

*Northern Geological Mapping Division*

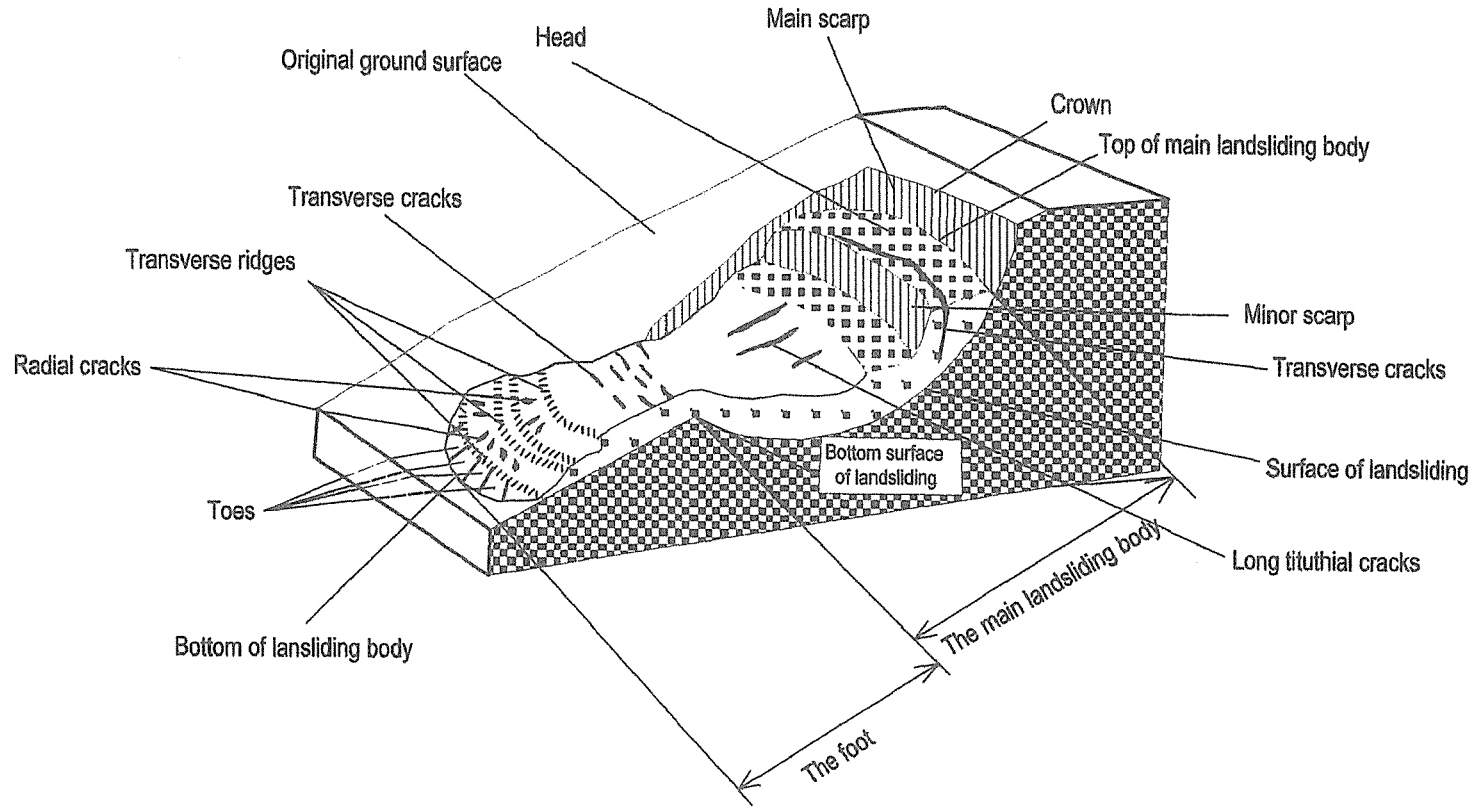
**Fig.No-1: Block diagram of idealized complex landslides**  
(According to Varnes, 1978)

During recent years the investigation and research of landslide in N-W part of Vietnam was carried out along main roads, big rivers, in high populated areas and along tectonic faulting zone. Where landslides often occurred. The landslide points had been described according to landslide model of W. Varnes, 1978 (see, fig. N° 1).

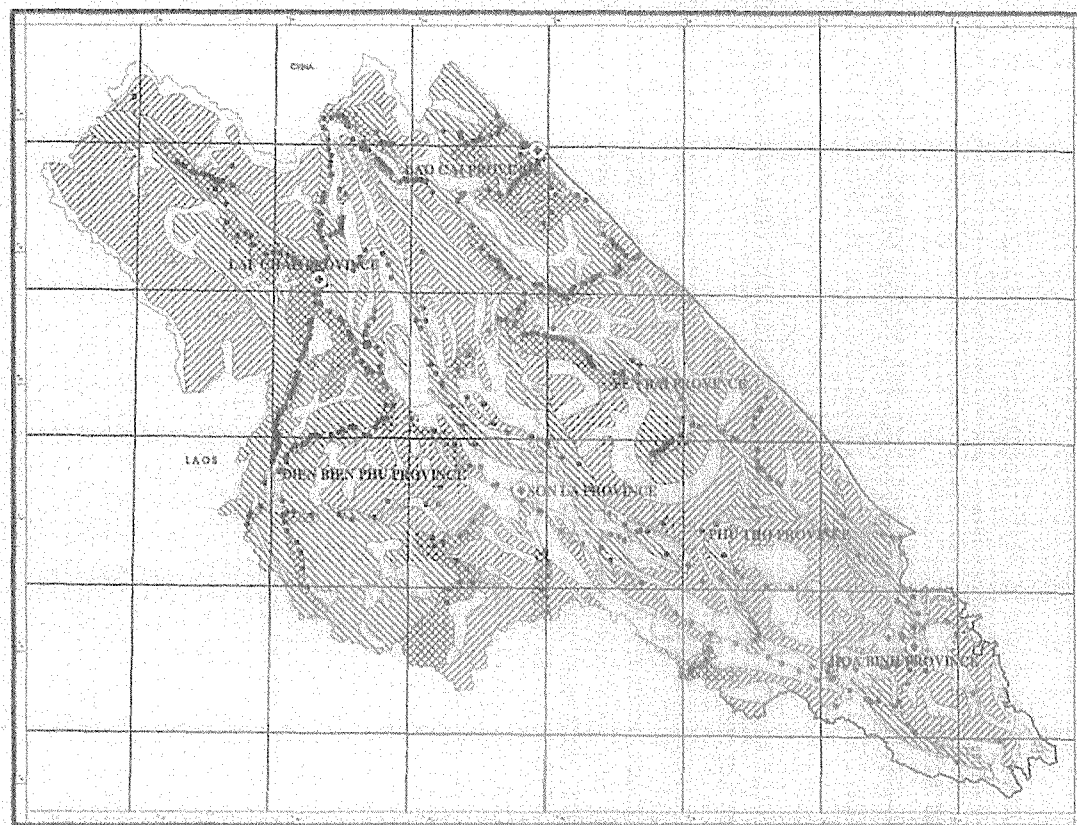
Fig No-2: Geohazard map of North-Western part of Viet Nam

By the results of investigation and research, the authors had established the Map of landslide in North-Western part of Vietnam. On this map the authors pointed out the danger levels of landslide occurring in various areas of North-Western part of Vietnam for the sustainable development planning of the territory.

By the results of investigation and research, the authors had established the map of landslide occurring in various areas of North-Western part of Vietnam for the sustainable development planning of the territory. This map was established on the basic of over-putting (integration) of different information layers (relief, slope, vegetation, rock types,...) by layer ration estimation and the distribution of investigated, studied landslide points (see fig. N<sup>o</sup>2).

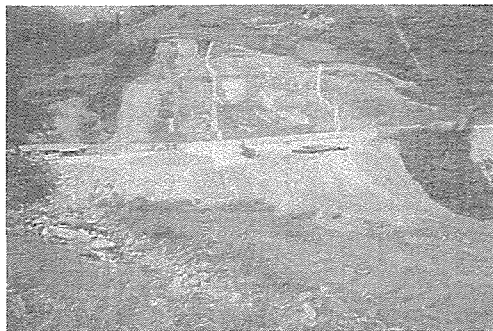
**a. The first landslide point** at Mong Sen II bridge on road of 4D, 22km far away from Sa Pa center.

*The main parameters of landslide:* original slope: 25°; slope of main body: 25°; slope of sliding surface: 30°;

*Reason:* by road making; rain; thick weathering crust; underground water (there is one water out-crop near the foot of main body). Landslide is in thick weathering crust (>5m) from granite rocks of Po Sen complex. The foliation of granite is 130<45. The vegetation is thinly populated.

*Sliding direction:* 130° (NE) and is coinciding with granite foliation.

*Type of sliding:* fast sliding on one plain surface. Material of main body is: broken up rocks, soil of weathering crust (silt, clay with dark brown, red-brownish color), soil layer (0,5-0,8m) and vegetation layer. Main body has the shape of semicircle with length of 150m; width of 130m; high of 50m; depth of 2-3m (according to electrical sounding the depth of weakened zone is >10m); main scarp of 3m. Area of main body is ~ 41.458m<sup>2</sup>; the volume of main body is ~ 207.290m<sup>3</sup>;

*Scale:* very big (I level).

*Damages:* 2 persons died before 1998; expenditure for repairing alone in 2000 was 10 billions VND. The engineering works for sliding protection (such as: wall, rock-baskets, water drainage canals) build in 2000. But they had been destroyed in 6/2002 because of a new landslide.

**Pic. No1. The typical landslide point at Móng Sến II bridge, Sa Pa district, Lào Cai province occurred several times in recent years and caused large material damages and human losses (taken by Đào Văn Thịnh, 2002)**

At present time this point is being repaired by transport Administration of Lao Cai province. This is the most typical multi-time landslide in NW part of Vietnam occurring in thick weathering crust from granite.

It is necessary to study at details all reasons causing landslide for making the method of protection and avoiding. For example, in Mong Sen II bridge landslide point the authors proposed to remove one part

of Road 4D to another side of the valley because all the protection methods done in recent years are not effective (see Fig. N° 3).

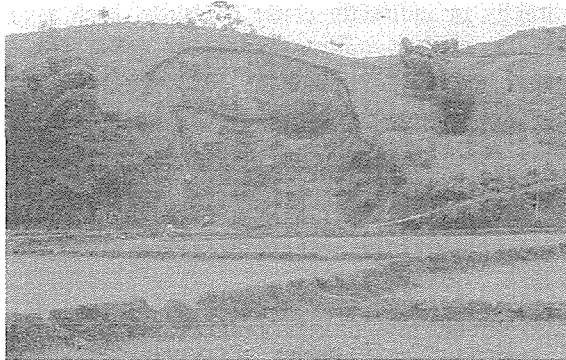
At Nga village, Ching Pha Commune, Thuan Chau district, Son La province.

*The main parameters of landslide:* original slope: 25°; slope of main body: 15°; slope of sliding surface: 15-45°;

*Reason:* rain; thick weathering crust; underground there may be limestone rocks with karst. Landslide is in thick weathering crust (>5m) from basalt rocks of Cam Thuy formation. The vegetation is thinly populated. Sliding direction: 130° (NE). Type of sliding: subsidence sliding on one curve, rolling surface.

Material of main body is: soil of weathering crust (silt, clay with dark brown, red-brownish color), soil layer (0,5-0,8m) and vegetation layer. Main body has the shape of accimmetrical oval with length of 20m; width of 10m; high of 5m; depth of 2,5m; main scarp of 5m. Area of main body is ~ 245m<sup>2</sup>; the volume of main body is ~ 612,5m<sup>3</sup>;

*Scale:* medium (III level). On the surface of the main body there are many cracks.

*Damages:* Destroyed about 300m<sup>2</sup> of cultivated land. This is the landslide with subsidence-sliding dynamics by a rolling curve surface in the weathering crust from basalt with the existence of many cracks.

Pic.No4. The landslide point in Bản Ngà village ,Chiềng Pha commune,Thuận Châu district , Son La province( taken by *Đào Văn Thịnh, 2001*).
