# THE ROLE OF MANGROVES IN MITIGATING NATURAL DISASTERS

Phan Nguyen Hong and Vu Doan Thai

*Mangrove Ecosystem Research Division (MERD)*

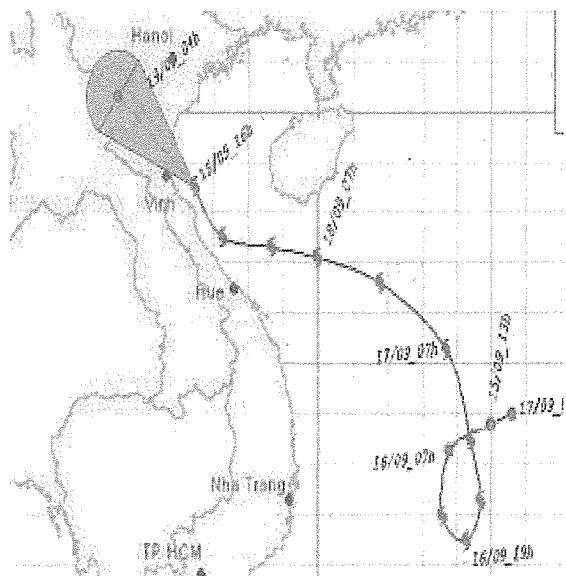
Figure 1. The storm Vincente (No. 6) attacked the country (Source: Viet Namnet 18/9/2005)

The storm Vincente with a wind power of 8 and 9, combined with heavy rain and spring tides caused destruction of property, flooding areas on September 18 - 19, 2005 (fig. 1). Many sections of seadykes in Quynh Luu, Dien Chau, Nghi Loc - Nghe An province were seriously damaged. Many concrete seadykes in Cat Hai island, Hai Phong were destroyed, and thus Hai Phong city was deep under water. Many places were flooded, and roads damaged (including the Ho Chi Minh highway) by storm rains in Quang Binh and Quang Tri (Vietnam net, 9/2005).

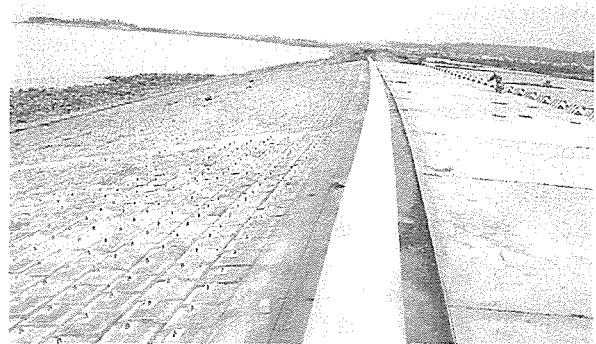
Figure 2. A section of seadyke in Hai Phong destroyed by the 2005 storms has just been consolidated with the cost of nearly 20 billion VND (1,250 million USD)

In the first half of 2006, the State of Viet Nam spent over 200 billion dong to repair sea dykes, but this amount has been sufficient to cover only the most strategic parts with concrete (Fig. 2).

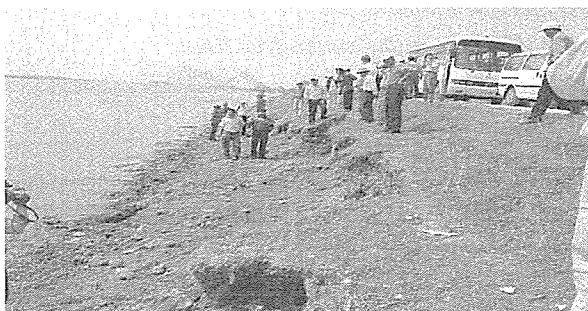
Figure 3. 650m of central seadyke in Tan Boi village, Thai Do commune, Thai Thuy district, Thai Binh province eroded due to storm Damrey (No 7) as a result of mangrove absence

In the storm Damrey on 27 and 28 September 2005, high waves crashed down over a 650m seadyke in Tan Boi village, Thai Do Commune (Thai Binh Province) (fig. 3) where no mangrove was present. At the same time many other sections of the seadyke in the commune suffered no collapse due to the protective green belt of mangroves decreasing wave intensity (fig. 4).

During the first quarter of 2006, the State had to spend 1.3 billion VND (equivalent to USD 81,200) to repair the above seadyke, which is equal to the total cost of planting and protecting a mangrove belt along this seadyke during many years.

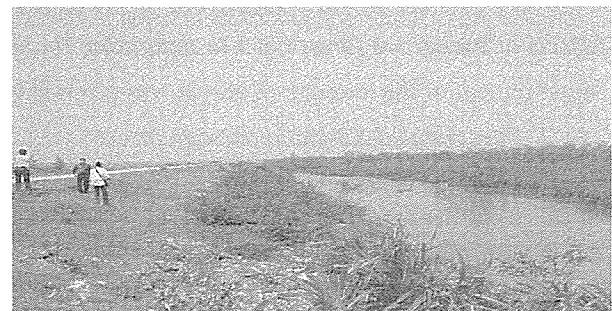
Figure 4. 5km of seadyke protected by mangroves in Thai Do commune and therefore, not eroded in presence of the storm Damrey

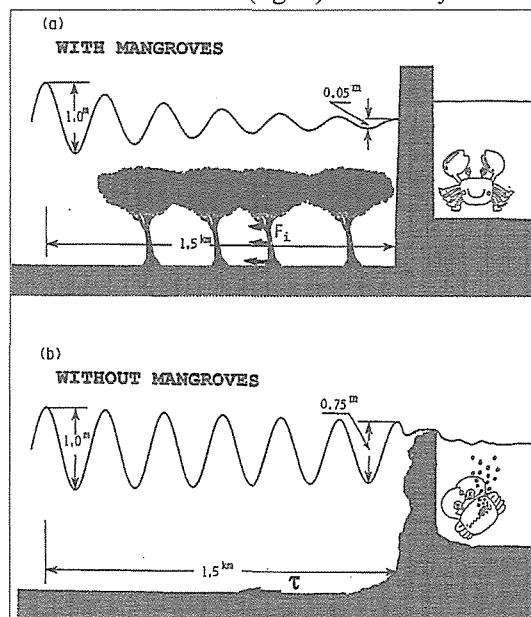
Figure 5. Wave decrease difference between mangrove (a) and non – mangrove areas (b) in Thuy Hai, Thai Binh

- The waves of 1m high from the bare flat that pass through the 1.5km wide mangroves are reduced in height to 0.05m when reaching crab ponds

- In the non-mangrove area, with the same wave movement distance, the wave height at crab ponds is 0.75m and the pond embankment is eroded.

Thuy Hai has planted *Kandelia obovata* forests of 1.5km width, with various ages. These types of forest have been newly planted; the trees are still small and sparse. Therefore, they would have little effect on reducing the strength of waves. The strength of waves is decreased only by friction with the substrate. Meanwhile, inside the forests, trees of over 2m high and their thick canopies of leaves and root systems under the tidal water (fig. 5) effectively reduce wave strength (fig. 6).

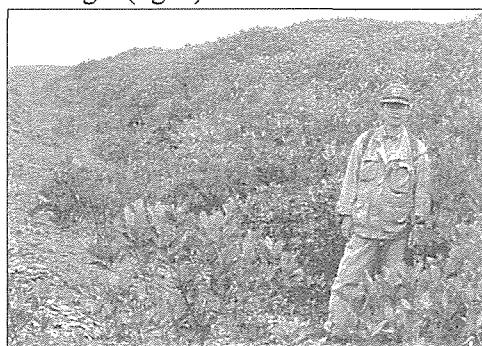
Photo 6. Mangroves in Thuy Hai, Thai

Thuy, Thai Binh (Photo: Le Xuan Tuan)

- The highest trees (close to the bank): 3.00m
- The trees of medium height (200m far from the bank): 2.5m
- The trees near sea water edge (newly planted): 0.3m

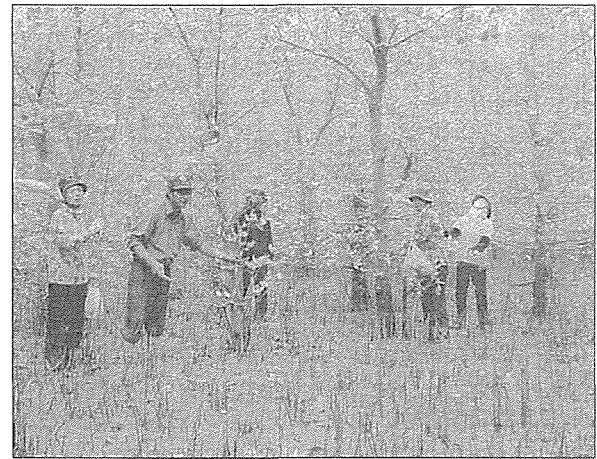
Figure 7. Planted *Sonneratia caseolaris* forest to protect sea dyke at Vinh Quang Com.  
(Source: Vu Doan Thai)

Forests of pure *Sonneratia caseolaris* in Cong Roc area of Vinh Quang commune planted in 1995\* are about 920m in width, 8-9m in height and with diameters of 15-18cm (fig. 7). Machines of DNW – 5M and Ivanop H10 coupled with Mia were used in some specific sites (Thai 2005) to calculate coefficients of decreasing height of waves. The results showed that: At the times of highest tides combined with the wind directions into forests, the average height of waves in the shallow water, 180m away from forests, was 0.43m; however, the wave level decreased to 6.8cm behind *Sonneratia caseolaris* forests of 920m wide. Wave height and its average decreasing coefficient at each range of forests are: 0.39m and 31%, respectively, after the first 100m; 0.19m and 57% after 300m; 13cm and 69% after 500m; 9.8cm and 77% after 700m; .6.8cm. and 84%, correspondingly, after 920m.

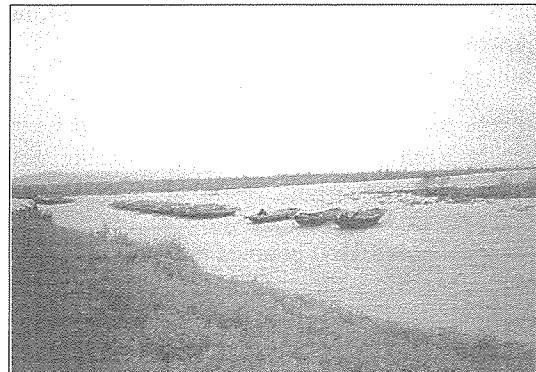
Figure 8. Planted *Kandelia obovata* reduce wave height at Bang La Com in Vincente storm  
(Photo Vu Doan Thai taken on 18 September 2005)

During Vincent storm, the height of waves decreased as they reached the large shallow mudflat close to shore wave measured at 17:30 at a point of 150 meters in front of the *Kandelia obovata* forest was 1.1m. Behind the forest of 650 meters wide, waves were only 0.09m, giving a Decrease Coefficient of 92% (fig. 8).

The above calculations show that *Kandelia obovata* forests of 650m wide, with a density of 182 plants/100m<sup>2</sup>, with branches growing 45-50cm from the ground level, thick canopy, 90-95% coverage have the effect of reducing up to 80-88% the height of waves during storms.
