# Keys for successful introduction of ecosan toilets: experiences from an ecosan project in Vietnam

Ecological sanitation (*i.e.*.. ecosan) is considered to be a possible approach to not only sanitize human excreta but also recover nutrients for agriculture. Eighty-five ecosan toilets were introduced in Vietnam from 2002 to 2003 by authors and a Japanese NGO. In this paper, we (1) reviewed the project, (2) analysed the project from the aspects of the toilet construction, the toilet use and management, and disinfection performance by the toilet, and (3) developed keys for successful introduction of ecosan toilets. It was considered that this project was introduced successfully. Based upon the analysis, construction quality, effect of local conditions and self-fixing of the toilet were proposed for successful ecosan-toilet construction. In this project, at least 3-month education on the ecosan toilet was required. This education period may become a valuable reference for other ecosan projects and education on applying ash and handling urine was considered as key issues. At least 10-month retention of faeces was required to disinfect faeces in this project. This period may become a v

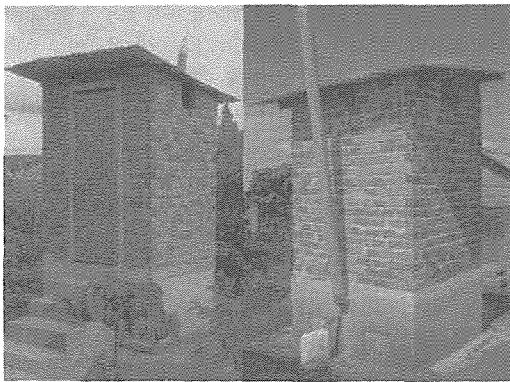
**Figure 2** Outside of the toilet

**Figure 2** shows the outside of the toilet and **Figure 3** shows the urine-diversion squatting pan in the toilet. The hole in the centre of the pan connects to a urine container at the back of the toilet. At both sides of the pan, there are red and blue covers for each of two-faecal chambers under the pan. **Figure 4** shows mechanism to divert urine from faeces. As diverted urine is considered to contain few pathogens generally, it is used for agricultural purposes after dilution. Faeces are deposited with ash in one of two chambers under the toilet for disinfection. After an appropriate retention period, the faeces are removed from small doors at the back of the toilet and also used for agricultural purposes.
