# Thermal Shock Resistance of $ZrO_2$ -8wt.% $Y_2O_3$ Coatings Prepared by Plasma Laser Hybrid Spraying Technique<sup>†</sup>

Sang Ok CHWA\* and Akira OHMORI\*\*

## Abstract

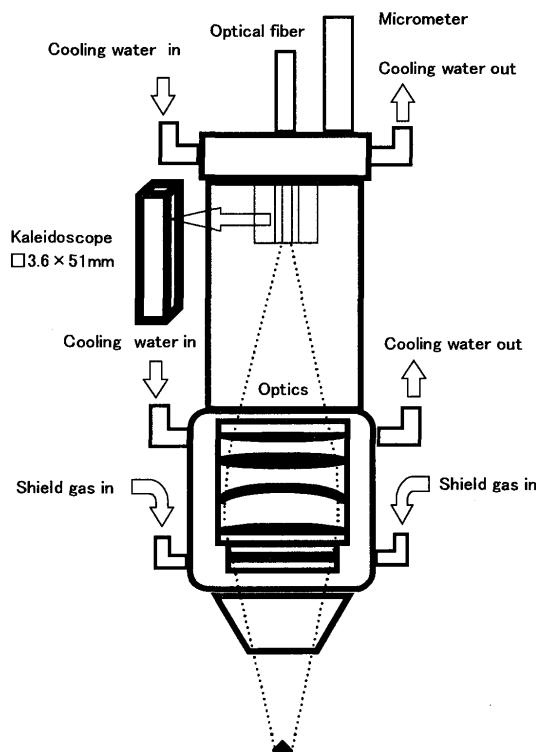
Fig. 1 Schematic diagram of YAG laser gun equipped with a kaleidoscope.

The beam delivered by an optical fiber is reflected many times on internal reflective metal walls and emerges well homogenized through the optics. The beam characteristics of the YAG laser were analyzed by laserscope UFF100 and laser beam powermeter (Prometec, Achen, Germany). The beam size of kaleidoscope-installed YAG laser varied from  $5 \times 5 \text{ mm}^2$

to  $15 \times 15 \text{ mm}^2$  by adjusting the distance between the optics and kaleidoscope with a micrometer. Beam profiles of kaleidoscope-installed YAG laser at the exit of nozzle are characterized by "top-flat" distribution. The usefulness in laser treatment using the kaleidoscope can be found in our previous report.<sup>7)</sup>

Post treatments of predeposited coatings and simultaneous treatments during the spraying process were carried out using the laser combined spraying system. Both plasma gun (SG-100 model, Miller Thermal, Appleton, WI, USA) and the laser gun were installed inside a chamber equipped with a exhaust system. An Nd:YAG laser (NEC, Sagamihara, Kanagawa, Japan) working in continuous wave mode at 1.06  $\mu\text{m}$  was used and the laser beam coming from the oscillator was delivered by optical fiber to the laser nozzle. The samples for the laser treatment were fixed onto an X-Y table, moved by a six-axes articulated robot. The details of the plasma spraying system combined with conventional-laser can be found in our previous report.<sup>9)</sup> To obtain a uniform beam intensity, a kaleidoscope composed of two pairs of gold mirror ( $3.6 \times 51 \text{ mm}^2$ ) was installed in a conventional YAG laser. The schematic diagram of a YAG laser gun equipped with a kaleidoscope is depicted in Fig. 1.

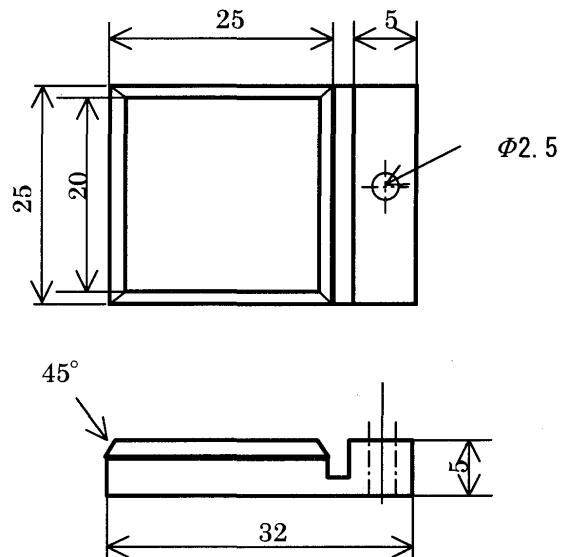
sample was evaluated by the following method. The substrates of plasma spraying for the thermal shock test were machined to have same tapered edges as shown in Fig. 2. The specimen was kept in the furnace for 3 minutes after reaching test temperature (1273 K) and then dropped into icy water( $279 \pm 2$  K). After each thermal cycle, the sample was visually observed. Testing was stopped when the TBC coat spalled from 50% of the test zone ( $20 \times 20$  mm<sup>2</sup>).

Fig. 2 Shape of substrate used for the thermal shock test

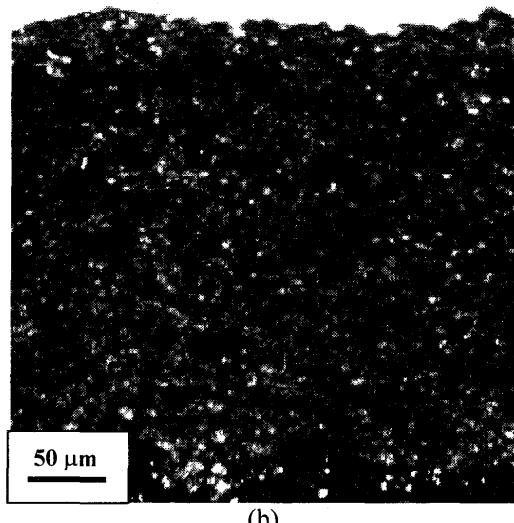
Fig. 3 show a CLSM image of a plasma sprayed coating prepared by vacuum impregnation of fluorescent modified Spurr resin. Fig. 3(a) shows images of 9 x-y sections obtained by cutting optically the sample with a step of selected  $\Delta z$  (3  $\mu$ m) and Fig. 3(b) is a finally reconstructed image from the stored images of Fig. 3(a). As can be seen in the Fig. 3(b), the fluorescent resin is observed deep inside the coating and reaches to the interface of bond coat and top coat, revealing a large number of pores with a different sizes.

Fig. 3 (a) CLSM series of 9 x-y optical sections of as-sprayed YPSZ coating; (b) three-dimensional reconstruction of Fig. 3(a) corresponding to a volume of 320 by 320 by 18  $\mu\text{m}^3$

When the coating contains very fine defects and microcracks, it is difficult to differentiate between original defects formed by the spray process and induced ones from metallographical procedures. Other methods for impregnation by metals or their salts may also be used. However, the main practical disadvantage is that it is impossible to get a three dimensional image. Vacuum infiltration technique with a fluorescent modified Spurr resin is considered to be a very effective way of visualizing the three dimensional structure.

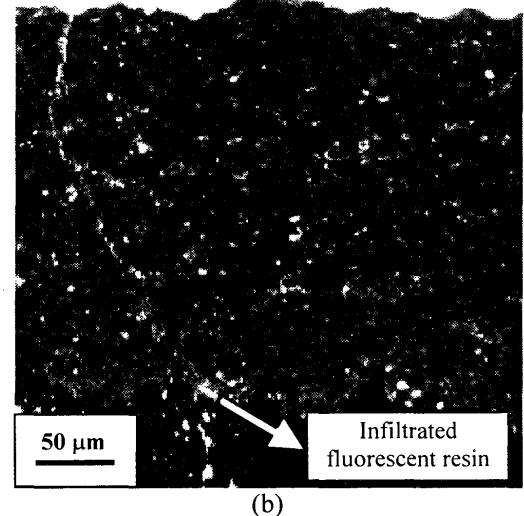
For the treatment of 1kW laser power with kaleidoscope (Fig. 4(a) and Fig. 4(b)), pores in the surface region decreased and microcracks generated though the boundaries of splats were observed. When the treated surface of specimen was examined, no glazing from a laser treatment was observed. Therefore, the reduced porosity and microcracks are considered to result from sintering between sprayed splats without remelting of coating. With the laser power of 1.5 kW with a kaleidoscope, remelting of sprayed coating occurred and resulted in formation of the vertical cracks extending to the interface between the bond coat and top coat as shown in the Fig. 5(a) and Fig. 5(b). The

Fig. 4 (a) CLSM series of 9 x-y optical sections of laser-treated YPSZ coating (laser power: 1kW, beam size: 7 × 7  $\text{mm}^2$ ); (b) three-dimensional reconstruction of Fig. 4(a) corresponding to a volume of 320 by 320 by 18  $\mu\text{m}^3$

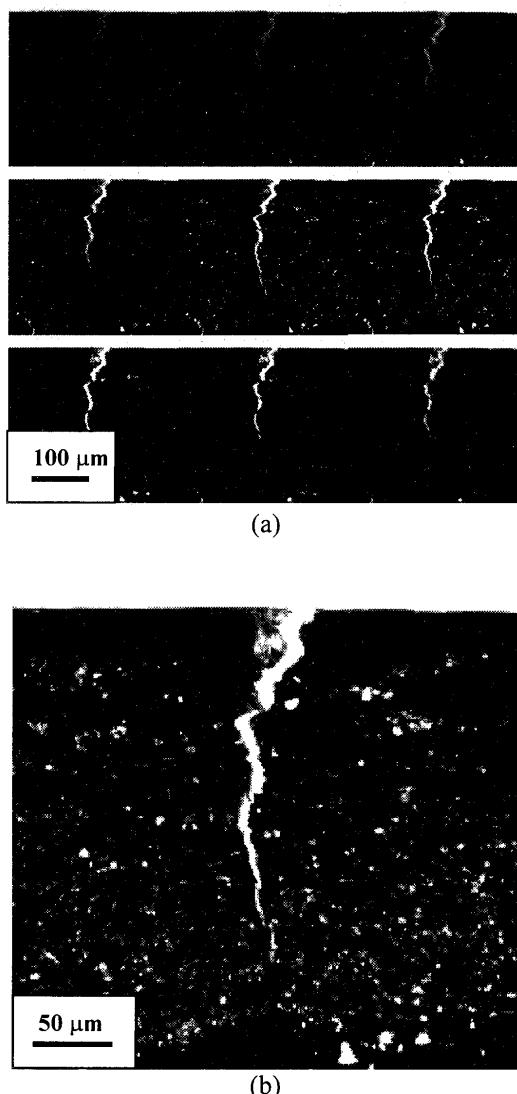
vertical cracks were generated by the relaxation of residual stress during the cooling down of molten zirconia to room temperature. Melted depth was about 50 $\mu\text{m}$ , and treated layer was very dense with no resin infiltration even in vacuum impregnation treatment. Depth and width of cracks increased with increasing power from 1 to 1.5kW, and very smooth surface was obtained.

Fig. 5 (a) CLSM series of 9 x-y optical sections of laser-treated YPSZ coating (laser power: 1.5kW, beam size:  $\square 7 \times 7\text{mm}^2$ ); (b)three-dimensional reconstruction of Fig.5(a) corresponding to a volume of 320 by 320 by  $18\text{ }\mu\text{m}^3$

increases of laser power density for laser treatment lower the lifetime in cyclic thermal shock tests. From the observation of cracks as shown in **Fig. 5** and **Fig. 6**, the depth and width of cracks and spacing between cracks appear to be a crucial parameters that influence the thermal shock resistance. When the excessively penetrated cracks exist, the thermal shock resistance of coatings suddenly drops.

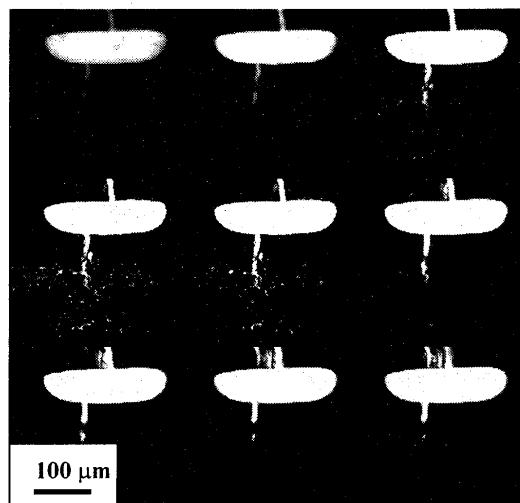
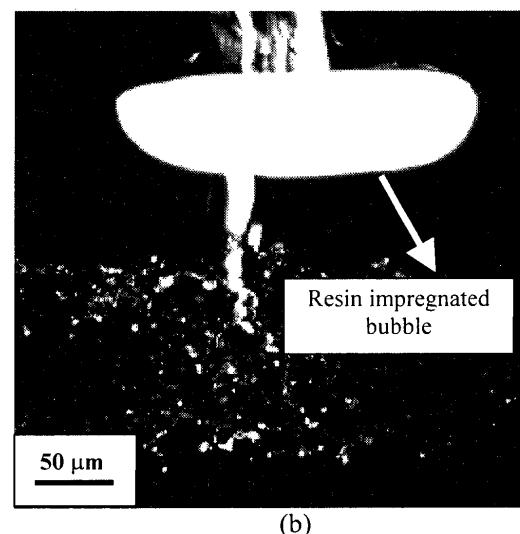
When the laser power was increased to 2.0 kW, large bubbles were found in the coating as shown in the Fig. 6(a) and Fig. 6(b). Y. Fu et al. also reported this phenomenon and explained the bubble formation mechanism as follows.<sup>11)</sup> when the as sprayed coating

is remelted by laser, with a flow of argon shield gas, the pores in the as-sprayed coating, (which initially have a similar size and are evenly distributed), begin to coalesce into large voids and tend to rise to the surface. Bubbles can occasionally be formed because of the involvement of some argon gas in the coating. As the laser beam moves away from any molten area with considerable speed, the molten coating solidifies rapidly. Some of the newly formed larger bubbles escape from the melting pool, while the remainder are trapped in the quenched melting pool. During the rapid solidification of the remelted coating, higher thermal stress causes the formation of cracks, and some cracks pass through the larger bubbles.

Fig. 6 (a) CLSM series of 9 x-y optical sections of laser-treated YPSZ coating (laser power: 2.0kW, beam size:  $\square 7 \times 7\text{mm}^2$ ); (b)three-dimensional reconstruction of Fig. 6(a) corresponding to a volume of 320 by 320 by  $18\text{ }\mu\text{m}^3$

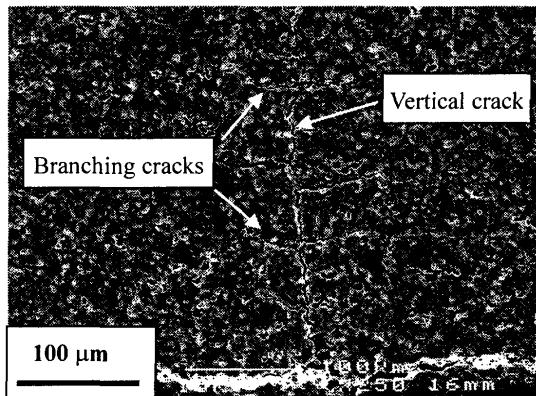
Microstructure observation by CLSM is very effective way of collecting three dimensional information of sprayed coatings and differentiating the original defects from ones induced by metallographical procedures. However, the resolution of CLSM is inferior to the scanning electron microscopy (SEM), so the observation of vacuum infiltrated specimen by SEM was also carried out. Fig. 7 shows the one example of a scanning electron micrograph of YPSZ coating prepared by plasma laser hybrid spraying process (laser power: 2.5kW, beam size:  $\square 5 \times 5\text{mm}^2$ ). In the case of coatings prepared by hybrid spraying processes, the feature of cracks in the coating was different from the post-treated coatings. From the post treatments of

coatings, sprayed coatings remelted and resulted in mainly vertical cracks which extended to the interface of bond-coat and top-coat.

**Fig. 7** Scanning electron micrograph of YPSZ coating prepared by plasma laser hybrid spraying process (laser power: 2.5kW, beam size:  $\square 5 \times 5 \text{ mm}^2$ )

However, the feature of cracks in the coating, prepared by hybrid spraying processes, was characterized as a feather-like structure with a significant number of branching cracks which was not observed in the post-treated coatings. During the hybrid spraying treatments, the sprayed particles were reheated by simultaneously irradiating laser and maintained at high temperature causing a gradual cooling of sprayed particles. The finely networked cracks of coatings prepared by hybrid process were considered due to the densification between sprayed splats by laser heat-treatment and retarded cooling procedure, whereas the rapid solidification of the remelted coating caused mainly vertical cracks with a broad width in post-treatment. It was also found that the branching number per vertical crack and the average length were significantly changed by the hybrid laser conditions.

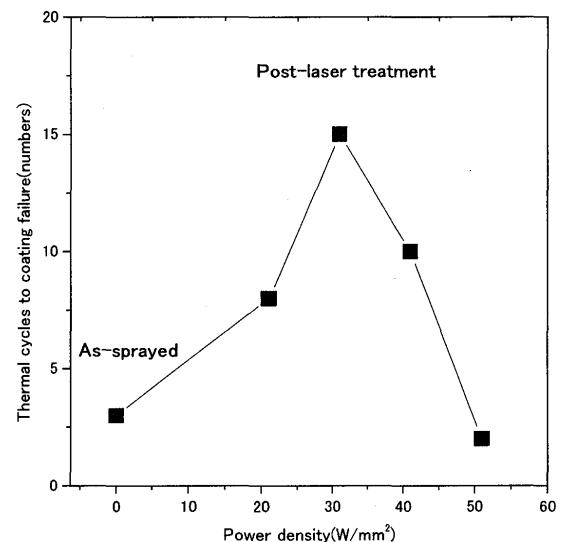
**Fig. 8** shows the experimental results obtained from cyclic thermal test of YPSZ coatings treated at different laser powers. As-sprayed coating failed after just three thermal cycle tests. On the other hand, the laser treated coating at 1.5kW (power density,  $31 \text{ W/mm}^2$ ) showed a five times of improvement of thermal shock resistance compared with the as-sprayed coating. Further

**Fig. 8** Cyclic thermal test results of YPSZ coatings treated at different laser powers (beam size,  $\square 7 \times 7 \text{ mm}^2$ ).

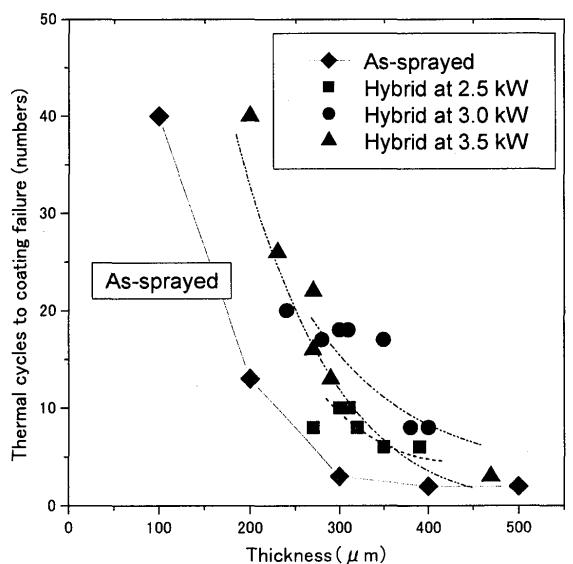
**Fig. 9** Cyclic thermal test results of YPSZ coatings prepared by hybrid spraying processes (beam size,  $\square 5 \times 5 \text{ mm}^2$ ).

**Fig. 9** shows cyclic thermal test results of YPSZ coatings prepared by hybrid spraying processes. The thermal shock resistance is a function of coating thickness, i.e., thinner coatings have a higher thermal shock resistance. When compared at the same thickness of post-treated coating of 300 $\mu$ m, the hybrid sprayed coatings show more improved thermal shock resistance (hybrid at 3.0kW) than post-treated coatings and a sudden drop of a thermal shock resistance was not observed, even at higher laser power (hybrid at 3.0kW). This improved thermal shock resistance is considered due to the microstructure of hybrid sprayed coatings which have a finely networked feather-like cracks
