Welding Mechanism of Laser-Arc Combination High Speed Welding[†]

Nobuyuki ABE*, Yasushi KUNUGITA**, Masakazu HAYASHI*** and Yoshiaki TSUCHITANI***

KEY WORDS : (CO₂ Laser Welding)(MIG Arc Welding)(Combination Welding)(High Speed Welding)(Welding Mechanism)

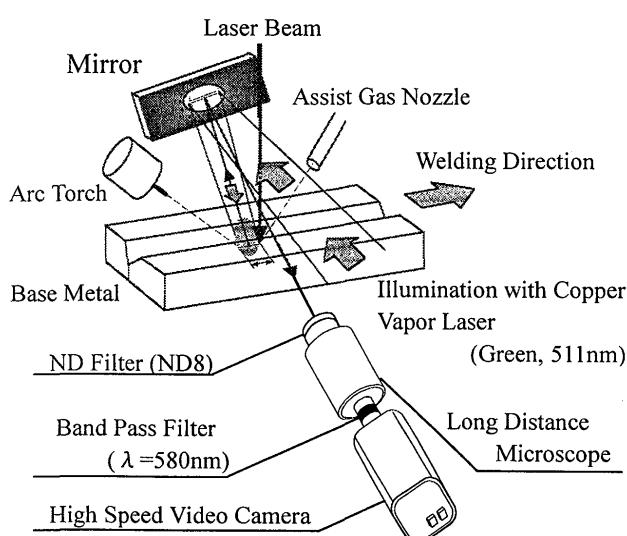
The observation system for welding phenomena is shown in Fig.1. A 7 kW CO₂ laser and a 10kW MIG arc welder were combined into the LPLAC welding system. Helium gas was used, both as the assist gas for the laser and the shield gas for MIG arc welding. Specimens used were mild steel plates SS400 of 16mm in thickness with a V groove. Welding speed was set at a constant speed of 5m/min. A long distance microscope was used for the observation of behavior of the molten metal, laser plasma and arc plasma in a narrow imaging area of 10mm x 10mm at the distance of 1m from the welding point. A copper vapor laser was used for illumination to suppress the intense light noise from laser and arc plasma.

Fig.1 Experimental apparatus

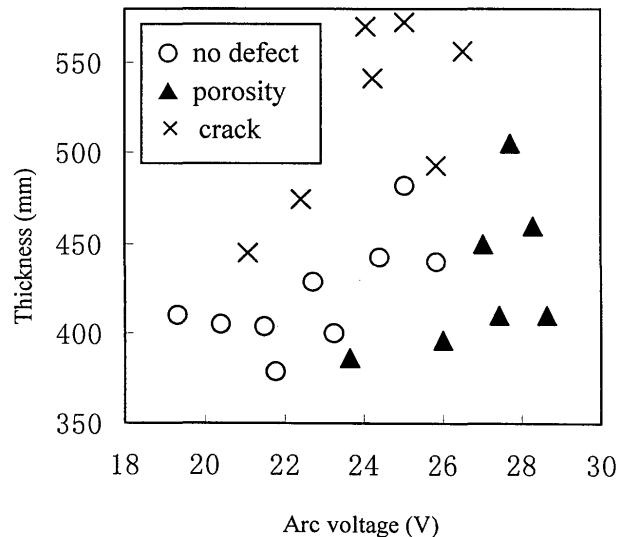
Fig.2 Arc condition dependency on welding defect

The occurrence of welding defects was investigated for various combinations of arc voltage and current in order to identify the non-defect arc condition area in Laser-Arc Combination welding at a welding speed of 5m/min. **Figure 2** shows the porosity, crack or non-defect zone plotted for various combinations of arc voltage and current. When porosities and cracks occurred in the same specimen, they were plotted in the crack zone. It can be seen clearly that three zones of crack, porosity and sound bead area are separated according to arc voltage and current. When the arc voltage was high, porosity occurred and when the current was high, cracks occurred. These phenomena were analyzed from the welding phenomena. **Figure 3** shows arc plasmas at different arc voltages and the same arc current of 450A. When the arc voltage becomes high, droplet transfer phenomena changed from globular transfer to spray transfer. **Figure 4** shows arc plasmas and molten metals at different currents and a constant arc voltage of 26V. With increasing arc current, the amount of molten metal was increased. On the other hand, it was observed that the penetration depth became shallower with increasing arc current.

It was thought that the irradiation of laser beam into the bottom part of the bead, which was the main factor of deep penetration, was suppressed by the increasing amount of molten metal caused by the high current arc. This caused the excess heat input to the upper part of the bead, inducing cracking in the bead. It was found that it is difficult for LPLAC welding to increase molten metal by increasing arc power because it also caused welding defects. Therefore, it is important to control the interaction of laser and molten metal by controlling the distance of laser and arc in accordance with increasing arc input power for further penetration depth in the LPLAC welding.

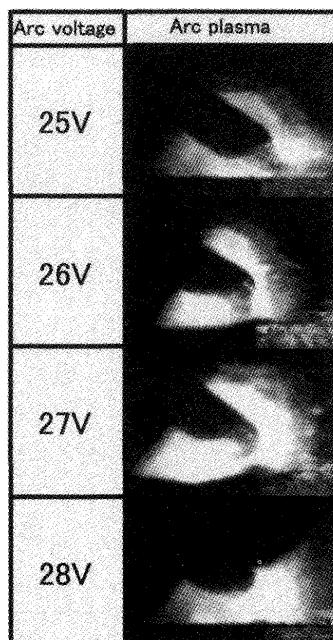
Fig.3 High speed photographs of Laser-Arc combination welding at various arc voltages
Laser power : 7kW, Arc current : 450A
Distance between laser and arc : 5.0mm, V groove

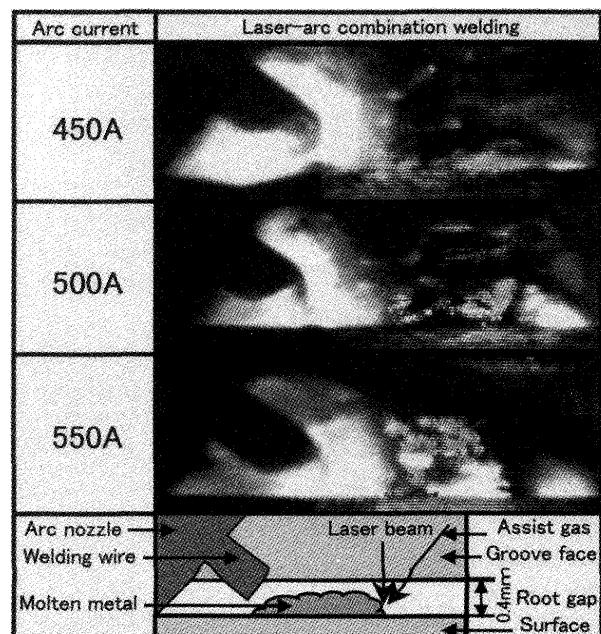
Fig.4 High speed photographs of Laser-Arc combination welding at various arc current
Laser power : 7kW, Arc voltages : 26V
Distance between laser and arc : 5.0mm, V groove
