# Proposal of Hydrogen Blistering Mechanism Associated with Disbonding between 2.1/4Cr-1Mo Steel and Type 309 Overlayed Metal

Fukuhisa MATSUDA \*, Hiroji NAKAGAWA \*\* and Sanae TSURUTA \*\*\*

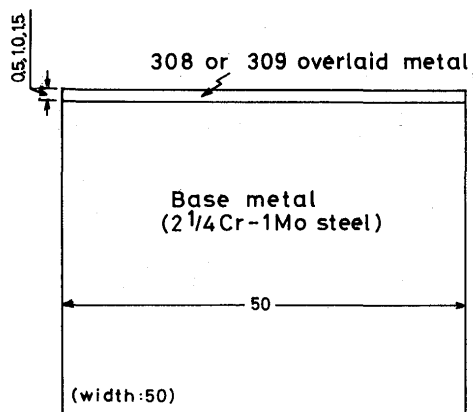
Fig. 3 Specimen configuration for the test in autoclave.

The specimen configuration for autoclave testing is shown in Fig. 3. The surface of overlayed metal was ground

to the thickness of 0.5, 1.0 and 1.5 mm to make the blistering noticeable, if it occurred. The conditions of autoclave were hydrogen pressure of 220 kgf/cm<sup>2</sup>, temperature of 450°C, holding time of 48 hr and cooling rate of about 350°C/hr to minimize the escape of hydrogen through thin overlayed metal.
