Analysis of Structural Features of Hard-Facing Overlays Performed Using Prototype Selfshielded Flux Cored Wires[†]

Robert A. BANKIEWICZ*, Kenji IKEUCHI***, Toshio ENJO**
and Yoshiaki ARATA**

Abstract

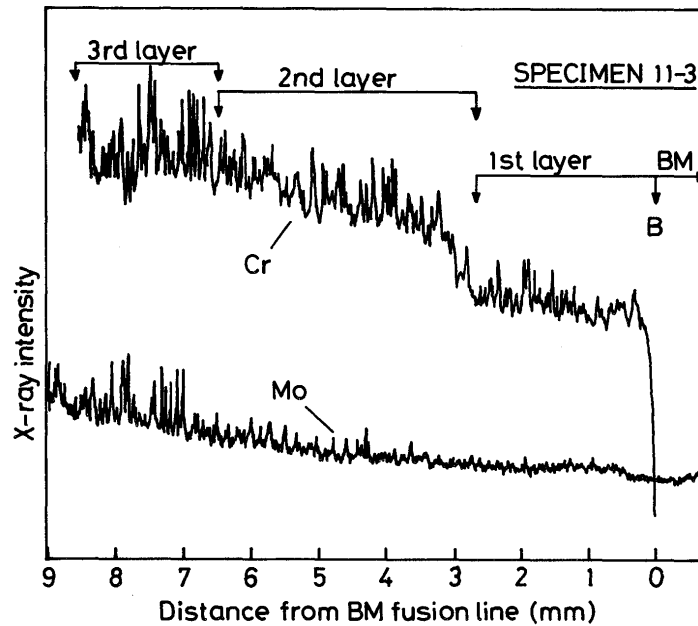
Fig. 5 EPMA results of Mo and Cr distribution in 11-3 specimen.

Figures 5 and **6** show results of wave-length dispersive x-ray microanalysis (EPMA) of specimens 11-3 and 14-3.

The increase of Mo and Cr content in first, second, and third layers, respectively, is evident in 11-3 specimen and corresponds to outcomes of chemical macroanalysis of individual layers (**Table 2**).

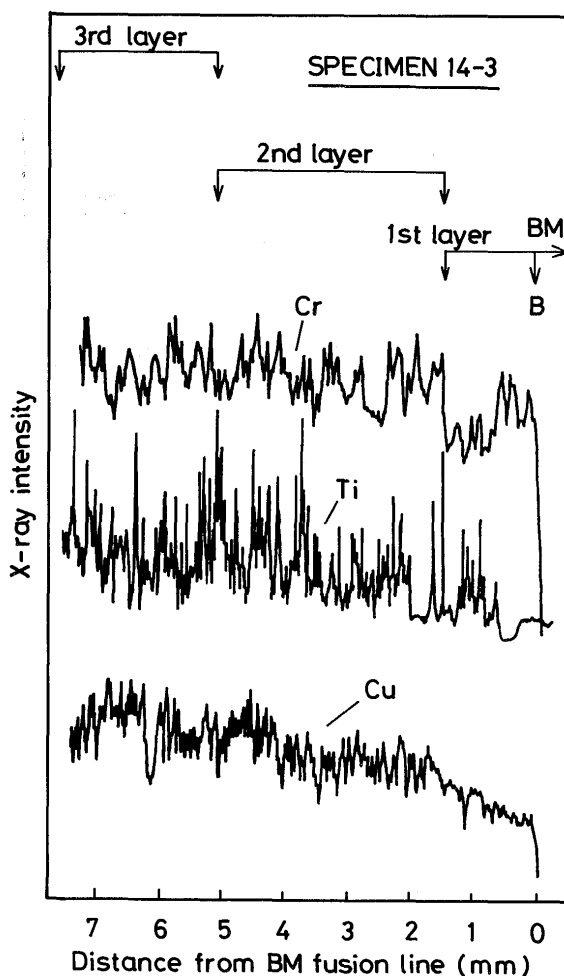
Fig. 6 EPMA results of Cu, Ti and Cr distribution in 14-3 specimen.

The variation of content of alloying elements in each layer of 14-3 specimen seems less distinct than in the 11-3 specimen, with the exception of Cu-line. These differences of elements distribution have likewise close connection with results presented in **Table 2** and will be discussed under fracture morphology of specimens.

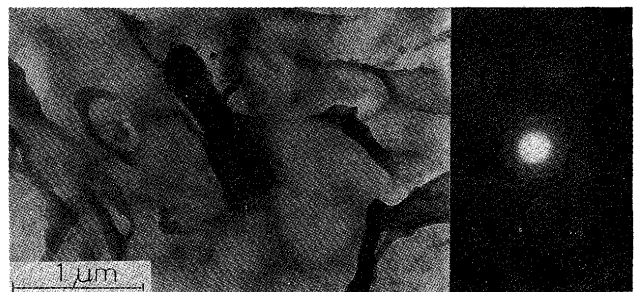
Fig. 18 Specimen 14-3: TEM micrograph of Cr₇C₃ carbide situated at the first layer grain boundary (CER).

the favoured region for precipitation is the grain boundary (Figures 11 to 20). Fusiform, coagulated, rectangular and acicular shapes of precipitates, respectively, were the prevailing forms observed using TEM. The size of precipitated particles ranged from 0.1 μm (MoC, TiB) to 1.5 μm (Cr_7C_3).

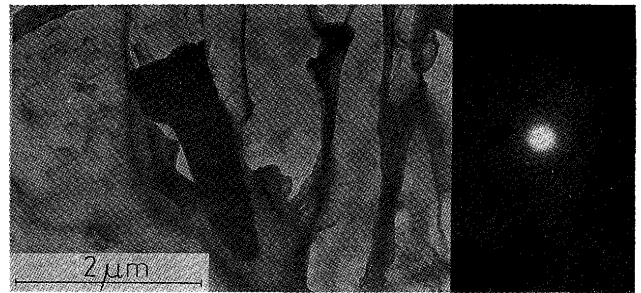
Fig. 20 Specimen 14-3: TEM micrograph of TiB boride situated at third layer grain boundary (CER).

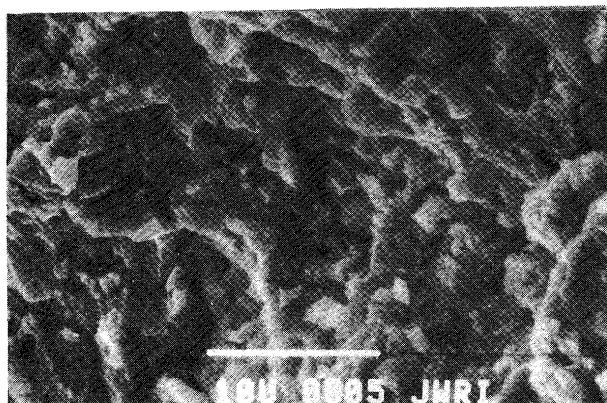
Fig. 27 SEM fractograph of the centre of 14-1 specimen overlay.

SEM examinations of 14-series specimens have shown high uniformity of their fracture morphology. Transcrystalline cleavage fracture of the area close to bond of 14-1 specimen, as well as the characteristics of the dendrite structure ductile rupture mode of the other regions of the overlay are shown in **Figures 26 and 27**.

The topography presented in Figs. 26 and 27 is representative for 14-series and shows some connection with both the hardness and alloying elements distribution.
