Doctoral Dissertation

**Sustainability of Cultural Heritage Assets
along with Self and Community Driven
Recovery from Natural Disaster in Indonesia**

Case Study in Yogyakarta and Padang

Graduate School of Engineering
Osaka University

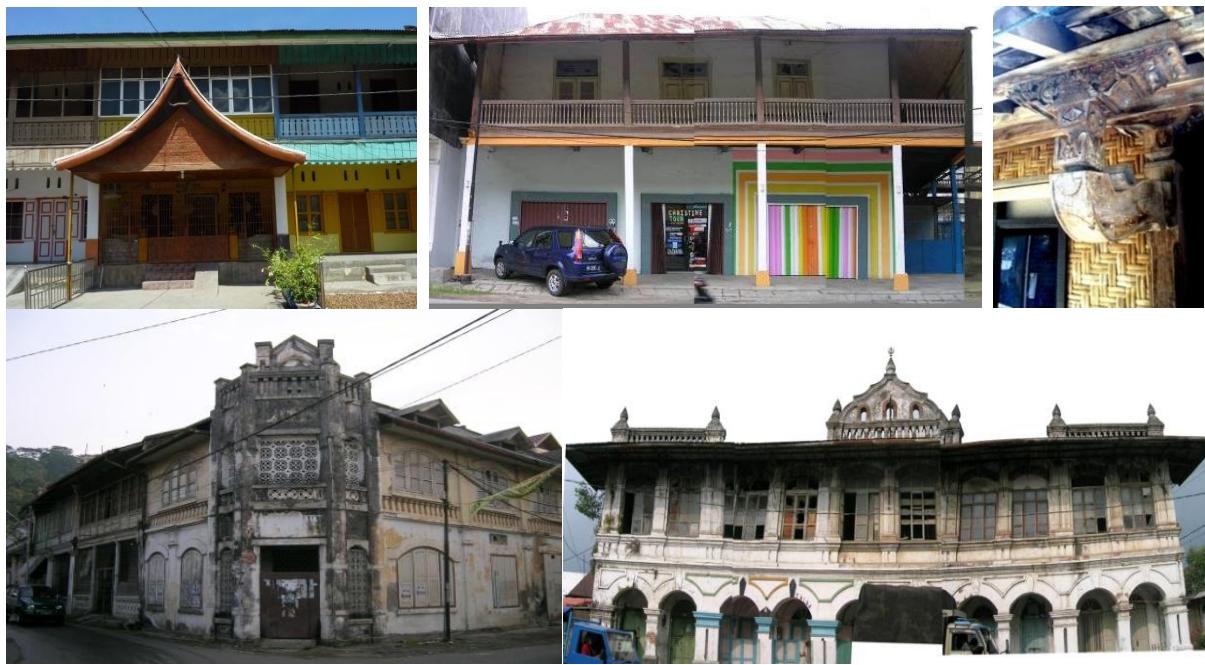
Fig.I.4 The degraded building condition, and uncontrollable transformation of the cultural heritage buildings before the earthquake in Padang old district and Kotagede

Privately/community owned cultural heritage buildings, presumably experience this owner driven rehabilitation as well through the years. This makes a lot of privately/community owned cultural heritage assets in Indonesia have suffered from all kinds of uncontrolled transformations. The deliberate changing of urban spaces, activities, and economic values reveal multiple ways of how the owner transforms their environment. Many historic buildings have been either demolished or transformed according to new designs even before the disaster struck (Fig.I.4).

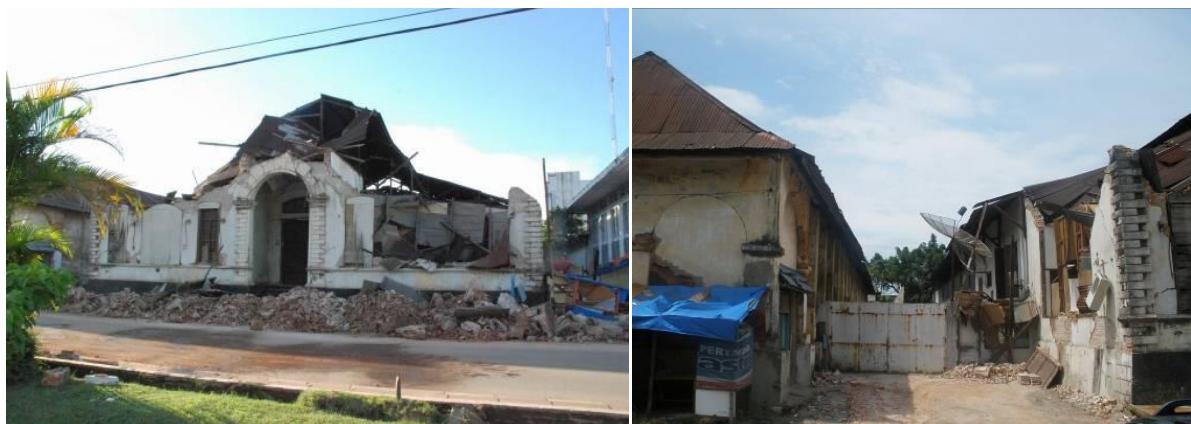
Fig.I.5 Debris clearing by the owner of cultural heritage building in Padang

Sometimes some programs such as clearing debris, rehabilitation and reconstruction are not in line with the spirit of cultural heritage building conservation. This can be clearly seen in the case of cleaning debris program of cultural heritage buildings in the Padang Old Town district. after the earthquake hit the debris were mostly treated like common building rubble (Fig.I.5). The Jakarta post (Bachyul, 2011), reported that scores of historical buildings of the Dutch colonial era that were damaged in the 2009 earthquake in Padang, West Sumatra, remain in poor condition due

to a lack of funds needed to renovate them. Things got worse for the buildings after the earthquake, as many people scavenged materials from the damaged historical sites, and some of the buildings' owners knocked down parts of their structures that they felt had become dangerous. Even one of the private company, The management of PT Perusahaan Perdagangan Indonesia, was reported to the police by the Batusangkar Prehistoric Legacy Conservation Center (BP3) two weeks ago for destroying a protected building on Jl. Batang Arau 23 using an excavator.

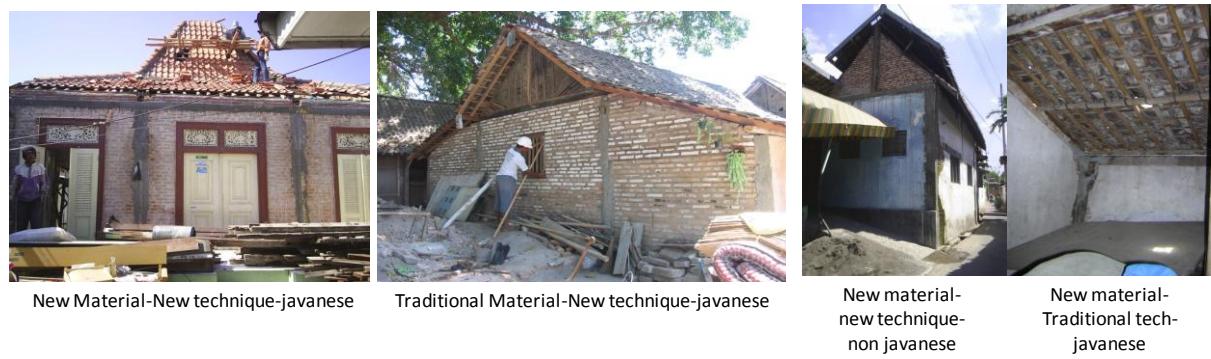
Fig.III.18 Recovery options in Kotagede

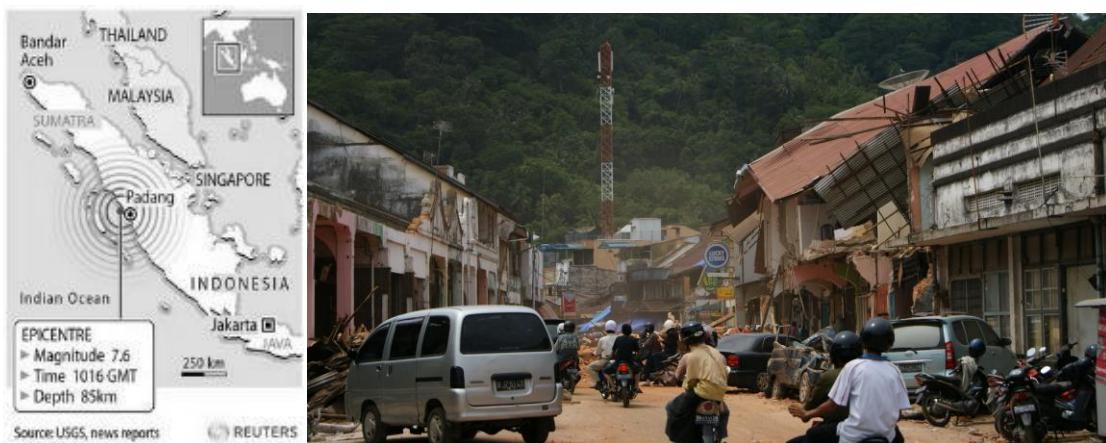
Fig.IV.2 Condition of Old Town District after the Earthquake. Source: (USGS, 2009)(left); the rapid assessment status after the earthquake; retrieved from (BPPI, 2011) (right)

This district is located in the earthquake and tsunami prone area. Great tsunami was recorded occurred in 1797 and 1833 (Natawidjaja & Triyoso, 2007). Recently, it has severely affected by two major earthquakes; 6.3 Richter Scale (RS) on March 6, 2007 and 7.9 RS on September 30, 2009. The latest earthquake gave a severe impact to 16th century brick structured buildings. Based on (BPPI, 2011), most of the house, shop, warehouse and shop-houses were severely affected by the earthquake (Fig.IV.2).

According to the heritage rapid assessments conducted by Bung Hatta University one day after the earthquake (Fig.IV.3), it is recorded that 46% was severely damaged, 30% was in

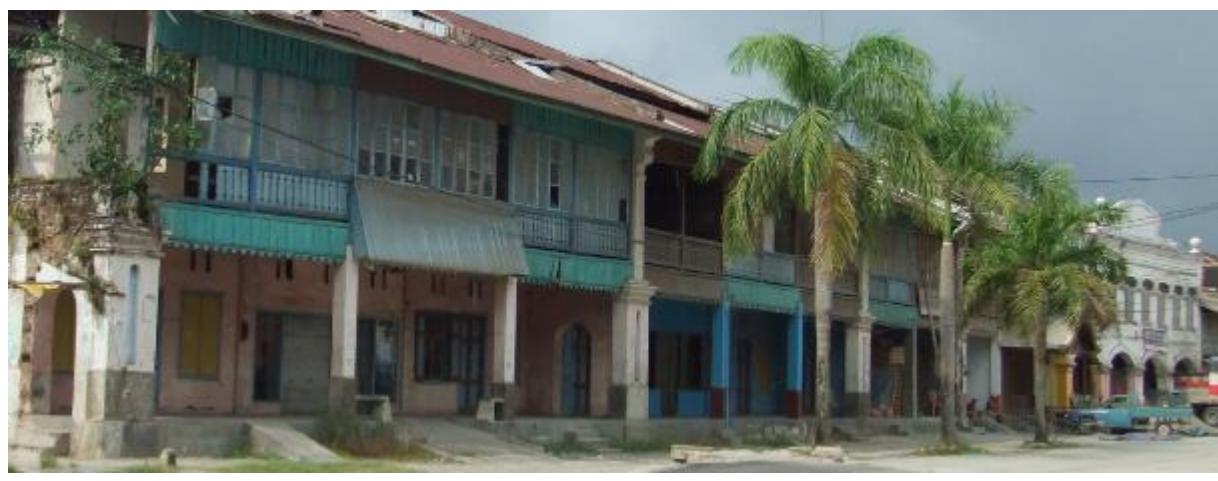
Fig.IV.6 Consecutive landscape of Padang old town district at Jalan Batipuh

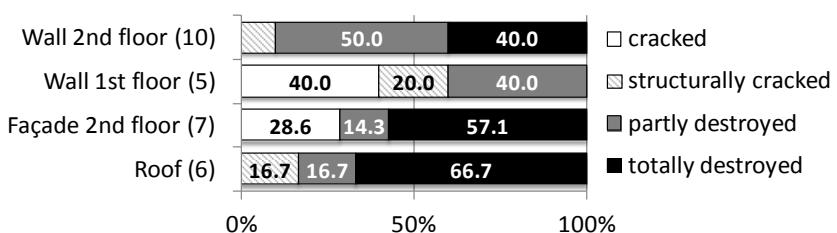
Fig.IV.18 The correlation between not doing recovery and level of damage

Fig.IV.18 shows the correlation between the level of the damage and the intention for not doing recovery. It shows that the tendency for not doing recovery shows at 2nd floor of the facades (71.4%), 2nd floor of the walls (90.0%) and the roofs (83.4%) that were impacted severely by the earthquake (indicated by partly destroyed the totally destroyed). On the other hand, the tendency for not doing recovery shows at very light damage level (cracked) in the entire part of the facade. Further, the tendency for not doing recovery shows higher on the second floor and the roof, compare with the recovery in the first floor.

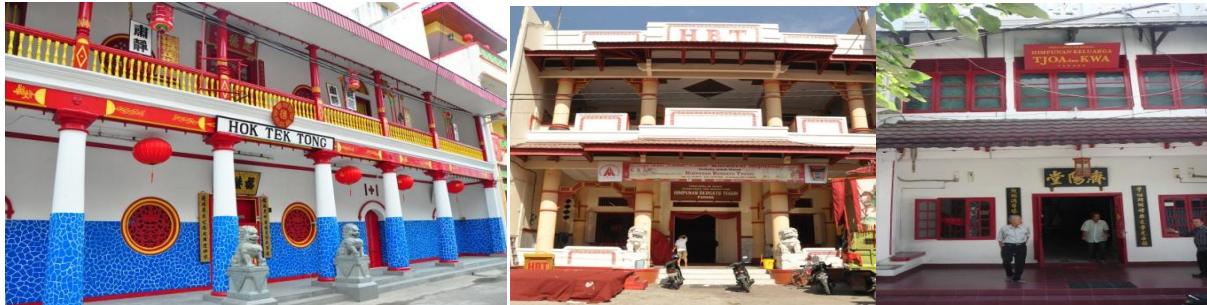
Fig.V.6 Chinese Community Cultural Heritage Building in Padang Old Town district

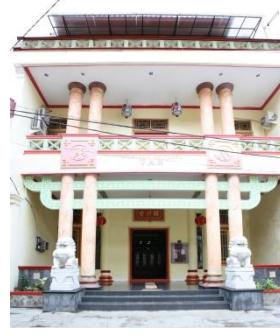
<ul style="list-style-type: none"> • Light damaged • cracks at the building facade

<ul style="list-style-type: none"> • repairing slight damage

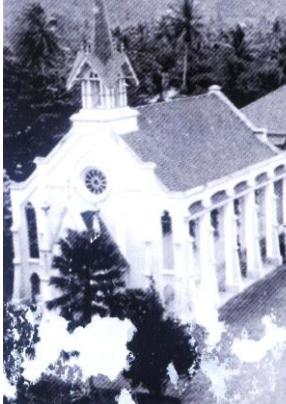
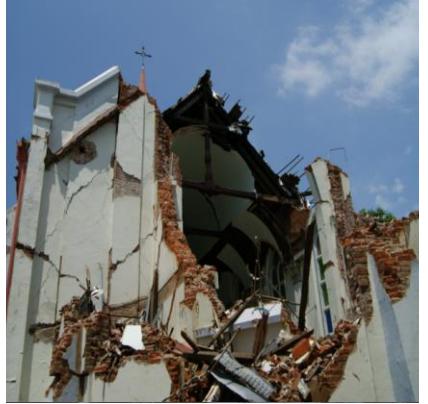
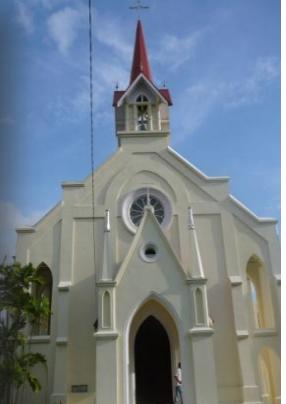
Before Earthquake	After Earthquake	After Recovery
Chapel St. Leo

Table V.3 The condition of Chapel St. Leo and Sukma Indah Nunnery before, after earthquake and after recovery
