Doctoral Dissertation

**Sustainability of Cultural Heritage Assets
along with Self and Community Driven
Recovery from Natural Disaster in Indonesia**

Case Study in Yogyakarta and Padang

Graduate School of Engineering
Osaka University

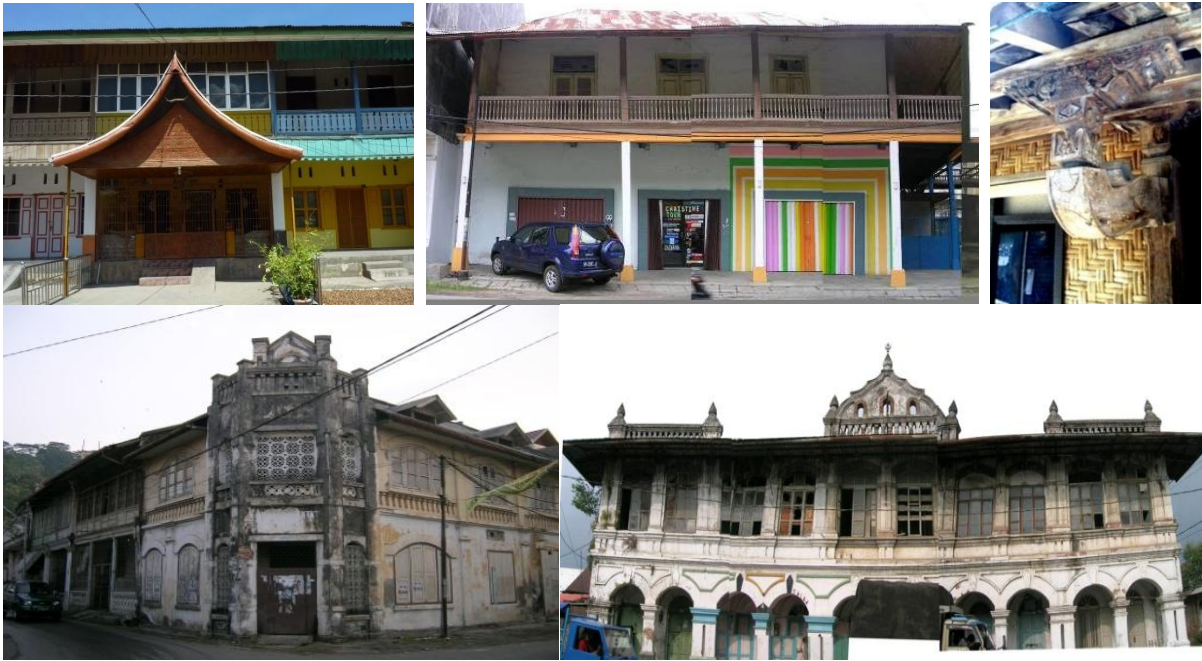
Fig.1.4 The degraded building condition, and uncontrollable transformation of the cultural heritage buildings before the earthquake in Padang old district and Kotagede

Privately/community owned cultural heritage buildings, presumably experience this owner driven rehabilitation as well through the years. This makes a lot of privately/community owned cultural heritage assets in Indonesia have suffered from all kinds of uncontrolled transformations. The deliberate changing of urban spaces, activities, and economic values reveal multiple ways of how the owner transforms their environment. Many historic buildings have been either demolished or transformed according to new designs even before the disaster struck (Fig.1.4).

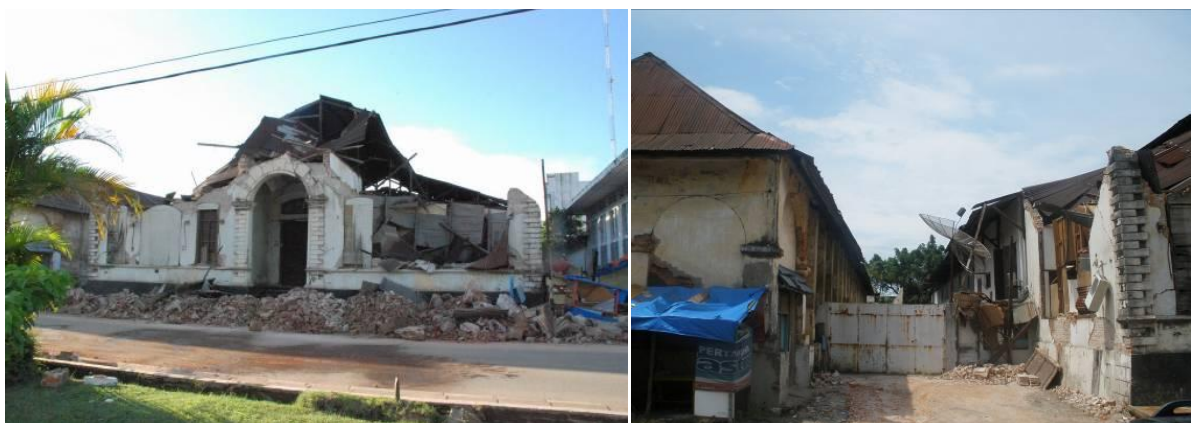
Fig.1.5 Debris clearing by the owner of cultural heritage building in Padang

Sometimes some programs such as clearing debris, rehabilitation and reconstruction are not in line with the spirit of cultural heritage building conservation. This can be clearly seen in the case of cleaning debris program of cultural heritage buildings in the Padang Old Town district. after the earthquake hit the debris were mostly treated like common building rubble (Fig.1.5). The Jakarta post (Bachyul, 2011), reported that scores of historical buildings of the Dutch colonial era that were damaged in the 2009 earthquake in Padang, West Sumatra, remain in poor condition due

to a lack of funds needed to renovate them. Things got worse for the buildings after the earthquake, as many people scavenged materials from the damaged historical sites, and some of the buildings' owners knocked down parts of their structures that they felt had become dangerous. Even one of the private company, The management of PT Perusahaan Perdagangan Indonesia, was reported to the police by the Batusangkar Prehistoric Legacy Conservation Center (BP3) two weeks ago for destroying a protected building on Jl. Batang Arau 23 using an excavator.

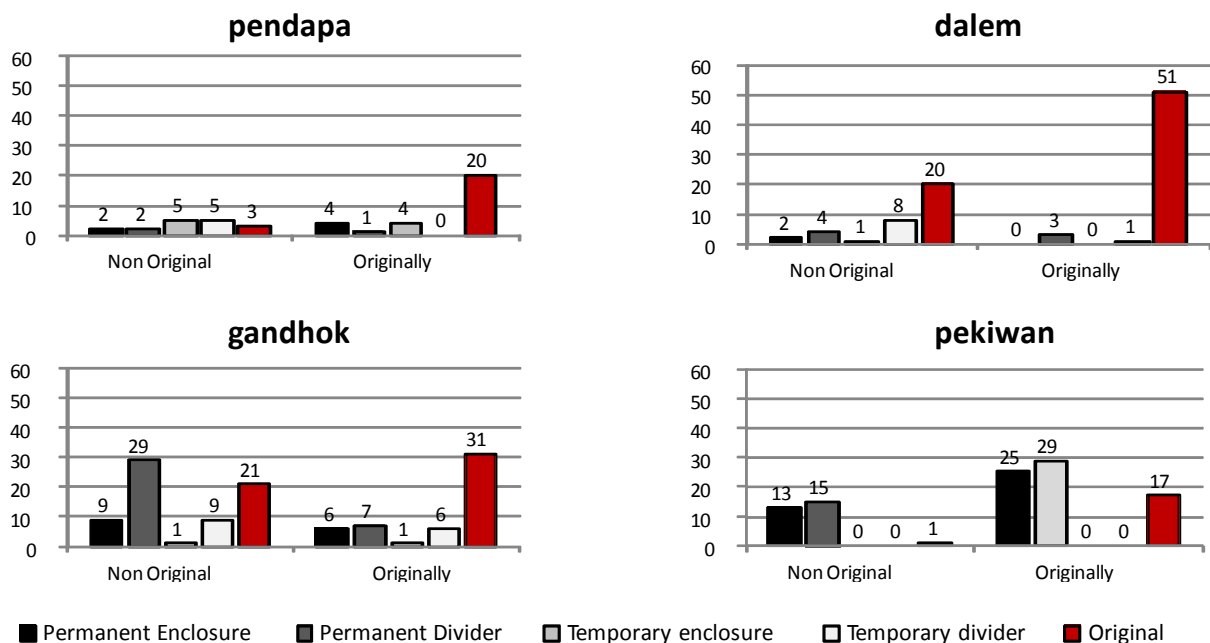
Fig.III.10 Constructional adaptation due to the functional changes of Joglo House before Earthquake

Fig.III.10 showed the comparison between the building masses that accommodates only the original function, and the building masses that also accommodate additional functions. It shows that the building mass that accommodate only original function has less tendency to experience physical changes compared with the building mass that accommodate also the additional functions. Building mass with original function indicated higher in preserving its authentic physical condition. This condition is exceptional in pekiwan, although the function still authentic, the physical changes were highly identified.

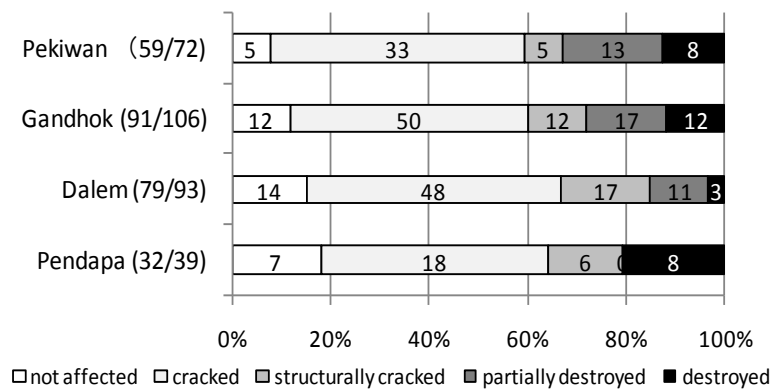
Fig.III.11 The Influence of Earthquake to the Building masses of Joglo Houses

Fig.III.11 it showed that more than 80% of the total house masses were affected by the earthquake, the severe damage indicated with structurally cracked, partly destroyed and totally destroyed only showed in less than 42%. Nevertheless, very massive damaged showed especially in *pendapa* where 8 of 32 *pendapa* buildings (20.5%) were totally destroyed. Since the *pendapa* structure consists of wooden joint structures, the experience of the structural crack on this building required the household to dismantle the entire structure for recovery.

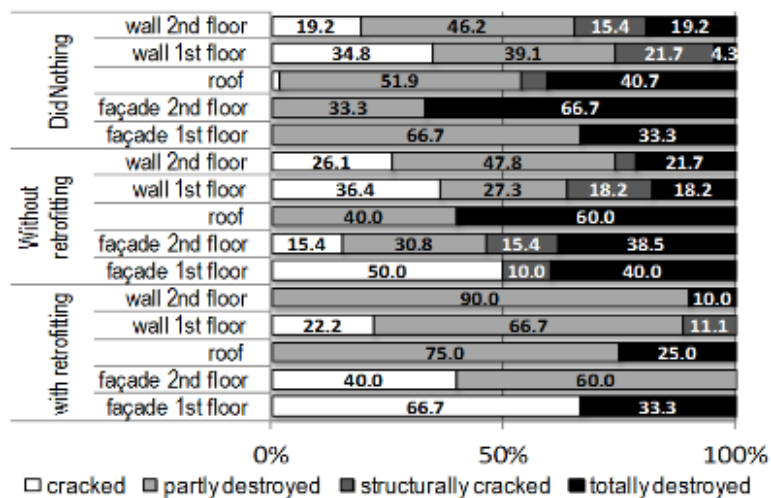
Fig.IV.14 Correlation between pre-earthquake maintenance and rehabilitation acts and the building damages

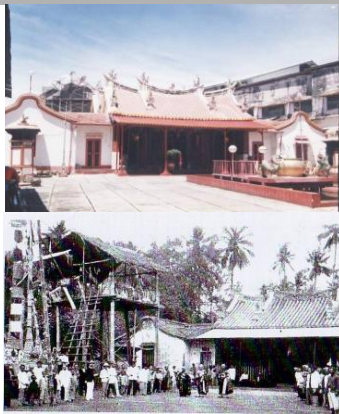
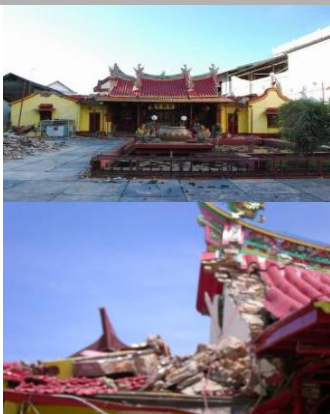
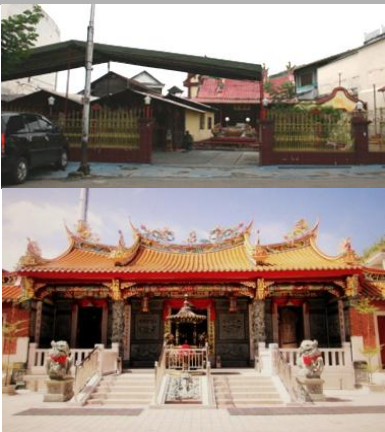
<ul style="list-style-type: none"> changing building color from white to yellow, reflecting the color of shrine's Flag 	<ul style="list-style-type: none"> structural damaged partly destroyed altar collapsed 	<ul style="list-style-type: none"> adding temporary building in front of the shrine for temporary praying room build new shrine in front of the authentic shrine
