Doctoral Dissertation

Seismic Strengthening of RC Exterior Beam-Column Joints
with Deficient Beam Rebar Anchorage by Wing Walls

SYAFRI WARDI

July 2019

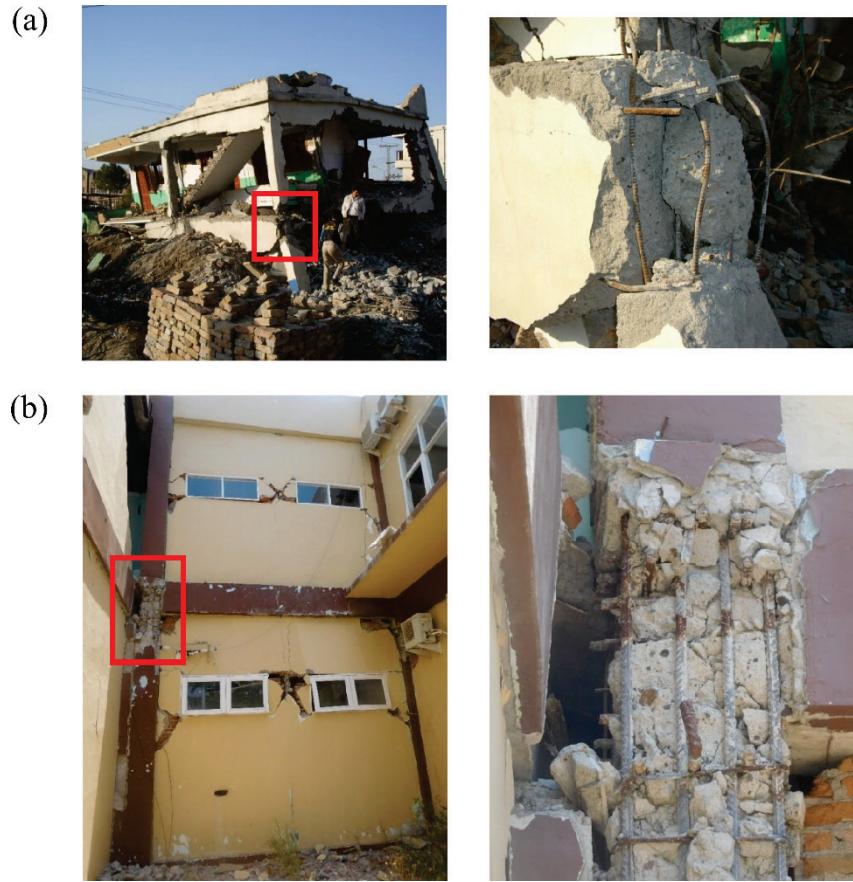
Figure 1.1 Earthquake-damaged RC exterior beam-column joints: (a) 2005 Kashmir earthquake in Pakistan [10] (b) 2018 Lombok earthquake in Indonesia (image by author)

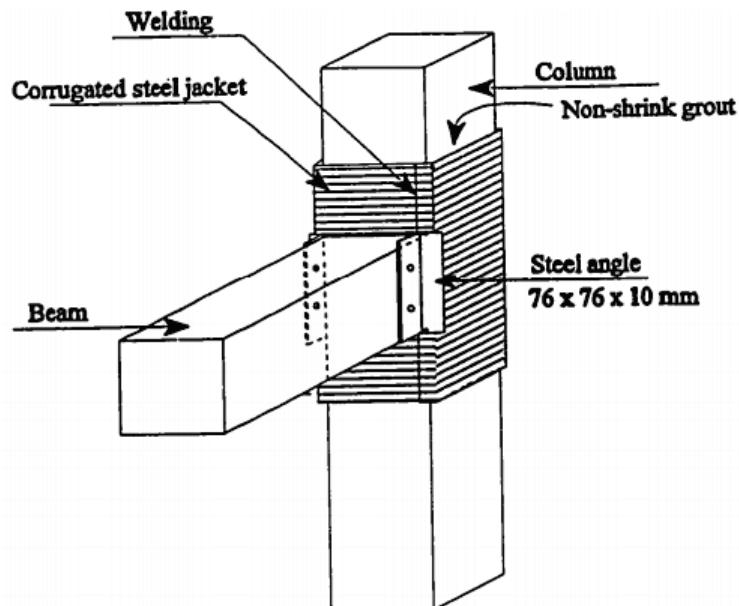
Figure 1.2 Proposed rehabilitation technique of specimen J6 [12]

Biddah [12] did an attempt to strengthen a beam-column joint with straight anchorage of the beam bottom longitudinal bar by attaching steel plates to the beam sides to replace deficient reinforcement bars, shown in **Figure 1.2**. The dimensions and details of reinforcement of the benchmark specimen with deficient anchorage are shown in **Figure 1.3**. A corrugated steel jacketing system was applied for confining the critical region of the joint and the column. For the joint region, two steel angles fixed with anchor bolts were installed at the beam sides to resist the pullout of the beam bottom longitudinal bars. The proposed systems did not effectively improve the joint response because of the failure of the anchor bolts.

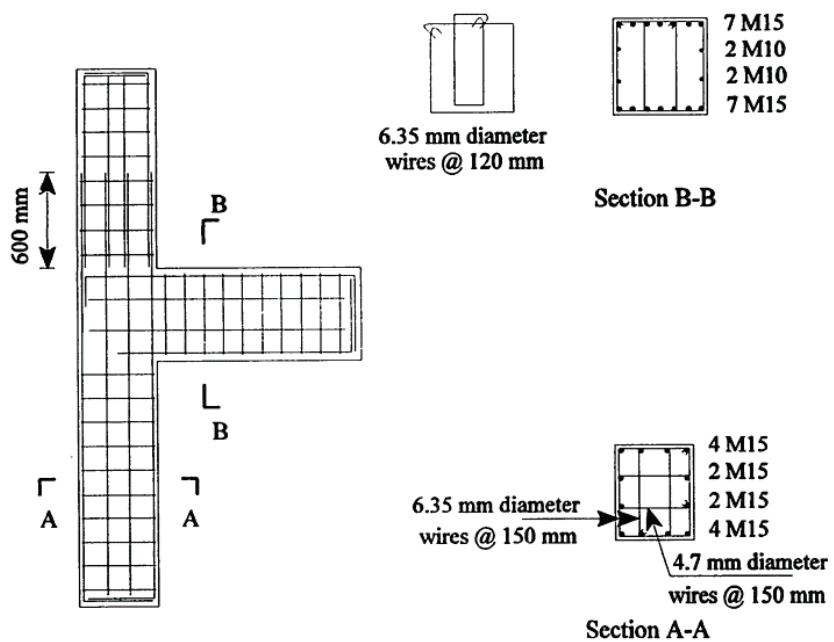
Figure 1.3 (a) Dimensions of the specimens (b) Details of reinforcement of specimens with deficient anchorage [12]

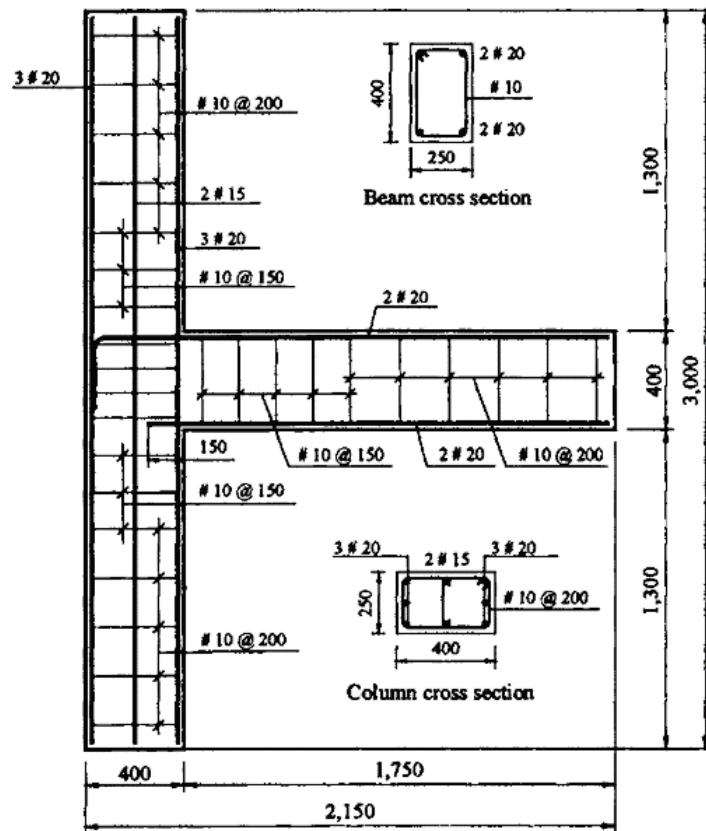
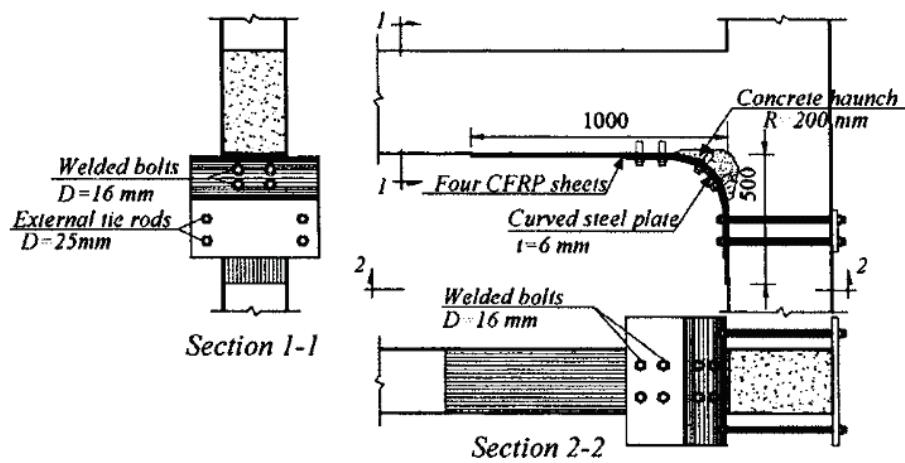
Figure 1.4 (a) Specimen dimensions and reinforcement details of anchorage-deficient joint

(b) Strengthened joint TB-11 [13]

Ghobarah and El-Amoury [13] proposed strengthening methods for the beam-column joints with straight anchorage of the beam bottom longitudinal bars by using FRP sheets, steel plates, rods, and a welding process. The proposed strengthening method was applied to the anchorage-deficient joint, and the shear-anchorage-deficient joint, as shown in **Figure 1.4(a)** and **Figure 1.5(a)**, respectively. The anchorage-deficient joint was strengthened by using carbon fiber-reinforced polymer (CFRP) sheets which were attached to the beam bottom face and extended along the column face, as shown in **Figure 1.4(b)**. The shear/anchorage-deficient joint was strengthened by external tie-rods welded to the existing beam bottom longitudinal bars for the anchorage strengthening, combined with GFRP wrapping around the joint for the shear strengthening, as shown in **Figure 1.5(b)**.

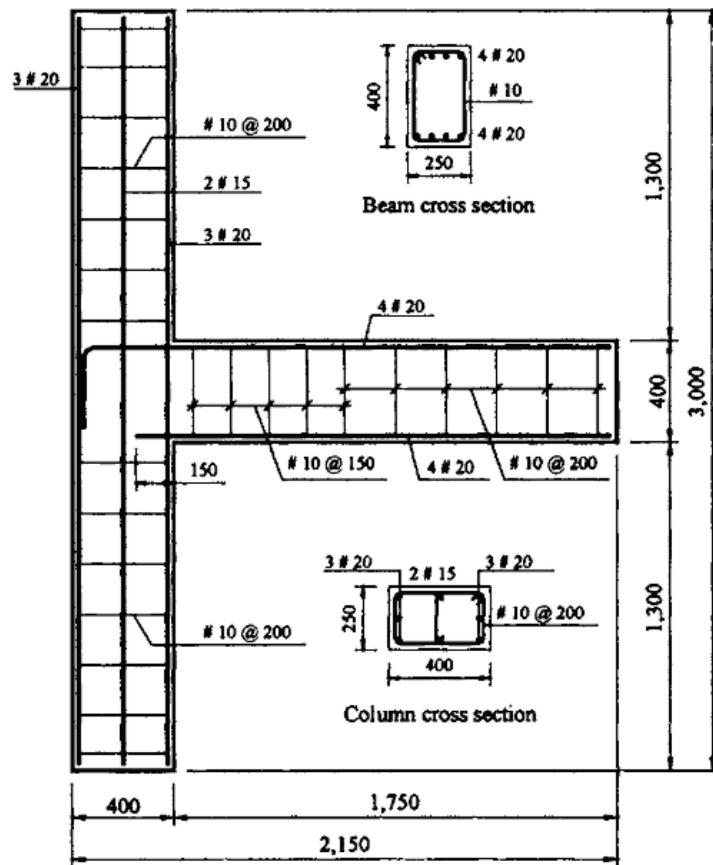
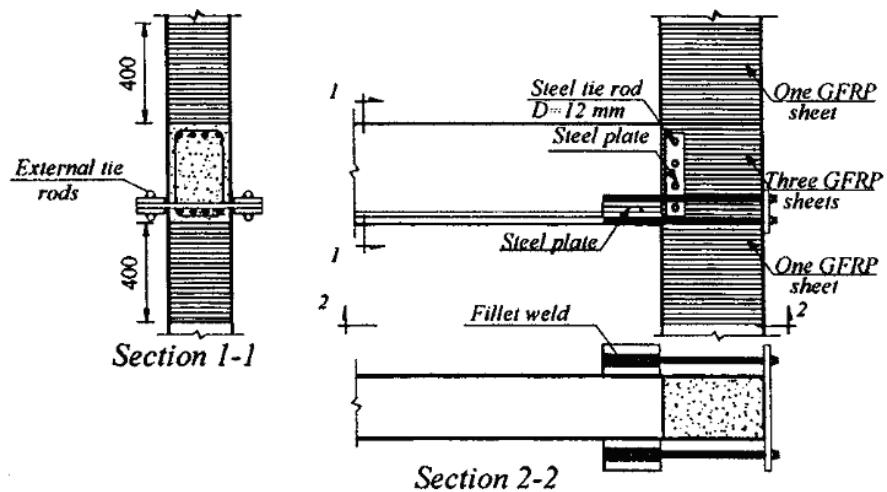
Figure 1.5 (a) Specimen dimensions and reinforcement details of anchorage-deficient joint

(b) Strengthened joint T-SB7 [13]

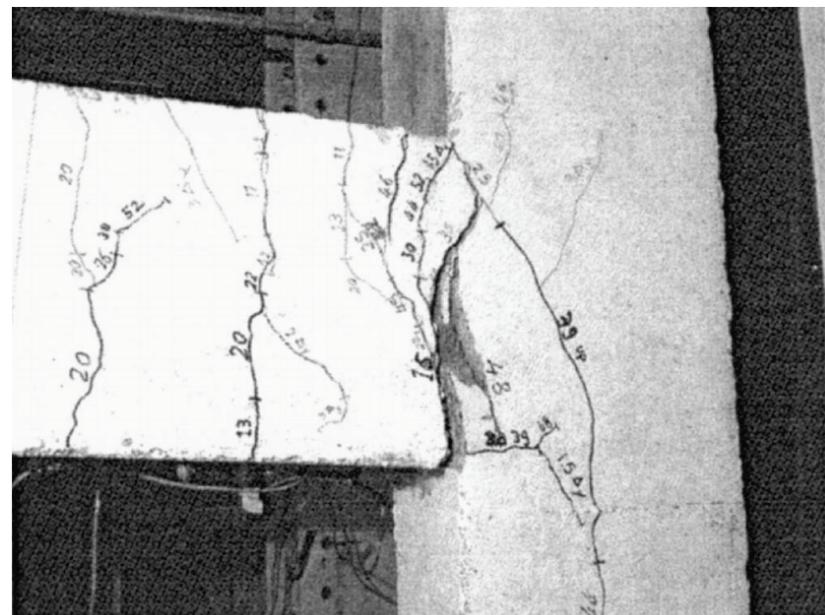
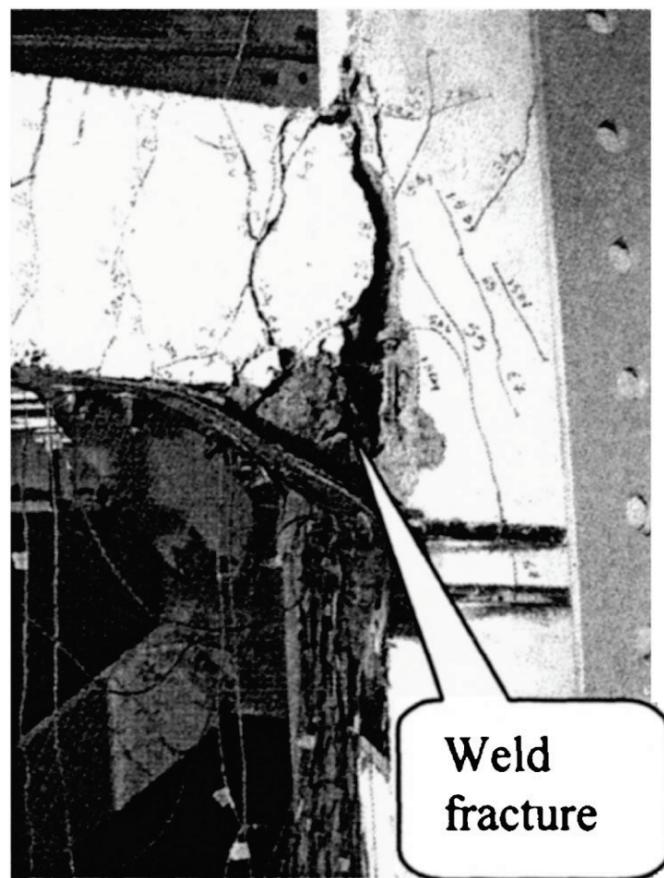
Weld fracture

Figure 1.6 Failure pattern of: (a) Benchmark specimen, (b) Strengthened specimen TB-11 [13]

The proposed strengthening methods were effective to improve the seismic performance of the joints and preventing the pullout of the beam bottom longitudinal bars, as shown in **Figure 1.6** and **Figure 1.7**. The splitting crack at the column face in **Figure 1.6(a)** indicated the slippage of the beam's bottom bars of the benchmark specimen, while the crack at the beam-column face in **Figure 1.6(b)** indicated the beam flexural hinging of the strengthened specimen. **Figure 1.7(a)** shows the failure pattern of the benchmark specimen which failed in shear failure and bond-slip failure of beam's bottom bars and **Figure 1.7(b)** shows the failure pattern of the strengthened specimen, in which both shear and anchorage failure were prevented.

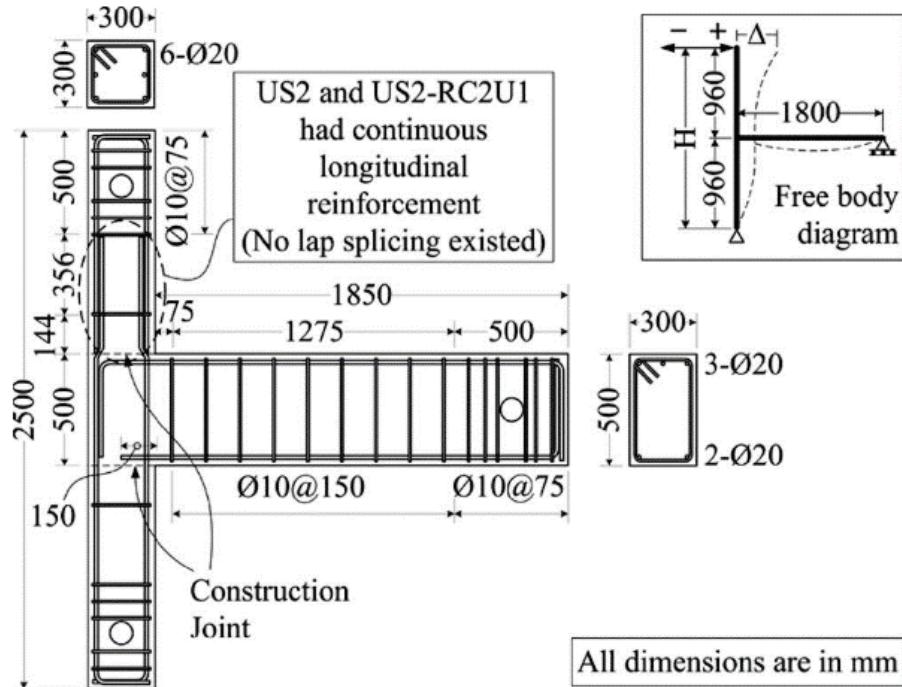
Figure 1.8 Reinforcement details and dimensions [14]

Parvin et al. [14] proposed a strengthening method for the beam-column joints with straight anchorage of the beam bottom longitudinal bars by using CFRP. The reinforcement details and dimensions of the benchmark specimens are shown in **Figure 1.8**. Two CFRP wrapping configurations were proposed, as shown in **Figure 1.9**. The proposed CFRP configurations in the retrofitted specimens successfully delayed the shear failure of joint and slippage failure of beam longitudinal bars from the joint. **Figure 1.10** shows the crack patterns of the benchmark specimen due to shear failure and slippage of the beam bottom longitudinal reinforcements. **Figure 1.11** shows the failure pattern of the strengthened specimens, in which the failure mode was governed by the rupture and the debonding of the CFRP sheets.

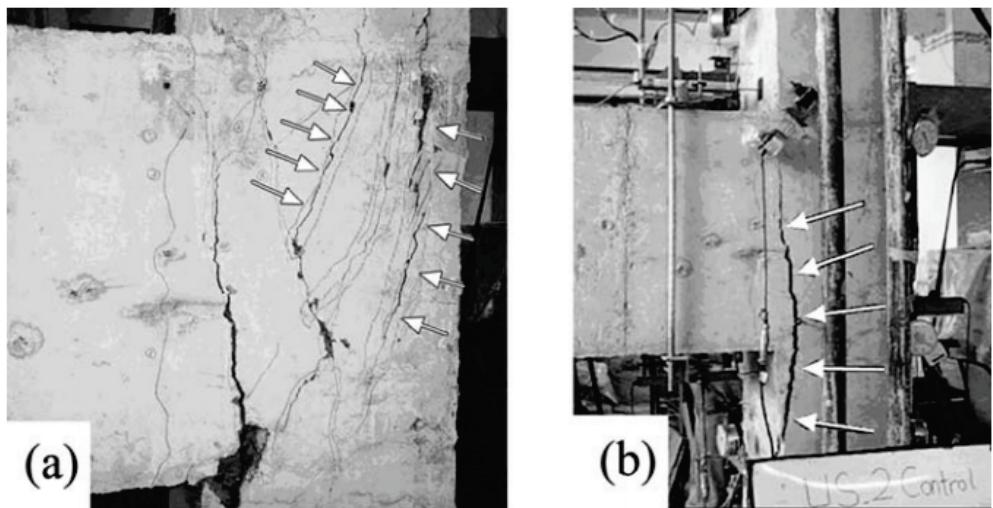
Figure 1.10 Crack pattern of benchmark specimen: (a) the shear failure at the joint; (b) the slippage of the beam bottom longitudinal reinforcements [14]

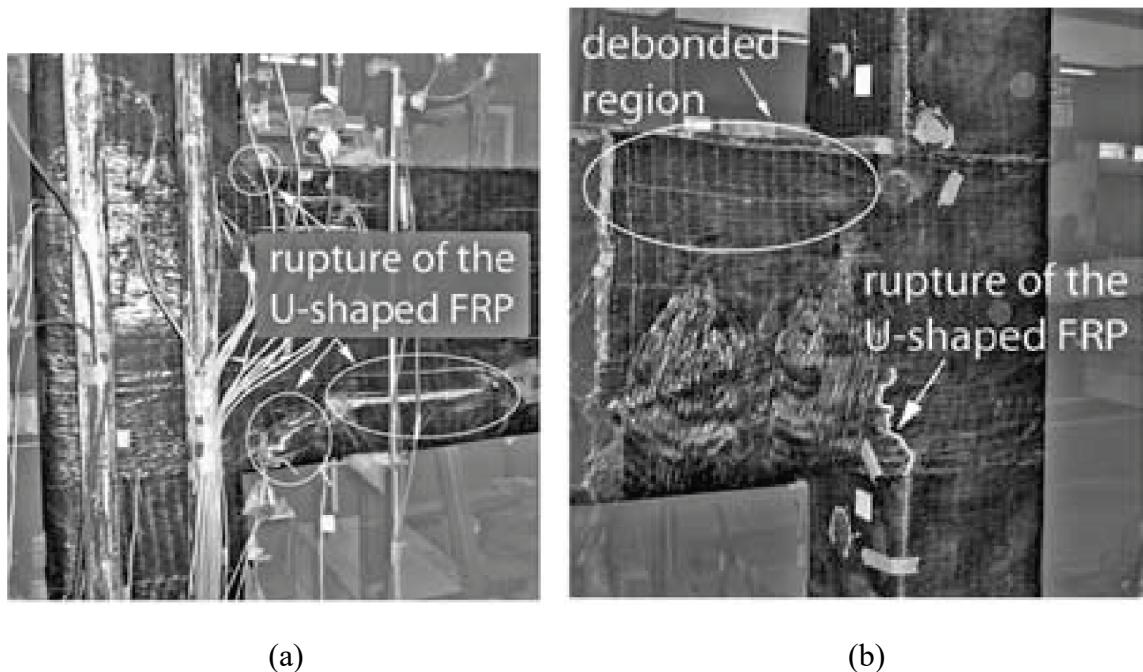
Figure 1.11 Failure pattern of: (a) strengthened specimen U.S.2-RC2U1, (b) strengthened specimen U.S.3-RC3U1 [14]

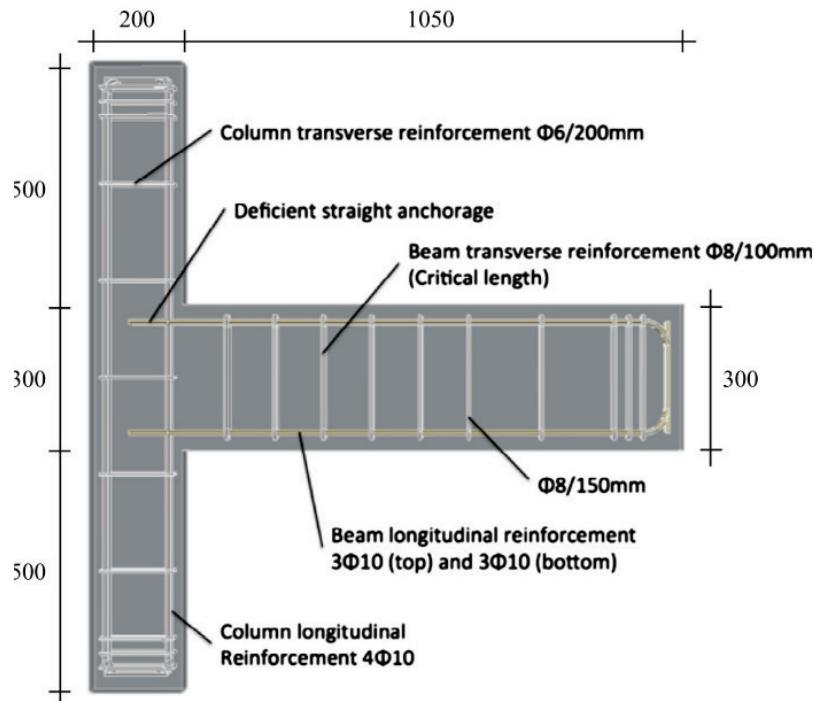
Figure 1.12 Reinforcement details of the benchmark specimen [15]

Kalogeropoulos et al. [15] proposed a strengthening method for the beam-column joints with straight anchorage of the beam top and bottom longitudinal bars by using extension bars welded to the existing beam rebar and steel plates for the anchorage of the extension bars, combined with the RC jacketing of the columns and the joint region. The details of the benchmark specimen are shown in **Figure 1.12** and the strengthening scheme is shown in **Figure 1.13**. The proposed strengthening method was effective to improve the seismic performance of the joints and to prevent the premature pullout of the beam reinforcing bars from the joint. **Figure 1.14(a)** shows the benchmark specimen which failed due to the pullout failure of the beam longitudinal rebar and **Figure 1.14(b)** shows the failure pattern of the strengthened specimen, in which the damage was shifted to the beam.

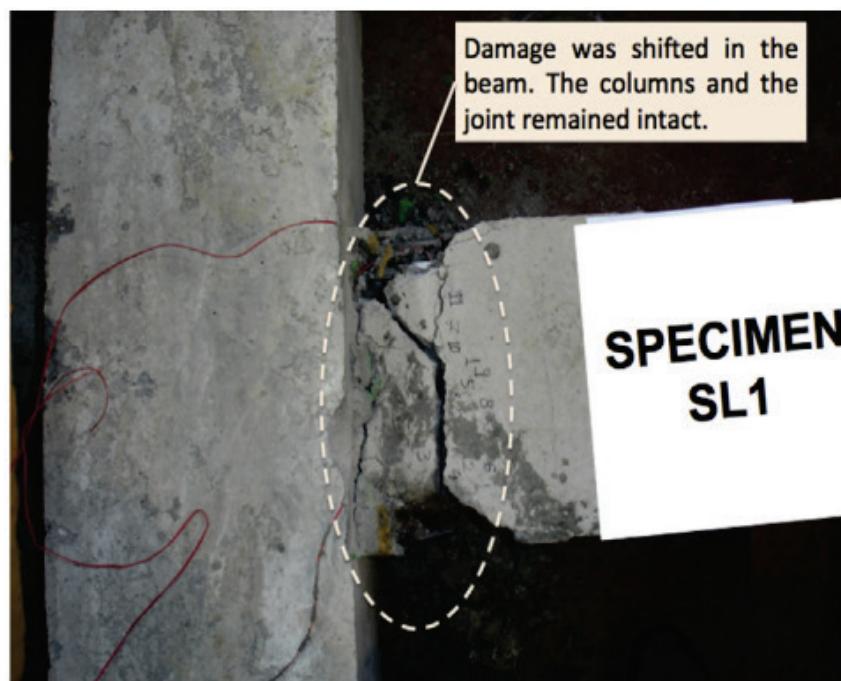
Figure 1.14 Failure mode of: (a) benchmark specimen (b) strengthened specimen

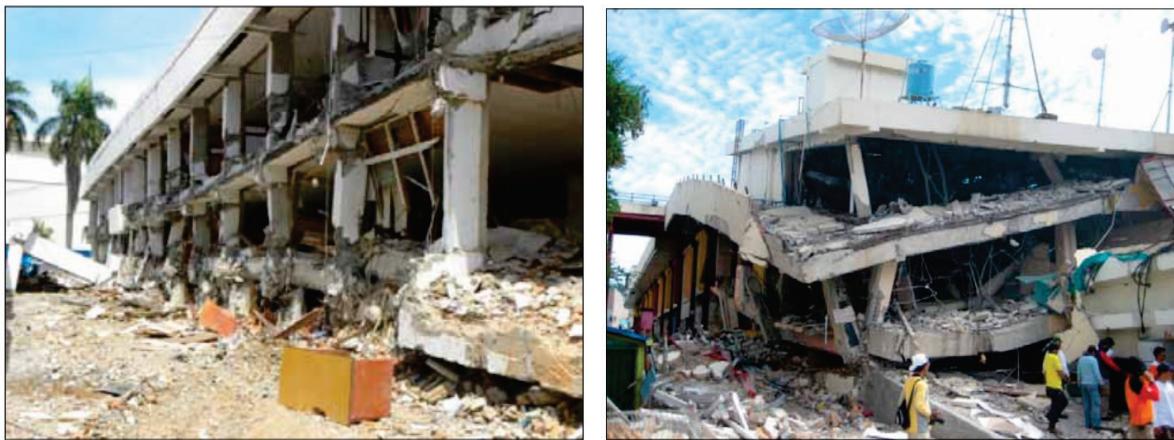
Figure 2.1 Example of collapsed buildings [3]

On 30 September 2009, an earthquake of magnitude 7.6 struck off the coast of West Sumatra, Indonesia, causing significant damage to many reinforced concrete (RC) buildings. An example of collapsed buildings in Padang, the capital city of West Sumatra is shown in **Figure 2.1**. The collapsed/damaged buildings showing deficiencies indicated that implementation of seismic detailing of RC buildings built prior to 2009 was lacking in Padang city and surrounding areas.

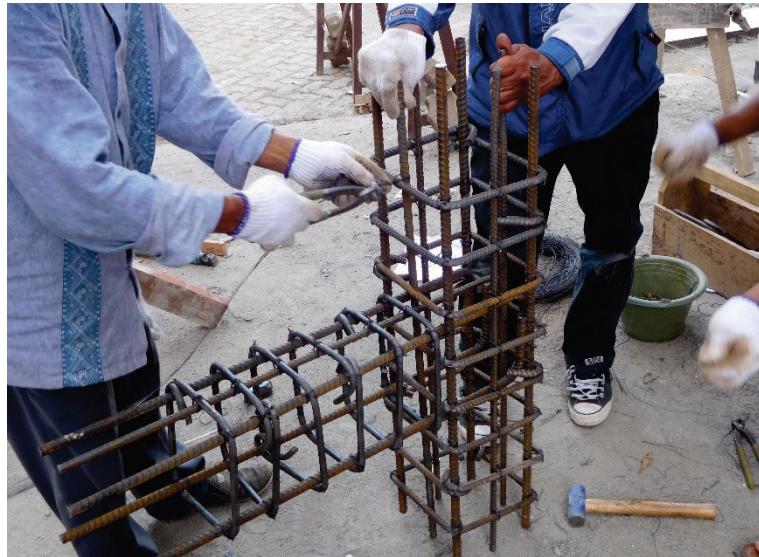
Figure 2.6 Rebar fabrication by local workers in the workshop

In the second phase investigation, local construction workers were invited to a series of workshops. The workers were from the five cities which were focused in the first phase investigation. In every workshop, 18 workers from each city were invited. A total of 90 workers were invited to 5 workshops. In the workshops, the local workers were requested to do rebar work practice using tools and methods that they usually used in real construction. The requested work was rebar fabrication of a full-scale beam-column subassembly, as shown in **Figure 2.6**. The rebar fabrication works consisted of cutting, bending, and assembling of rebar. Evaluation of the works by the workers was done by comparing the result of their works with a given drawing for the practice. Interview was also conducted for several items which could not be observed during the practice.

In the rebar works of the workshops with local workers, it was observed that all workers applied the hooks inside the beam-column joint (of the model shown in **Figure 2.6**), which did not agree with the observation results in real buildings from the field investigation. It seemed to be caused by easier works in the practice using the subassembly model. However, in real construction practice, hoops in the exterior and interior joints were not likely to be applied without eliminating difficulties posed by rebar congestion.

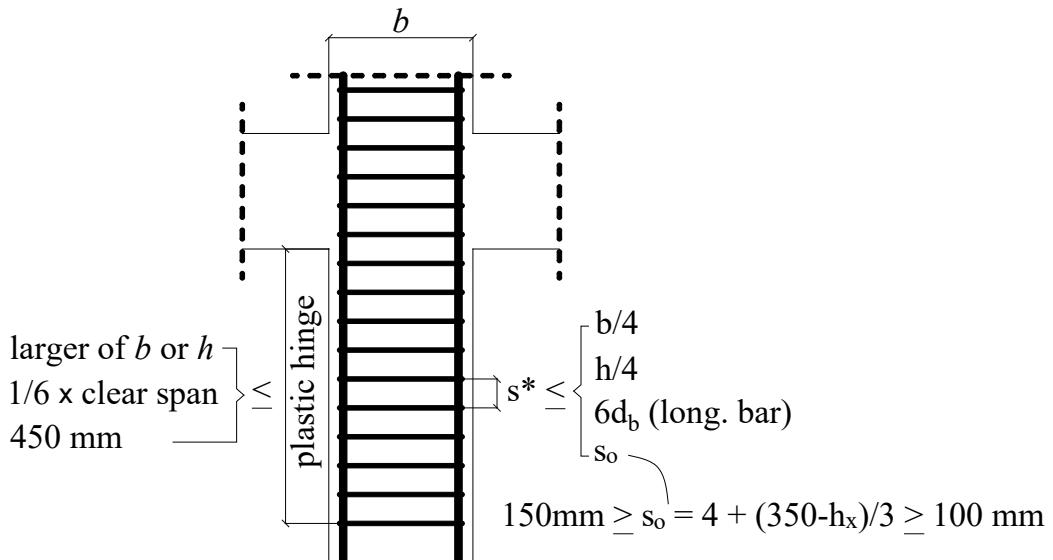
Figure 2.9 Requirements for spacing of transverse reinforcement of column in the plastic hinge and in the beam-column joint

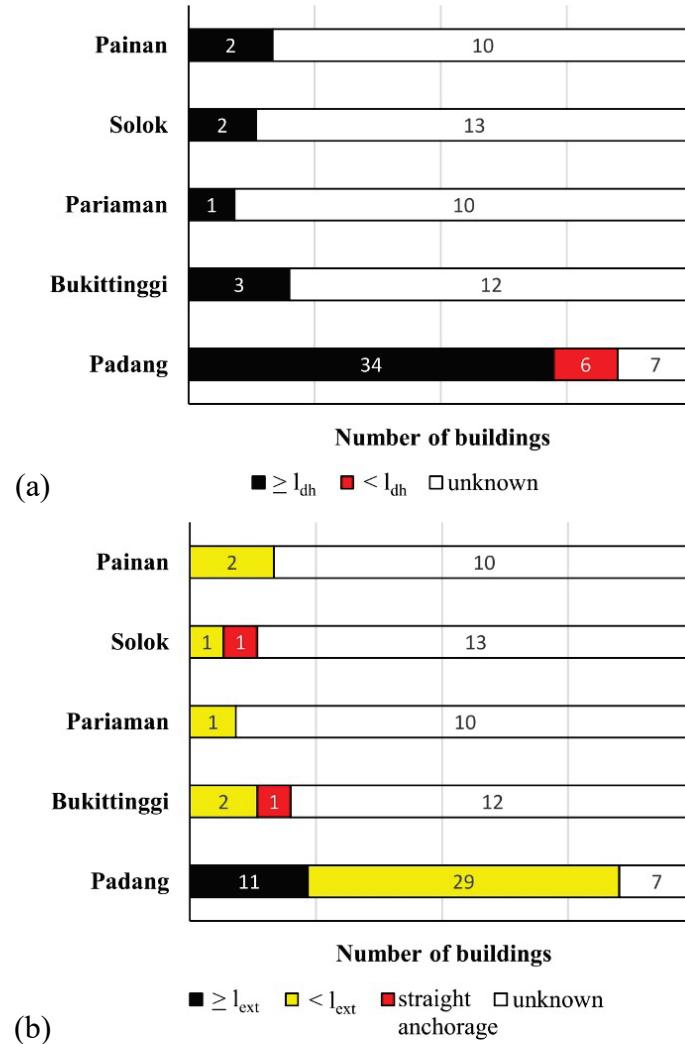
Figure 2.12 Field investigation results on anchorage of beam reinforcement into exterior joint; (a) Length of anchorage; (b) Length of tail extension

Most of the observed joints in the field investigation satisfied the requirement for the length of anchorage, as shown in **Figure 2.12(a)**. The observation of the rebar works in the workshops with local workers showed that all the workers applied the anchorage length to the far face of column, therefore most of the observed joints satisfied the requirement.

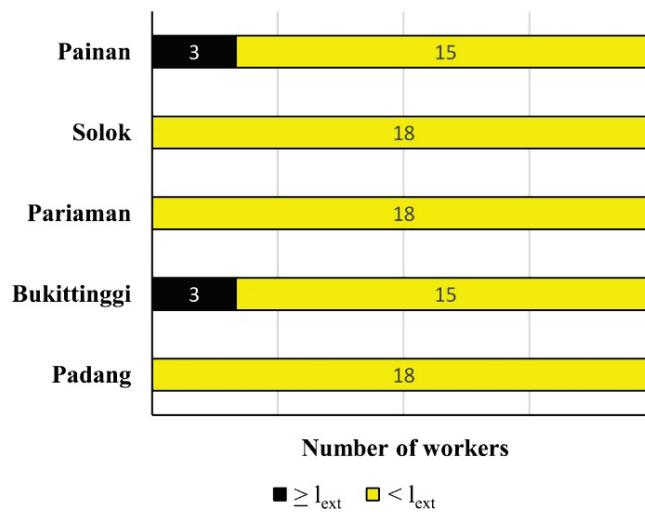
Figure 2.13 Workshop results on anchorage of beam reinforcement into exterior joint; Length of tail extension

Furthermore, the end of rebar shall be bent with a 90° hook and the length of tail extension (l_{ext}) must not be less than $12d_b$ (diameter of longitudinal bar). However, most of the observed joints in the field investigation did not satisfy the requirement for the length of tail extension, as shown in **Figure 2.12(b)**. In fact, during the rebar works of the workshops with local workers, it was observed that most of the workers applied the length of tail extension less than the requirement, as shown in **Figure 2.13**.

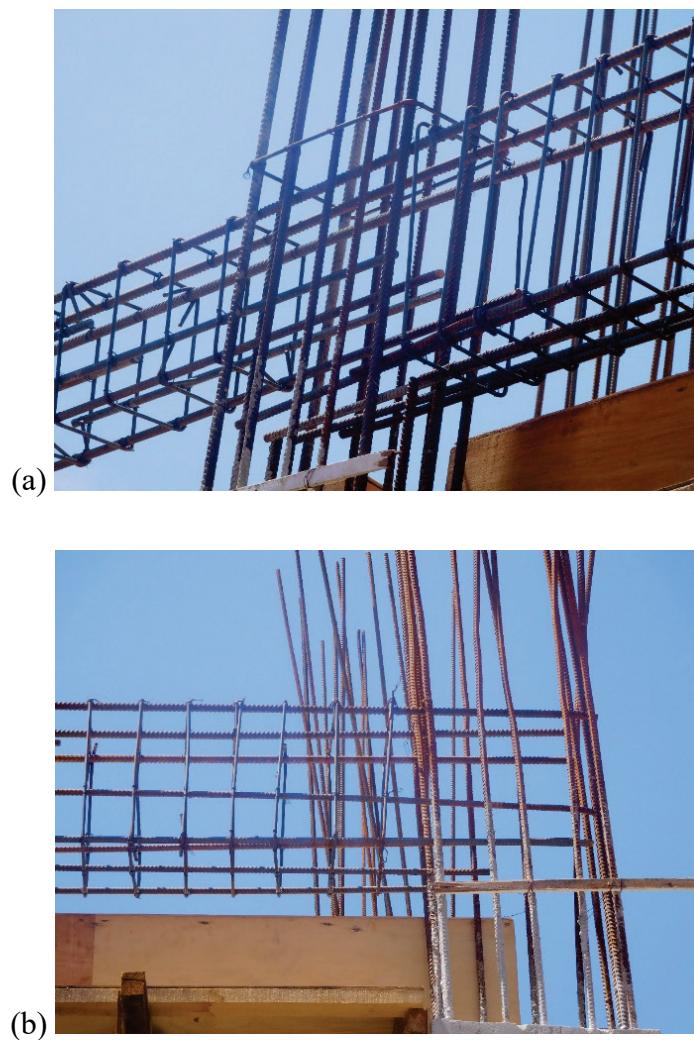
Figure 2.14 Deficiencies in detailing of beam-column joint; (a) Interior joint; (b) Exterior joint

Figure 2.14(a) and **Figure 2.14(b)** show typical deficiencies of interior joint and exterior joint without transverse reinforcement, respectively. **Figure 2.14(b)** also shows the worst detail for the anchorage of beam reinforcement to exterior joint in which straight anchorage was applied. The straight anchorage was observed only in case that deformed bar was used as longitudinal reinforcement. The deficient joints had potential shear failure and/or anchorage failure which can lead to building collapse if an earthquake occurs; therefore, a practical strengthening method for the deficient beam-column joints with is a very urgent issue.

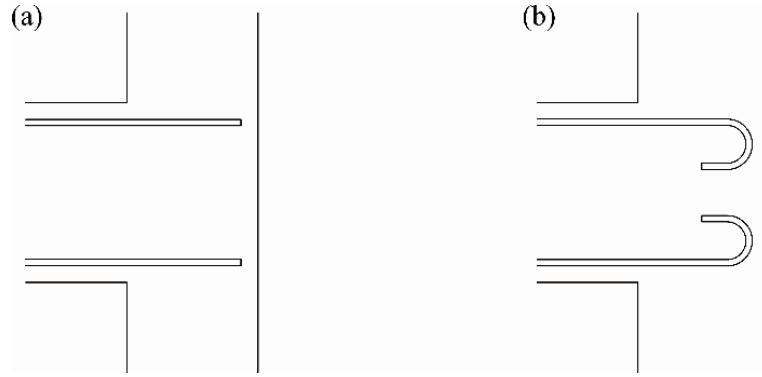
Figure 3.1 Typical details of the anchorage of beam rebar into exterior joints in Bangladesh:

The seismic detailing of beam-column joints is usually given less attention in construction practice, particularly for details of beam rebar anchorage into exterior joints. **Figure 3.1(a)** shows the typical deficiency of joints with deformed bars and straight anchorages at the end. This deficiency seems to be the worst case observed in buildings built after 1995, when deformed bars were introduced in Bangladesh. **Figure 3.1(b)** shows the other typical details of joints using plain bars with 180° hooks. This case is typical for buildings built before 1995, when all buildings in Bangladesh were constructed using plain bars.

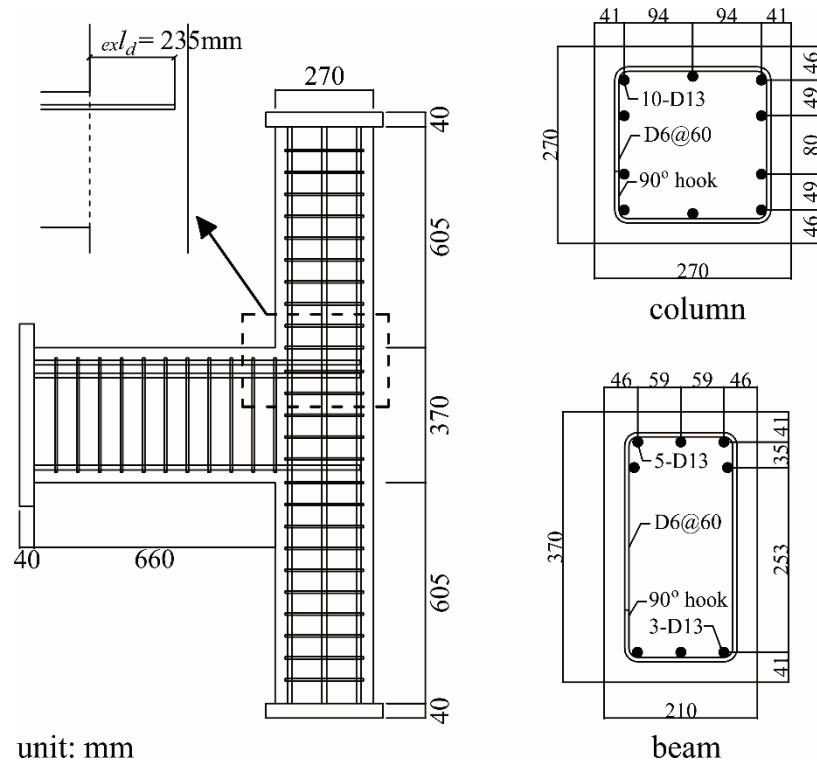
Figure 3.3 Dimensions, reinforcement and anchorage details for specimen J1

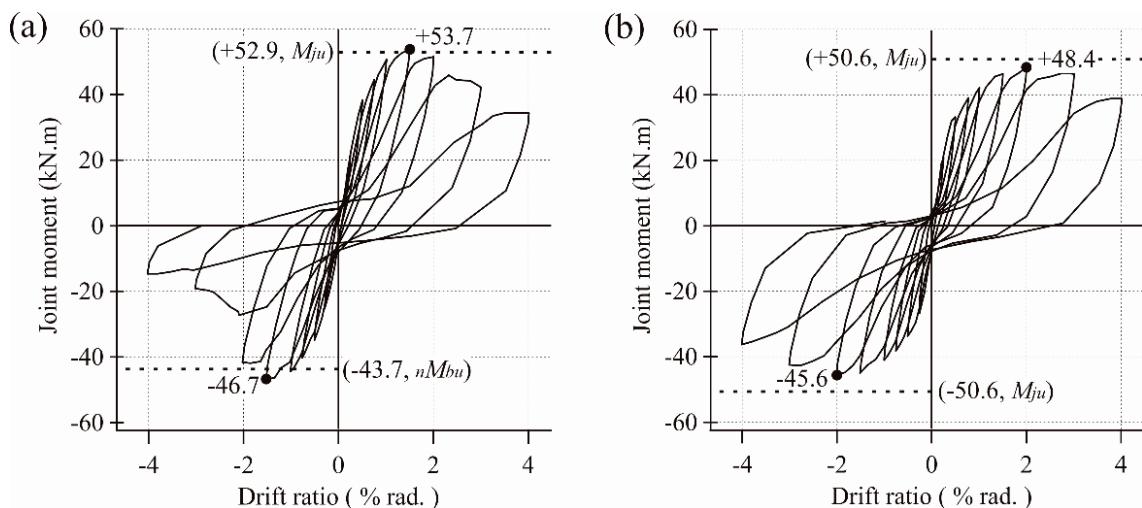
Figure 3.14 Joint moment-drift ratio relationships: (a) Specimen J1 (b) Specimen J2

Figure 3.14 shows the applied joint moment and drift ratio relationships for both specimens. The joint moment is the product of the shear force of the beam measured by the load cell and the distance between the roller center at the end of the beam and column center (refer to **Figure 3.9**).

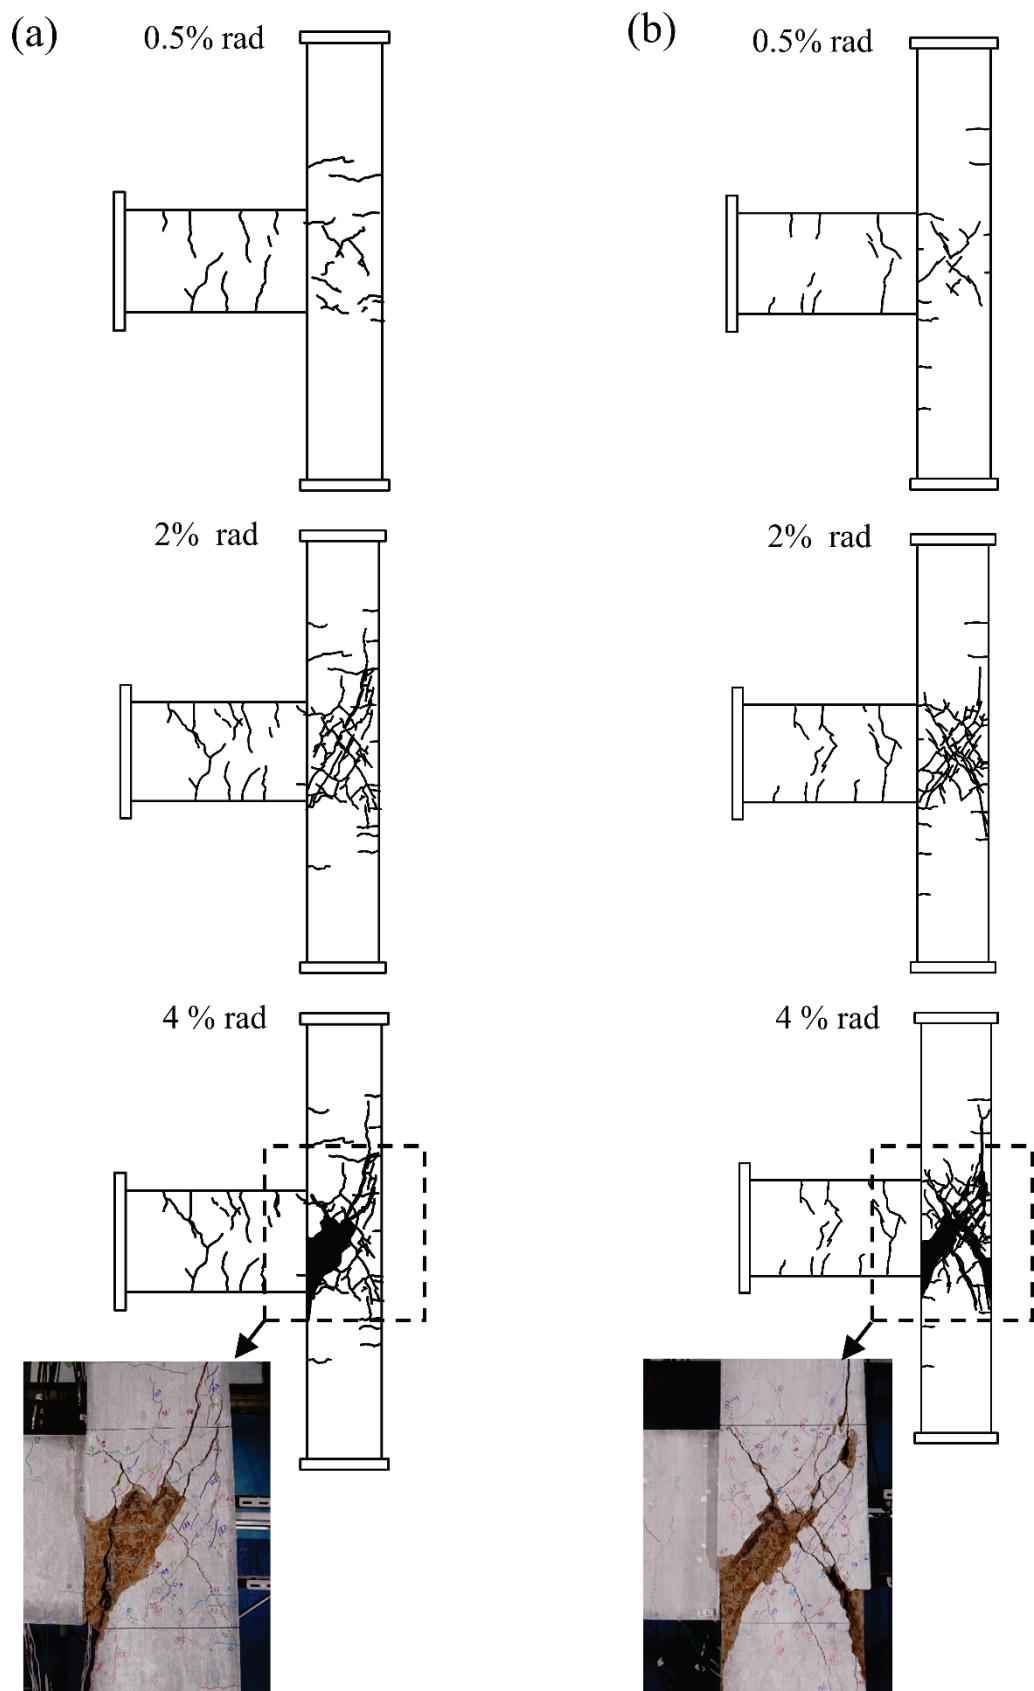
Figure 3.15 Damage to the specimens: (a) Specimen J1 (b) Specimen J2

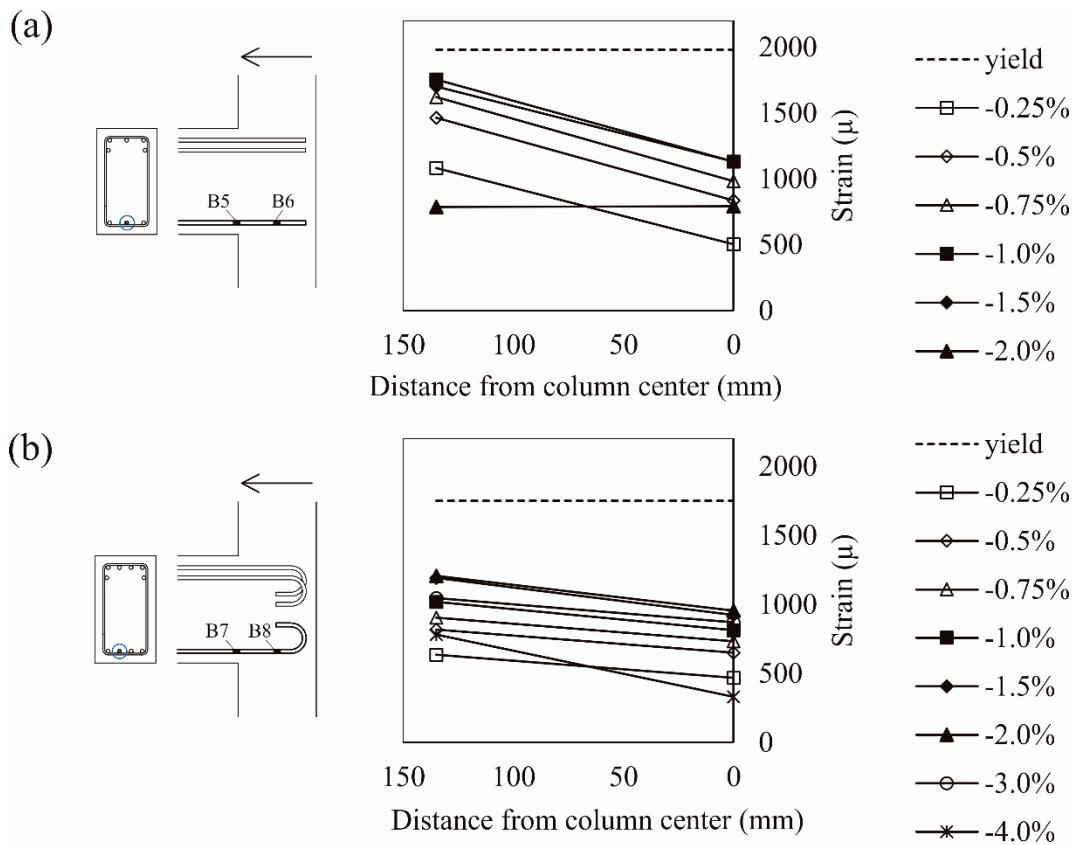
Figure 3.16 Strains along the bottom beam longitudinal bar:

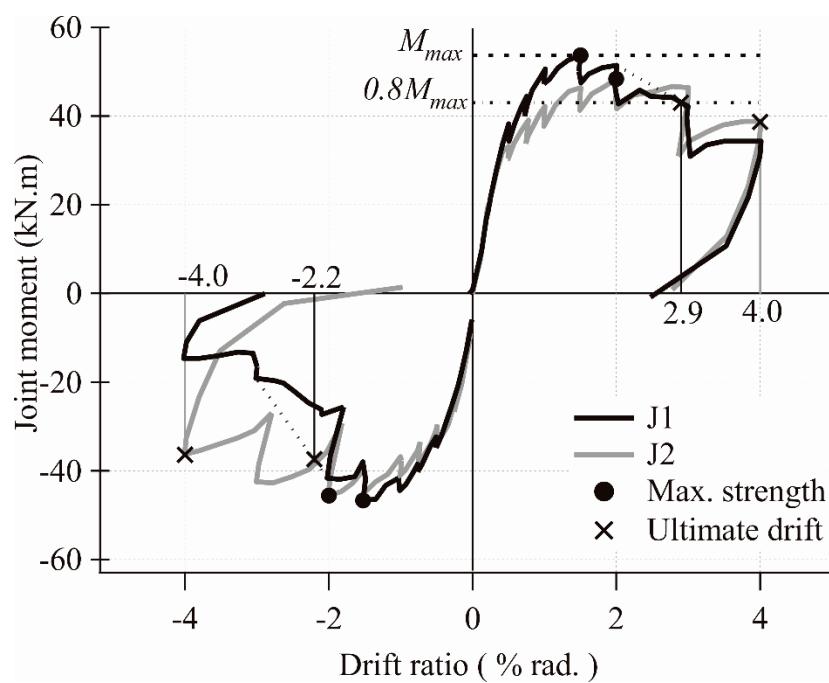
Figure 3.17 Comparison of the ultimate drift ratio of specimens J1 and J2

Figure 3.17 compares the envelopes of the hysteresis loops of both specimens shown in **Figure 3.14(a)** and **3.14(b)**. The ductility of specimen J1 in both the positive and negative loading directions was lower than that of specimen J2 because the deformability of specimen J1 decreased substantially after the loading cycle in which anchorage failure was observed.

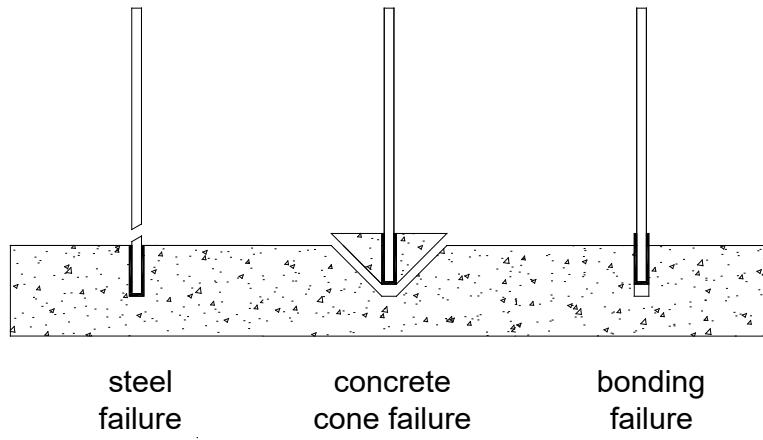
Figure 4.2 Basic failure modes of bonded anchor

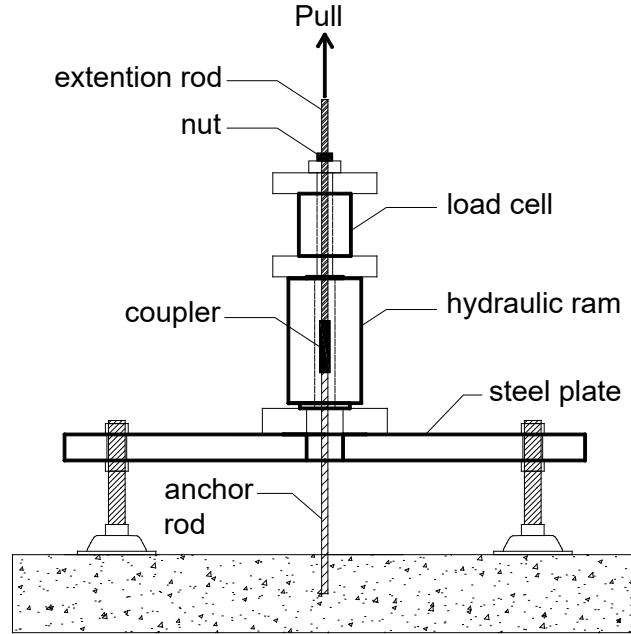
Figure 4.3 Setup of pullout test

extension rod with coupler connection was used considering the anchor rod length for applying tension using the equipment. Monotonic pullout loading was applied for each single anchor.

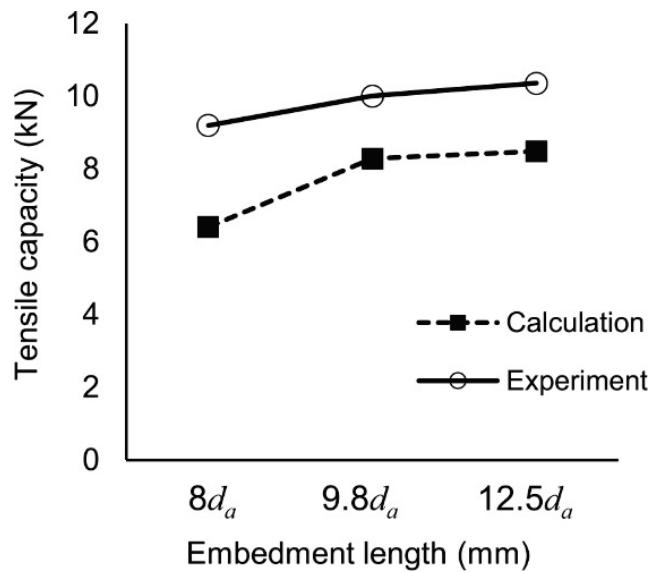
Figure 4.4 Tensile capacity of M6 specimens

Figure 4.4 and **Figure 4.5** show the average tensile capacity from the experiments and design calculations of the M6 and M8 anchor specimens, respectively. The experimental tensile capacity of all specimens was higher than the calculated strengths. This indicated that the equations to estimate the tensile capacity of anchor in Japanese guidelines [22] were conservative for low strength concrete with brick chips.

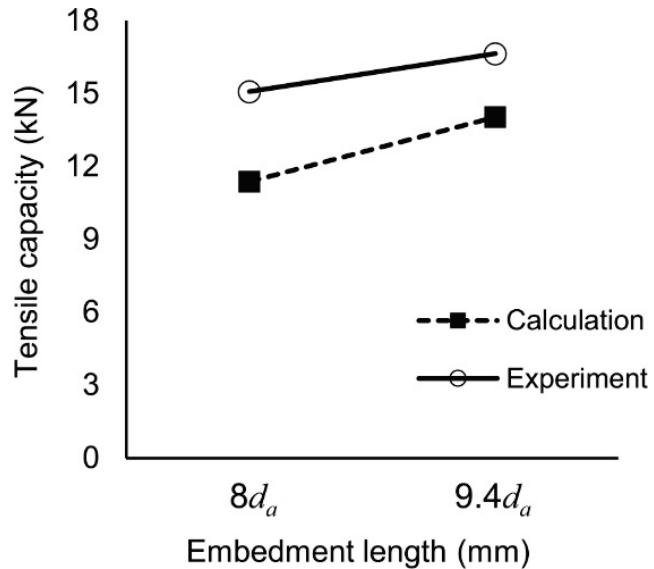
Figure 4.5 Tensile capacity of M8 specimens

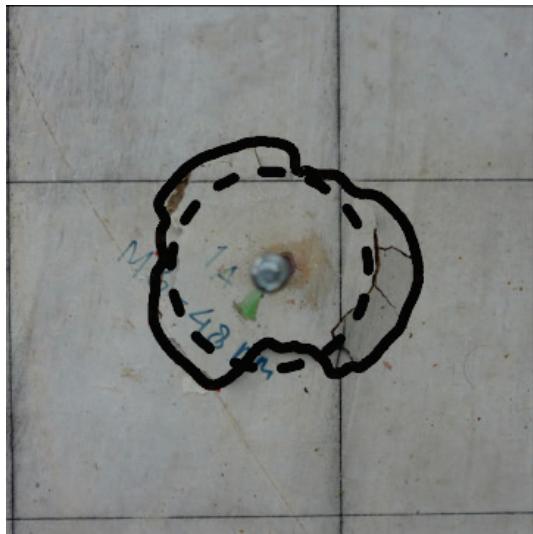
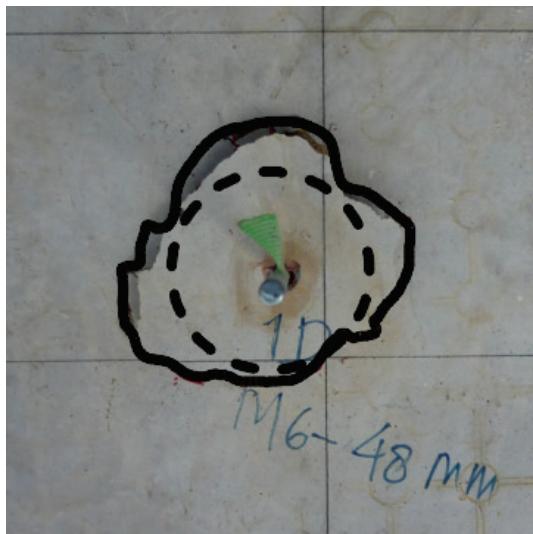
Figure 4.6 Concrete cone failure area of M6 specimens

The specimens with concrete cone failure, No.1 (M6- $8d_a$) and No. 4 (M8- $8d_a$) showed that the tensile capacity determined by concrete cone failure was much higher than the design calculations. **Table 4-6** compares the calculated tensile capacity determined by concrete cone failure (T_{a2_cal}) with the experimental results (T_{a2_exp}). The experimental tensile capacity was more than 30% higher than the design calculations. The concrete cone failure areas observed in the experiment also exceeded the design assumption in Japanese guidelines [22], as shown in **Figure 4.6** and **Figure 4.7**.

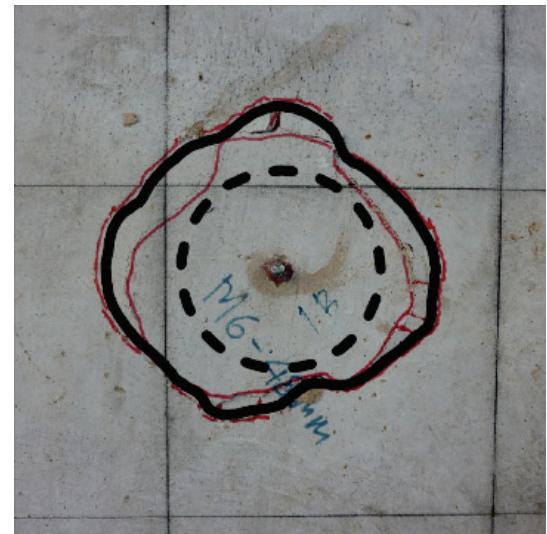
M6-8d_a(2)

Figure 4.8 Concrete cone failure with pullout of M6 specimens

All specimens with concrete failure showed the formation of a shallow concrete cone at the upper part of anchor embedment with a pullout of the lower part of anchor embedment, as shown in **Figure 4.8** and **Figure 4.9**. The formation of combined failure with shallow concrete cone and anchor pullout might be affected because the anchors were not installed in pure concrete block but the concrete slab with reinforcement; however, such embedment condition is likely to be more realistic.
