Doctoral Dissertation

Seismic Strengthening of RC Exterior Beam-Column Joints
with Deficient Beam Rebar Anchorage by Wing Walls

SYAFRI WARDI

July 2019

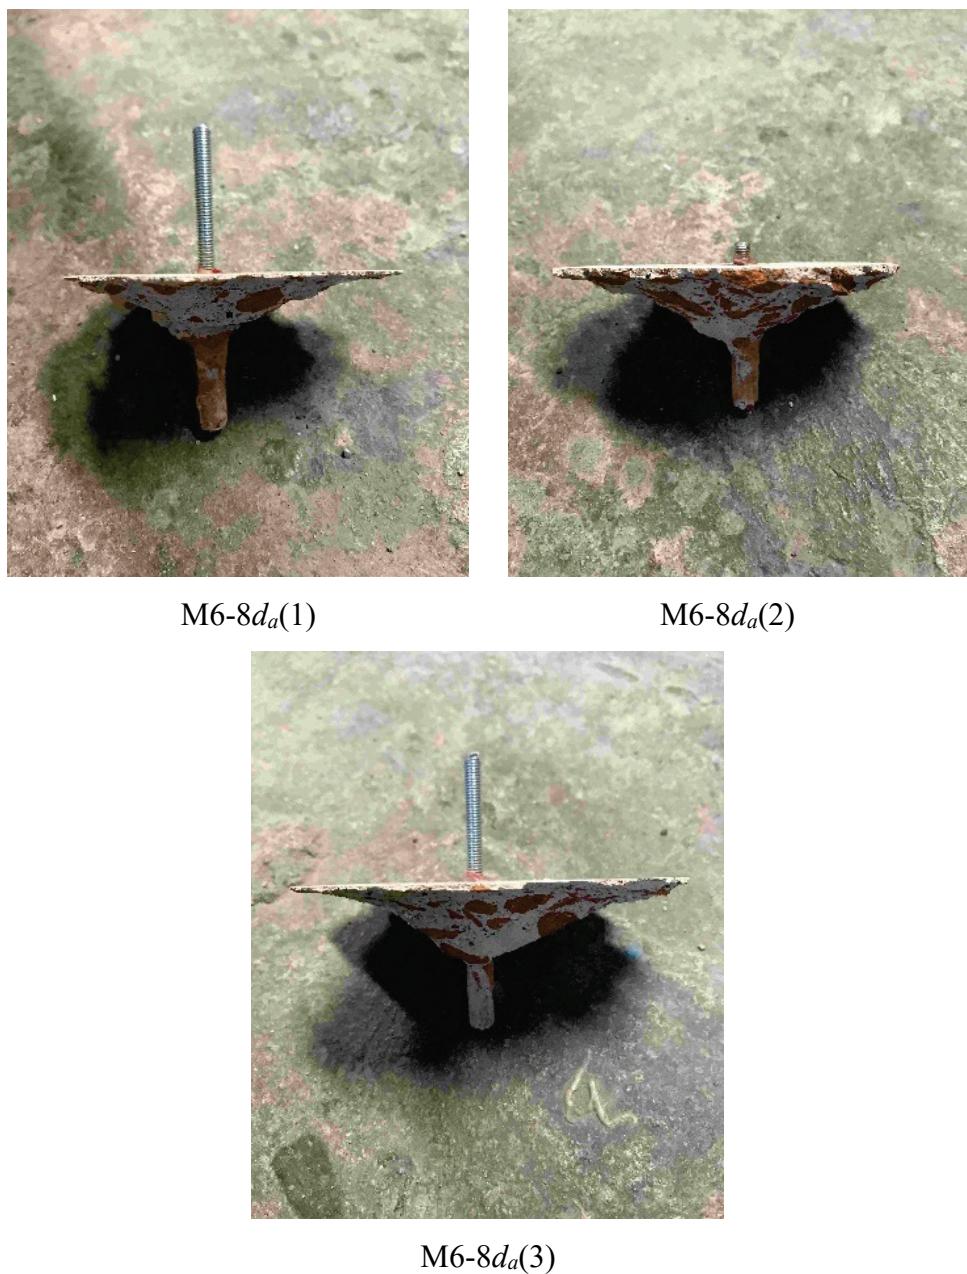
Figure 4.8 Concrete cone failure with pullout of M6 specimens

All specimens with concrete failure showed the formation of a shallow concrete cone at the upper part of anchor embedment with a pullout of the lower part of anchor embedment, as shown in **Figure 4.8** and **Figure 4.9**. The formation of combined failure with shallow concrete cone and anchor pullout might be affected because the anchors were not installed in pure concrete block but the concrete slab with reinforcement; however, such embedment condition is likely to be more realistic.

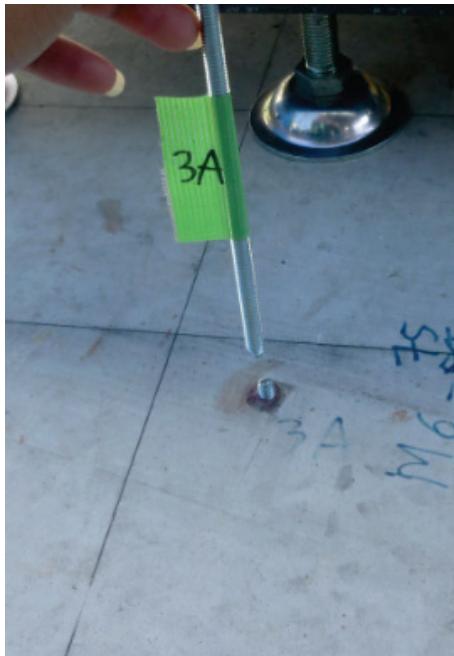
M6-12.5 d_a (1)

Figure 4.10 An anchor specimen with tensile fracture

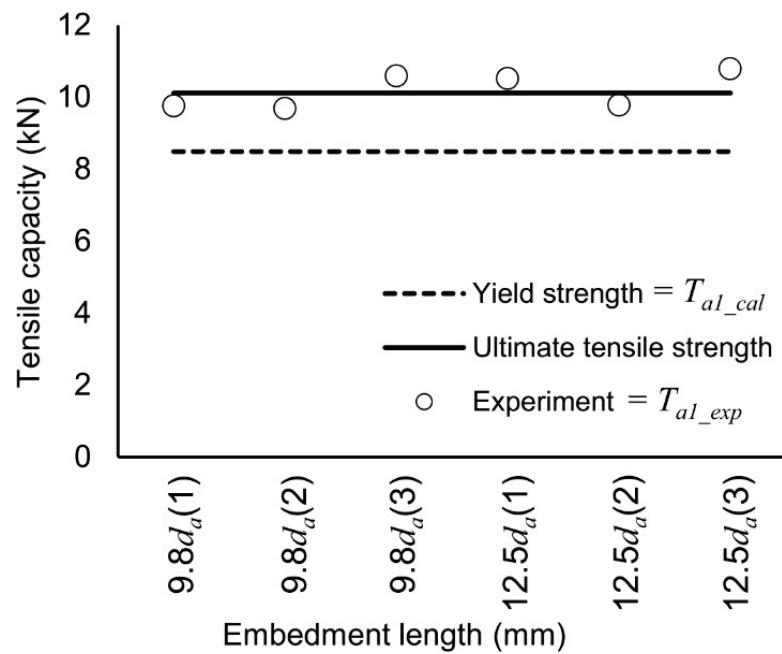
Figure 4.11 Tensile capacity determined by tensile fracture of M6 specimens

In **Figure 4.11** and **Figure 4.12**, the experimental tensile capacity of M6 and M8 anchor specimens determined by steel failure is compared with not only T_{al_cal} but also the ultimate tensile strength based on **Table 4-4**. The figures show that the tensile capacity of anchors agreed with the ultimate tensile strength beyond yielding. When the tensile capacity is designed assuming tensile failure to be ductile, the exceedance of tensile capacity needs to be considered.

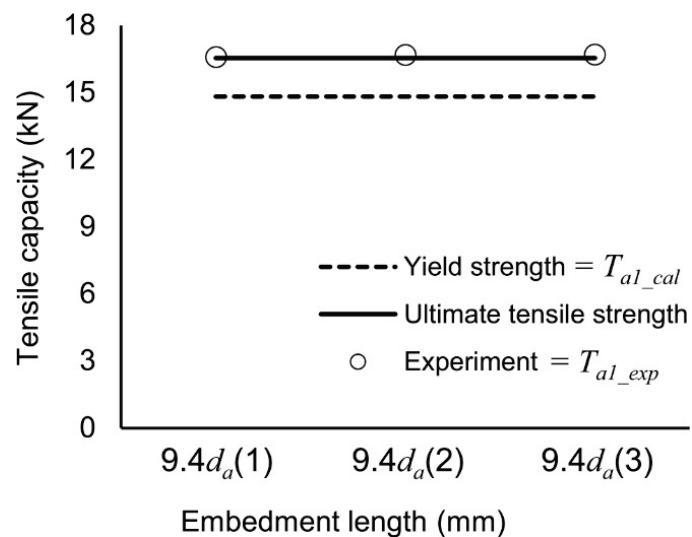
Figure 4.12 Tensile capacity determined by tensile fracture of M8 specimens

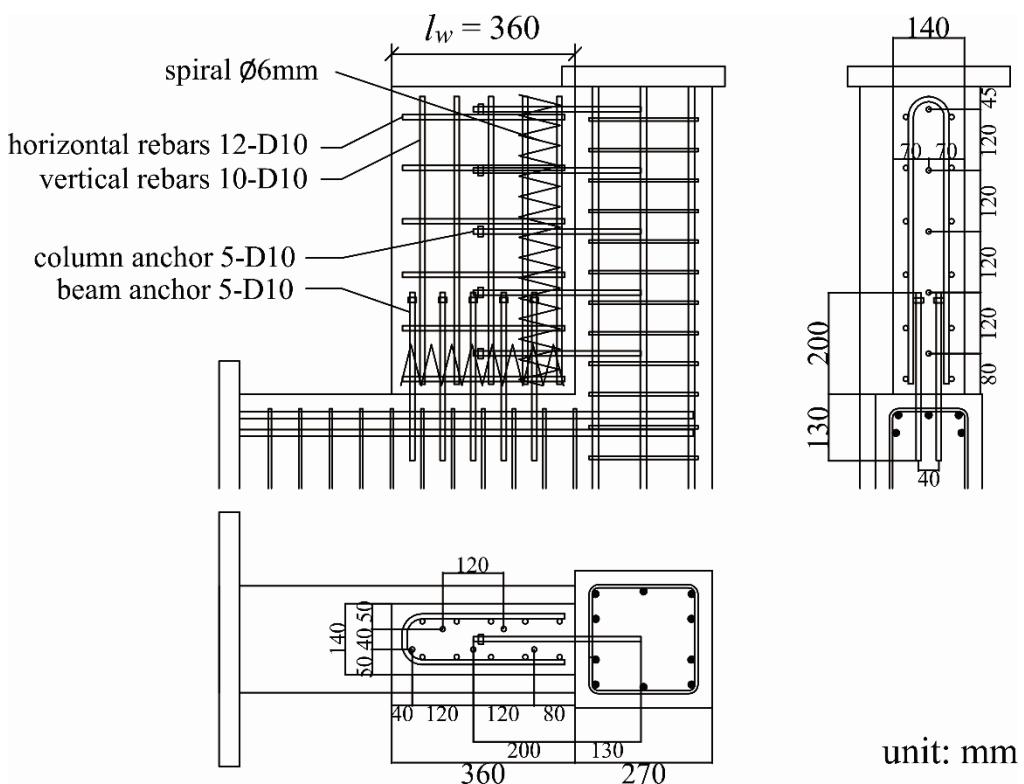
Figure 5.2 Dimensions and reinforcement details of the strengthened specimen J1-W

The vertical and horizontal reinforcements of the wing walls used double layers of D10 bars. The reinforcements of the wing walls were designed to not be less than a minimum reinforcement ratio of 0.25% according to the Japanese guidelines [22] and to be greater than the total sectional area of the beam/column anchors. For prevention of splitting failure of the concrete, $\phi 6$ spirals were installed at the boundaries between the wing walls and the frame.

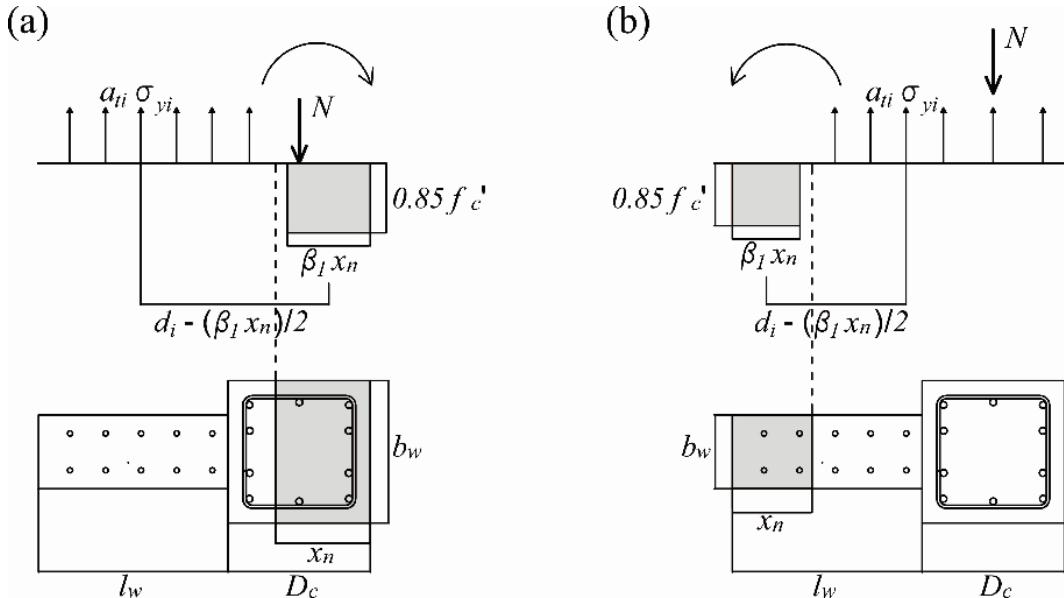
Figure 5.8 Evaluation of the ultimate strength for the column with a wing wall: (a) Wing wall in tension (b) Wing wall in compression.

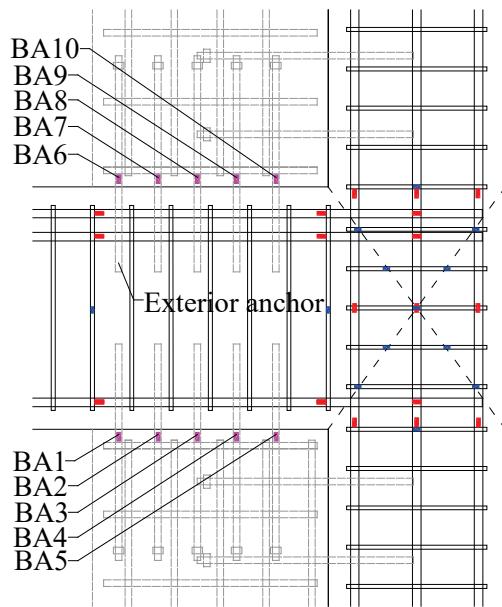
- Strain gauge of longitudinal reinforcement
- Strain gauge of shear reinforcement
- Strain gauge of beam anchor bars
- - Assumed diagonal crack position

Figure 5.9 Strain gauge arrangement of specimen J1-W.

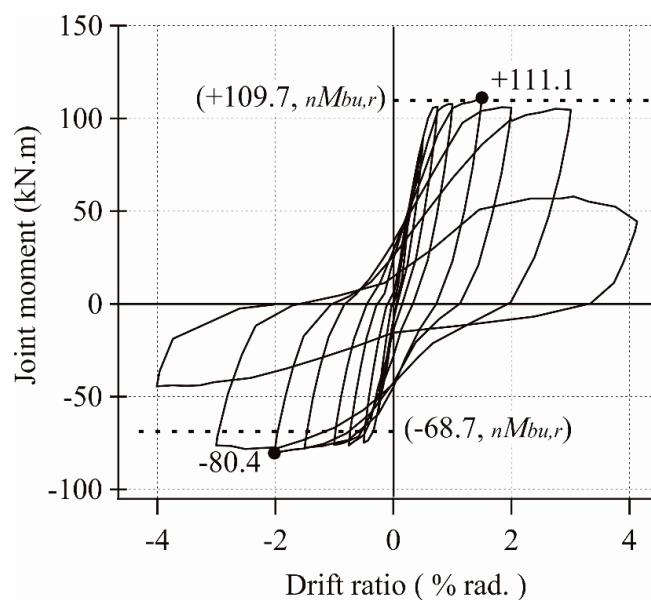
Figure 5.11 Joint moment-drift ratio relationship of specimen J1-W.

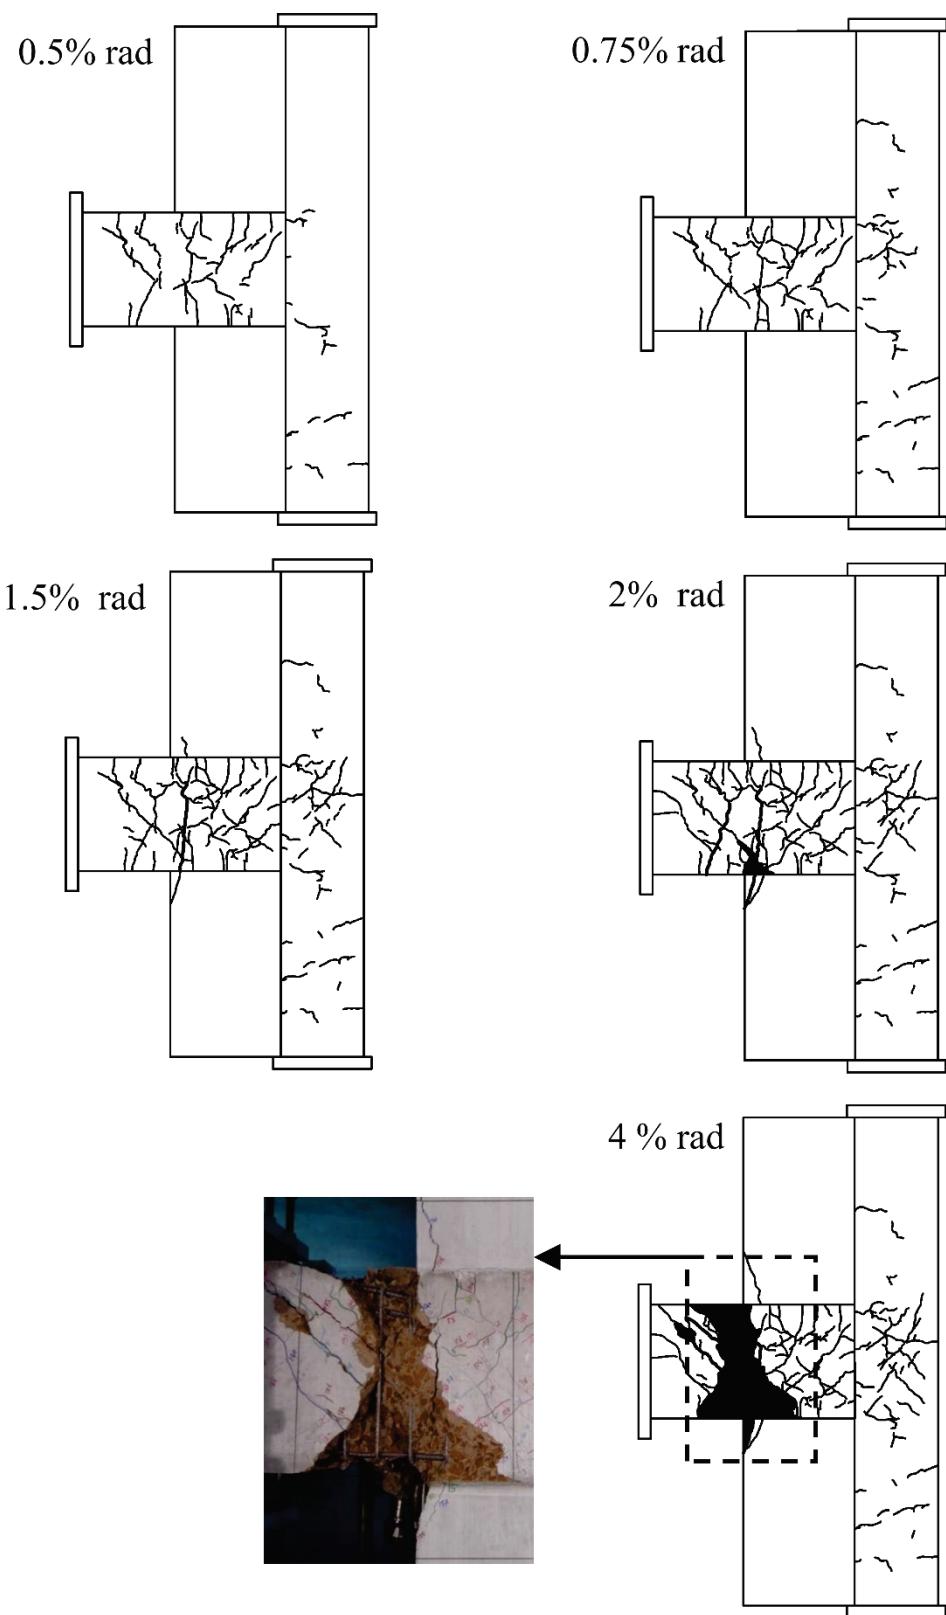
Figure 5.12 Damage to specimen J1-W.

In the retrofitted specimen, J1-W, the beam suffered damage at the wing wall end, indicating a beam yielding mechanism. The beam longitudinal bars yielded at the wall end in the positive and negative loading directions. **Figure 5.13** shows the strain measurement results along the beam bottom longitudinal bar of specimen J1-W. The lower strains at the column face indicated a significant reduction in the horizontal shear force transmitted to the joint, thus preventing joint shear failure. The high plastic strains developed at the end of the wing walls indicated that a plastic hinge formed in the beam. The anchorage (bond) was not lost until the last cycle to $R = \pm 4\%$ based on clear gradients between the strain values at the middle joint and at the column face.

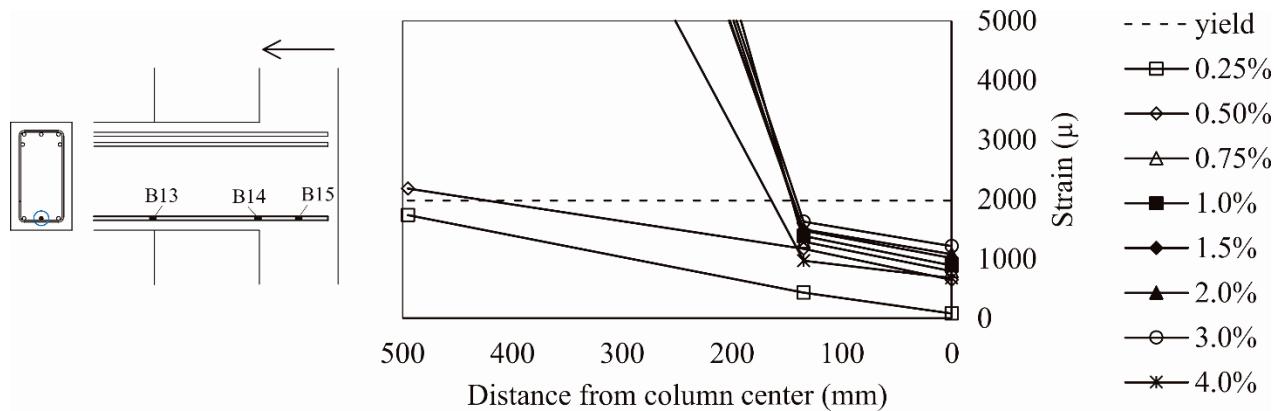
Figure 5.13 Strains along the bottom beam longitudinal bar of specimen J1-W.

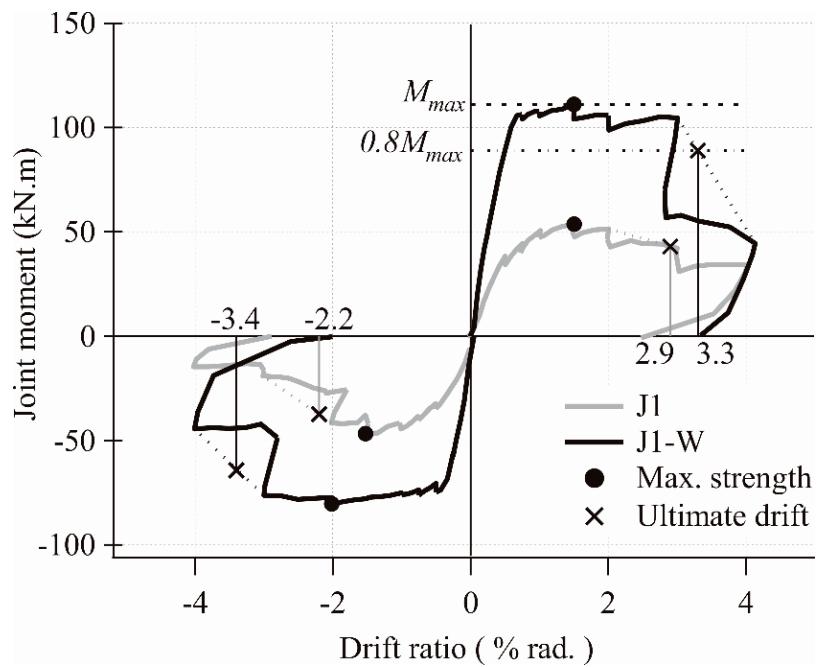
Figure 5.14 Comparison of the ultimate drift ratio of specimens J1 and J1-W.

Figure 5.14 compares the envelopes of the hysteresis loops shown in **Figure 3.14(a)** and **Figure 5.11**. In particular, the deformation capacity of the strengthened specimen, J1-W, was improved by 155% in the negative loading direction. It was confirmed that the deformability was improved by preventing anchorage failure. In the positive loading direction, the improvement in deformation capacity was limited; however, joint shear failure was prevented. To improve the deformation capacity beyond these results, shear strengthening should be applied to the beam end. The method to estimate the deformation capacity at the flexural-shear failure of beam will be explained later in **Section 5.8**.

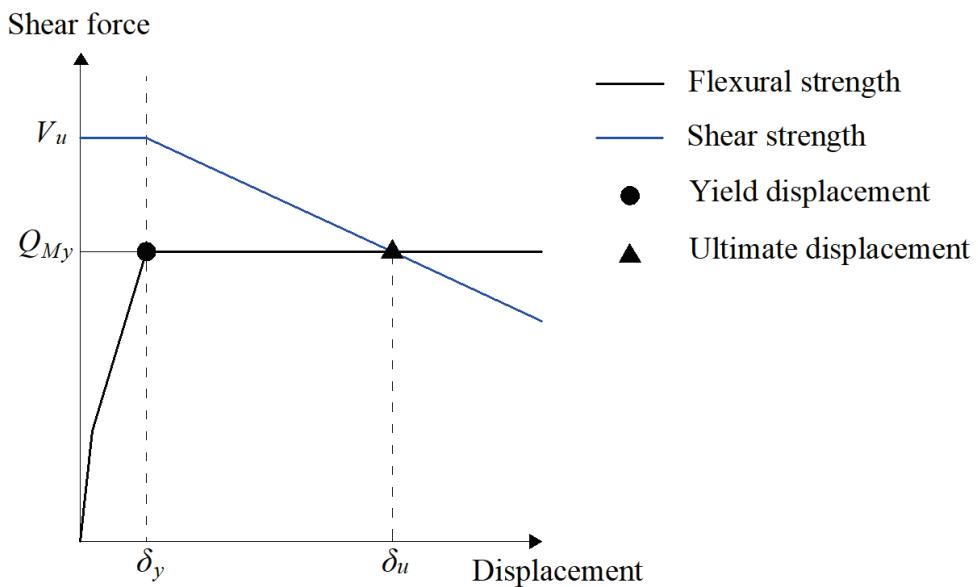
Figure 5.15 Evaluations of the deformation capacity of RC beams

Figure 5.15 shows a conceptual drawing for determining the deformation capacity of RC beams by combining the flexural performance curve with the shear strength curve. The deformation capacity at flexural-shear failure is defined as displacement at the intersection of the two curves.

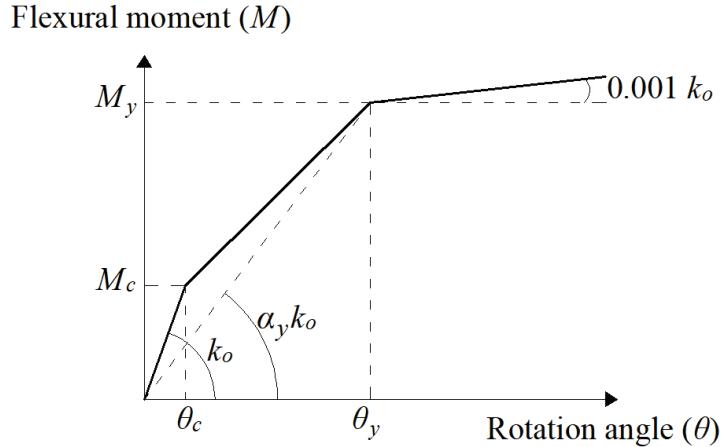
Figure 5.16 Flexural performance curve of the beam

were calculated by **Equations (5-12)** and **(5-13)**, respectively. The cracking rotation θ_c and yielding rotation θ_y were calculated by Equations **(5-14)** and **(5-15)**, respectively. **Equation (5-16)** gave the value of secant stiffness at the yielding point (α) and the post-yield stiffness was assumed to be 0.001 of the elastic flexural stiffness (k_o).

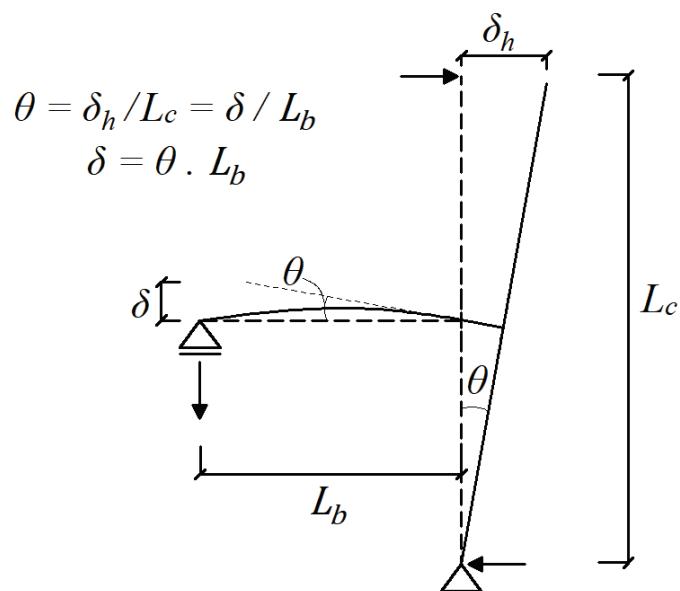
Figure 5.21 Converting drift angle to beam displacement

In the experiment, inter story-drift angle (θ) was defined as the ratio of column-relative displacement (δ_h) to the column height (L_c), as shown in **Figure 5.21**. However, for the evaluation of deformation capacity of beam, beam displacement (δ) need to be defined. Assuming rigid column, the drift angle (θ) is assumed equal to the ratio of beam displacement (δ) to the beam length (L_b). The conversion of joint moment – drift ratio relationship of specimen J1-W in **Figure 5.11** into beam shear force (Q) – beam displacement (δ) relationship is shown as experimental hysteresis curve in **Figure 5.22** or **Figure 5.23**.

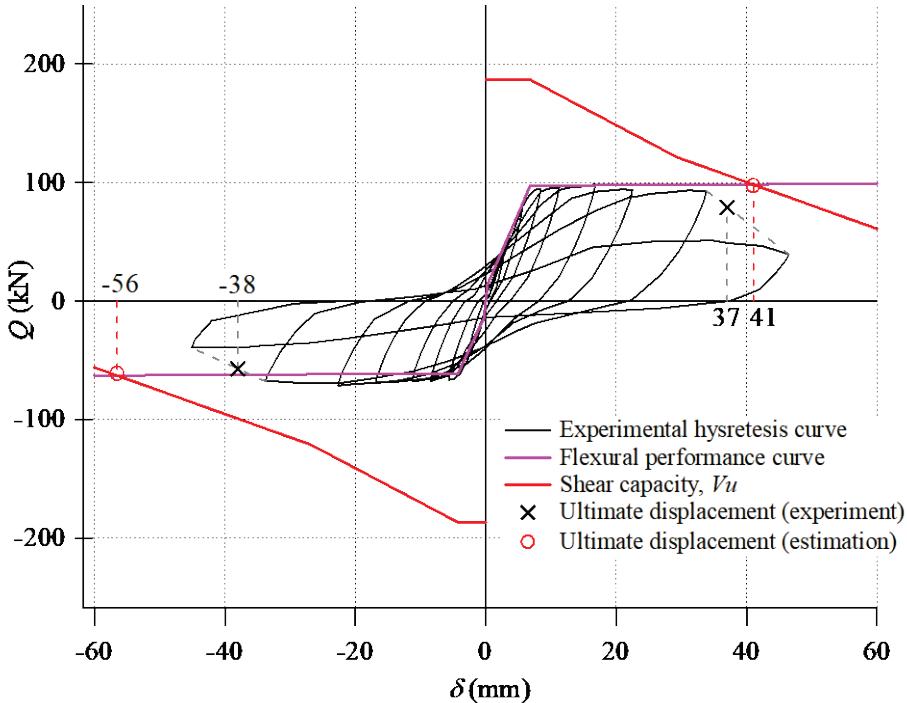
Figure 5.22 Estimated deformation capacity of beam using AIJ 1990 shear strength model [28]

Evaluation results of deformation capacity of beam using the AIJ 1990 shear strength model [28] combined with the flexural performance curve are described in **Figure 5.22**. The tested material properties, explained in **Section 5.3**, were used for calculations. The flexural performance curve obtained using the method explained in **Section 5.8.1** well predicted the flexural behavior of the specimen before the flexural-shear failure occurred. However, the application of the AIJ1990 shear strength model quantitatively overestimated the ultimate displacement of beam at flexural-shear failure in both positive and negative loading direction. Therefore, this model is not recommended for estimating the deformation capacity of beam within the present investigation.

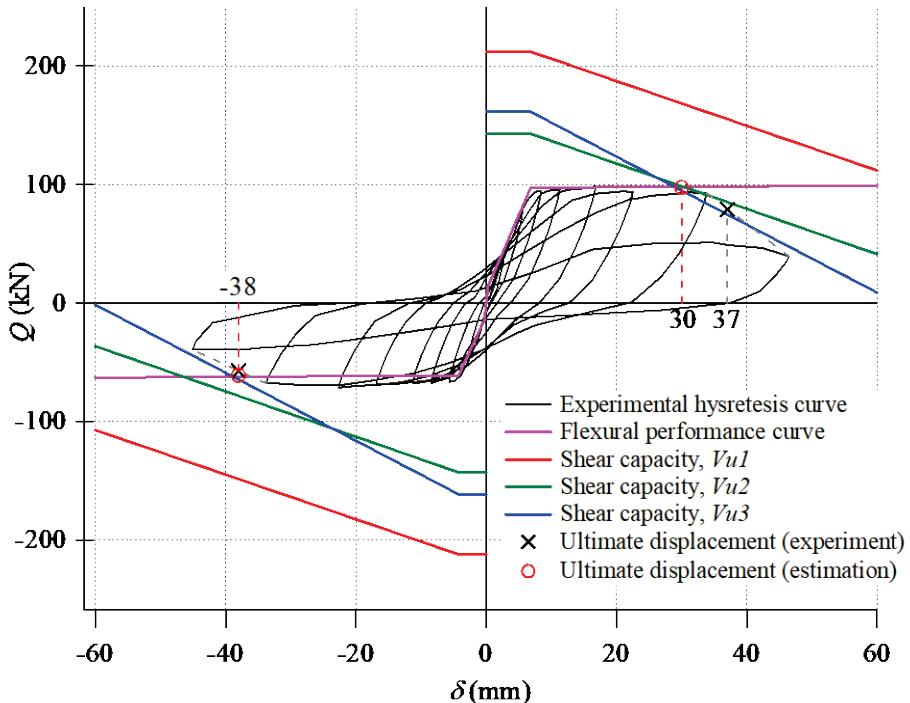
Figure 5.23 Estimated deformation capacity of beam using AIJ 1997 shear strength model [23]

The minimum value of the estimated ultimate displacement of beam was 30 mm, equal to beam drift angle 2.67% rad. If a larger deformation capacity is expected in design, shear strengthening of beam should be applied.

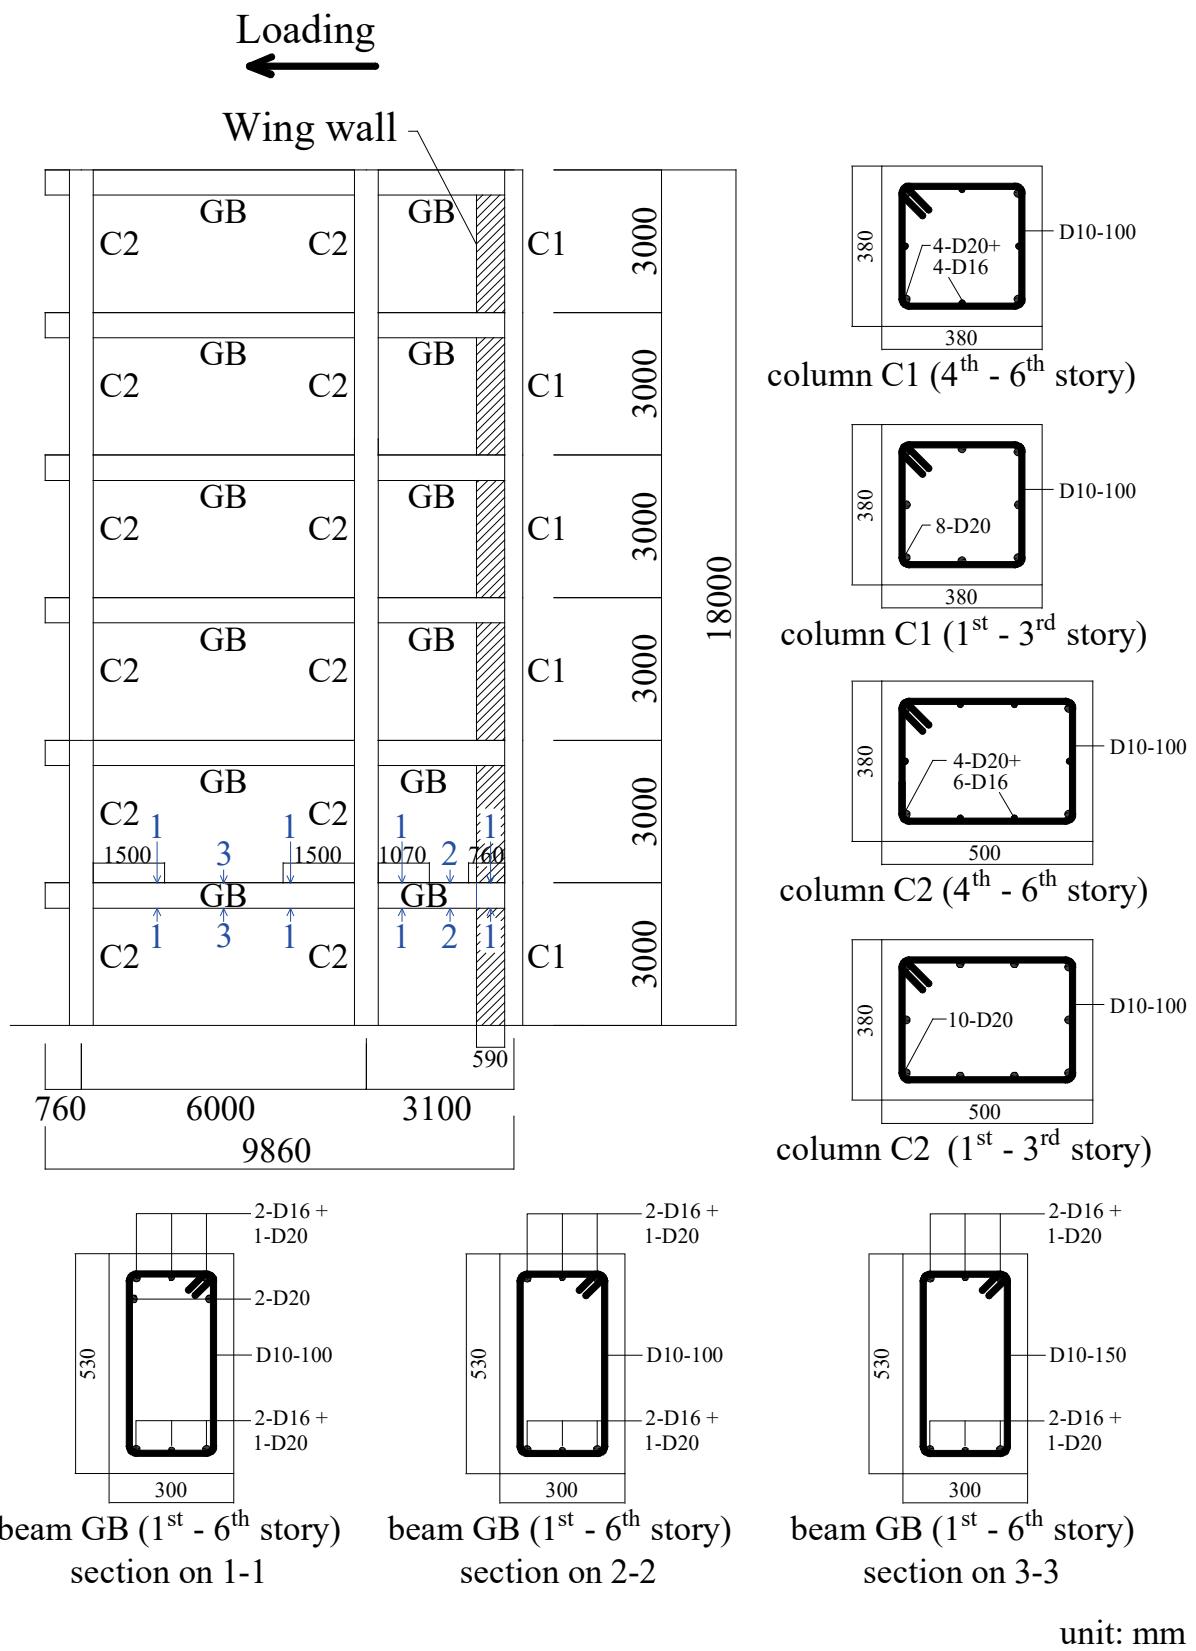
Figure 6.1 The focused building and reinforcement details of the structural members

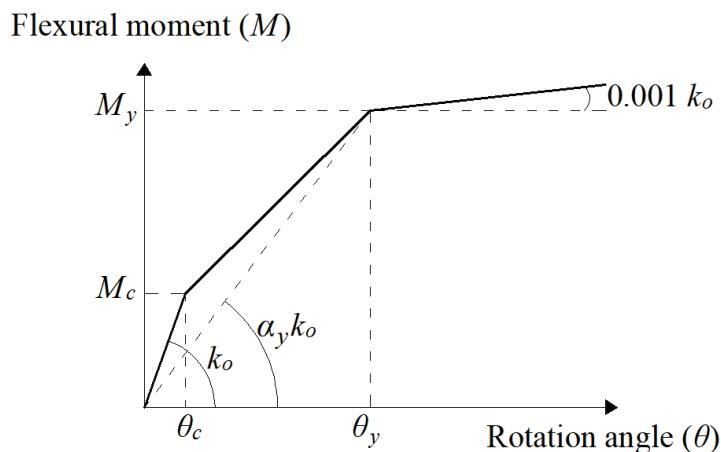
Figure 6.4 Trilinear moment-rotation relationship of flexural spring

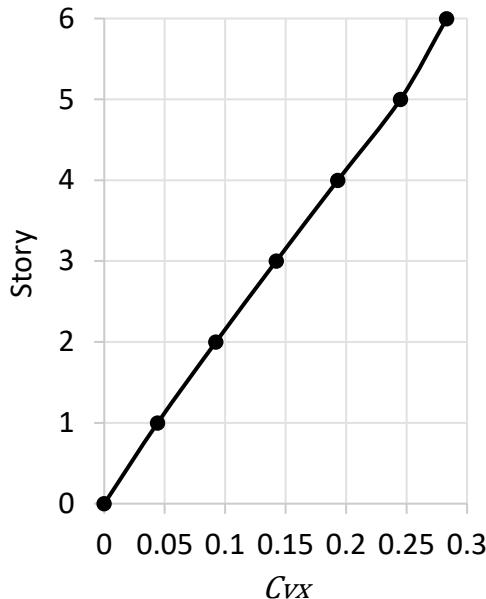
Figure 6.5 Lateral force distribution

where h_n is the height of buildings in meters from foundation or from top of rigid basement; $C_t = 0.0466$ and $m = 0.9$ for concrete moment-resisting frames.

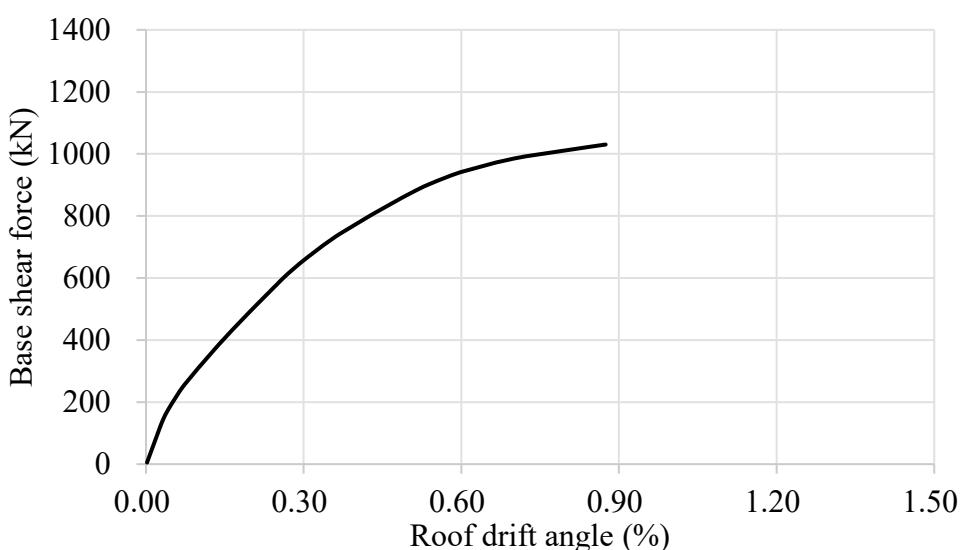
Figure 6.6 Base shear force – roof drift relationship for frame without wing walls

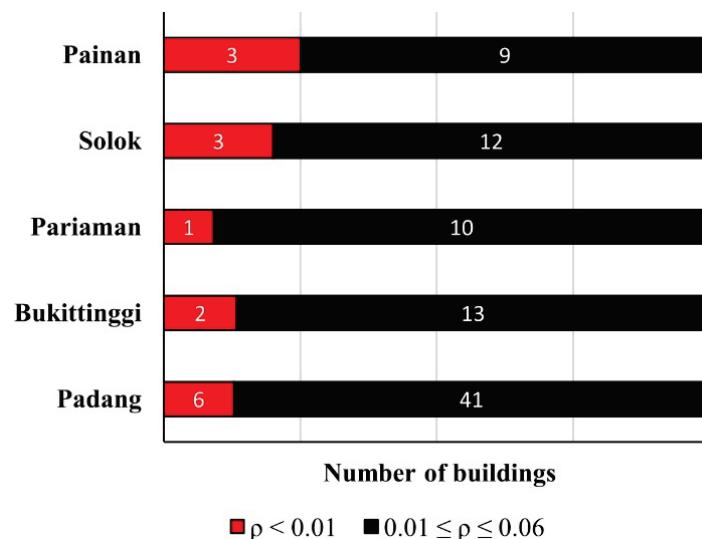
Figure A.2 Field investigation results on ratio of flexural reinforcement in column

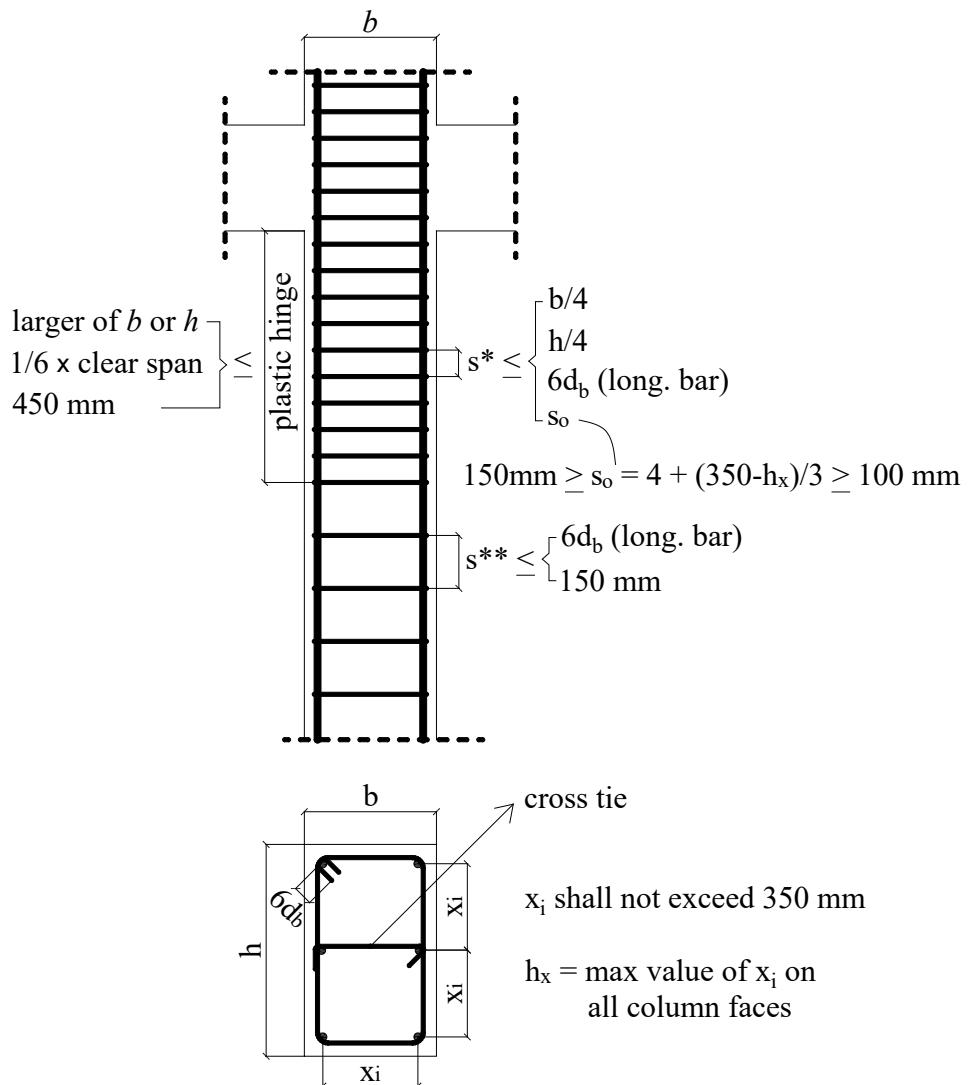
Figure A.4 Requirements for transverse reinforcement of column

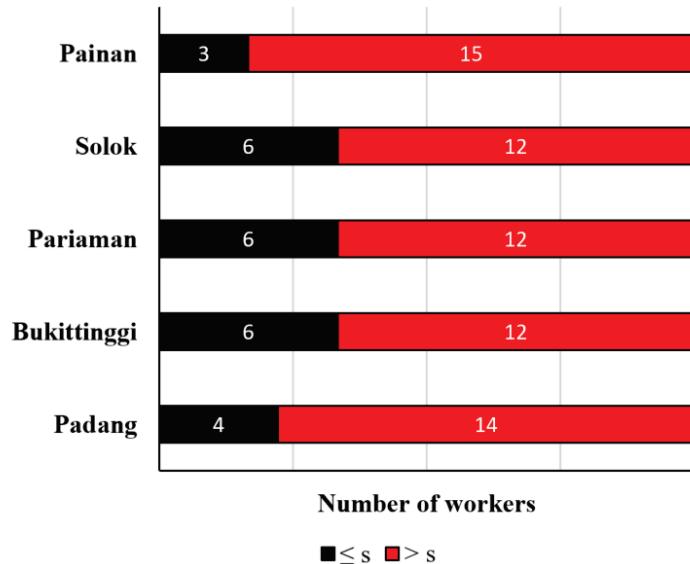
Figure A.14 Workshop results on spacing of transverse reinforcement in beam

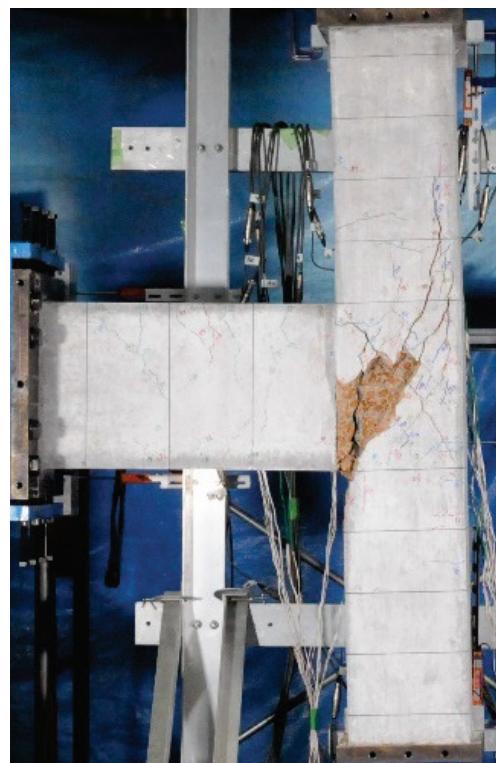
Final crack pattern

Figure B.1 Crack pattern of specimen J1

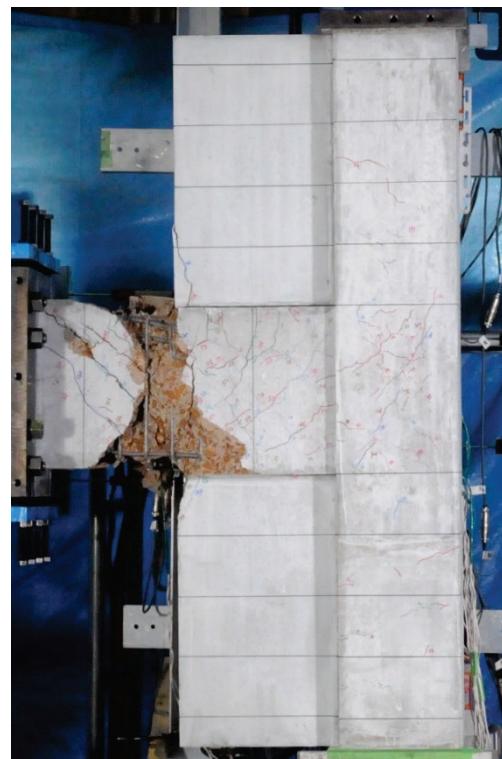
Final crack pattern

Figure B.3 Crack pattern of specimen J1-W
