Doctoral Dissertation

REHABILITATION OF HERITAGE BUILDINGS:

Energetic Retrofit in the Historical District

of the Budapest Old Jewish Quarter

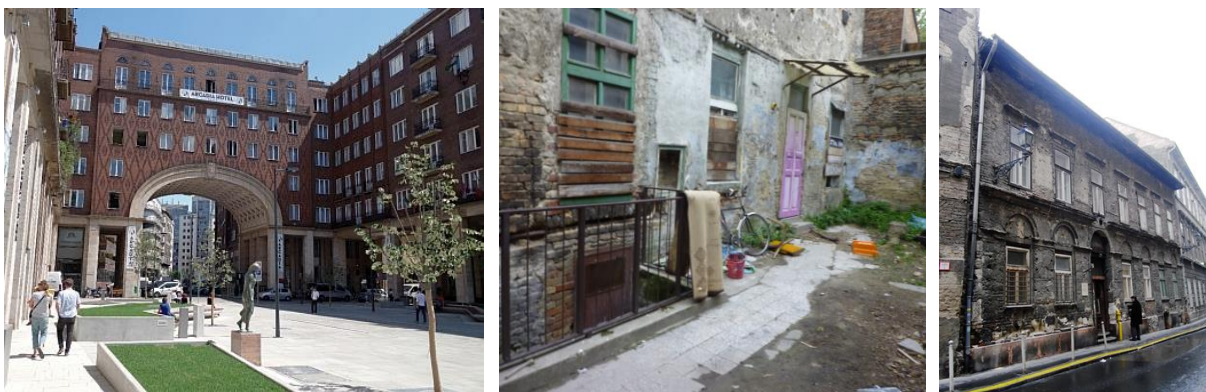
Figure 13: Left: Renovated public place in front of the Madách House gate. Middle: Courtyard in poor condition. Right: Façade of a ruin pub, residing in one of the oldest buildings in the area. (source: Authors' own figure)

In the case study area, presently only 19% of the buildings are in acceptable condition, while the remaining 81% require renovation (Nagy, 2008). The above problem is topped by an intensive functional transformation. In the last few years, the area became the “party district” of Budapest, with its internationally famous ruin pubs. Although this function was historically part of the area and resulted in minor renewal recently (mainly on public places), the process accelerates demolitions (Figure 13).

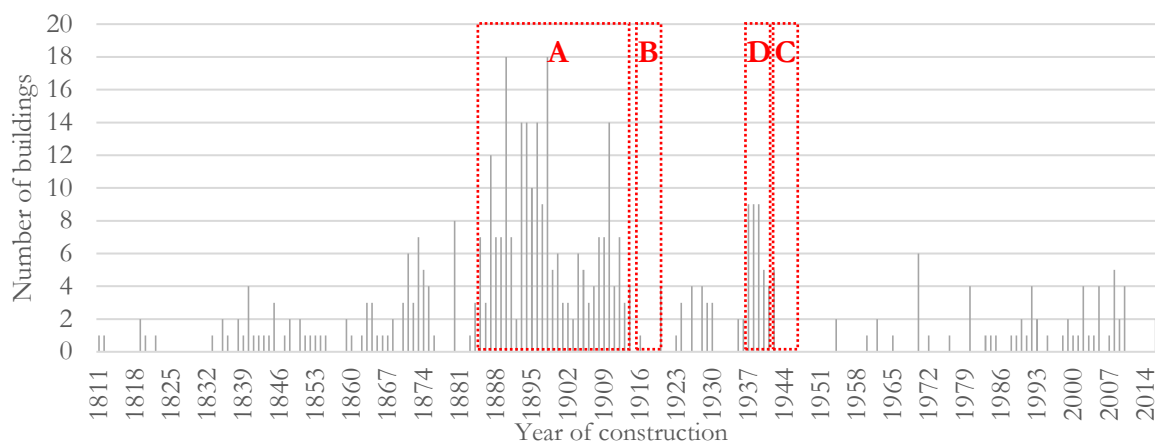
**Figure 14: Number of buildings built in each year in the surveyed period, considering the construction year of the current buildings.**

Figure 14 shows the number of buildings built in each year on the survey area (on current stock, not considering the demolitions and rebuilding). The peak of the construction activities of the area was between 1885 and 1915 (A). The figure also shows clearly the less active construction periods, for example during the First (B) and Second World War (C) and the following financial crisis, when a low number of new buildings can be observed. The peak around 1938 shows the project of Madách Houses (D), where a significant part of the old fabric was replaced. The average age of the buildings is 115 years.

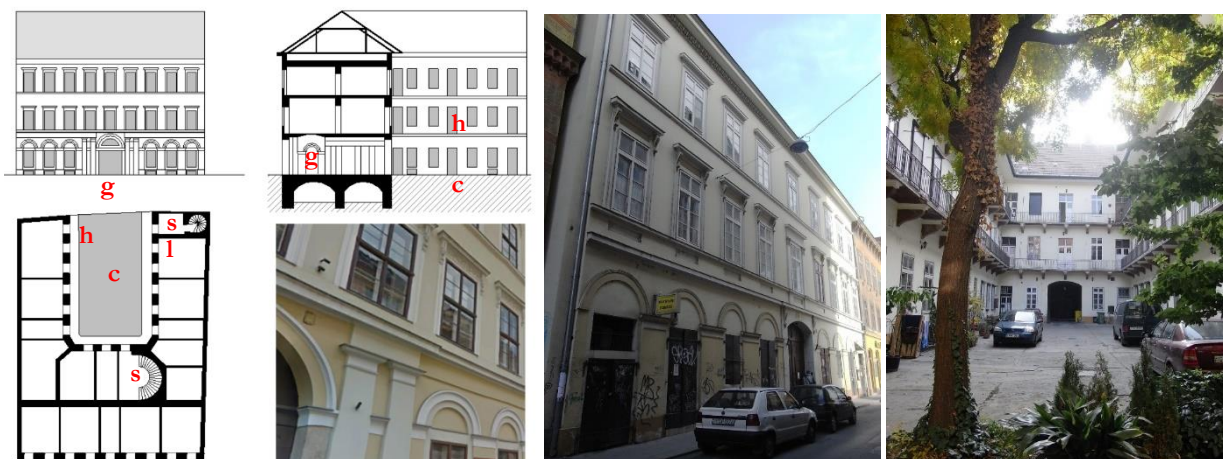
Figure 19: Left: Example of a Neo-Classistic building. Façade, layout, section and detail of a building. Middle and right: Another example façade and courtyard from the case study area. (c = courtyard, g = gate, h = hanging corridor, s = staircase, l = common lavatory) (source: Authors' own figure)

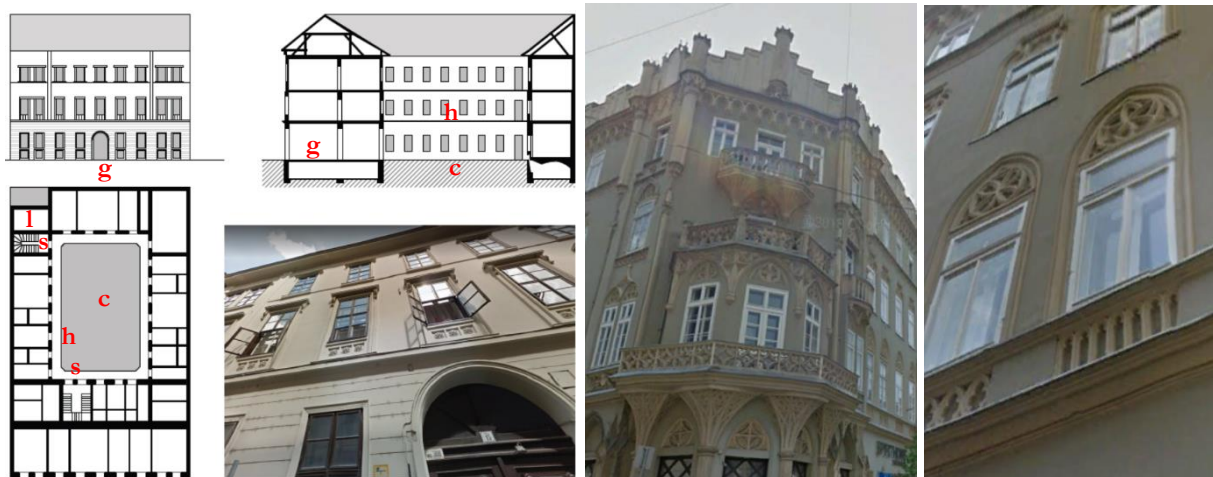
Figure 20: Figure: Left: Example of a Romanticism building. Façade, layout, section and detail of a building. Middle and right: Other example façades from the case study area. (c = courtyard, g = gate, h = hanging corridor, s = staircase, l = common lavatory) (source: Authors' own figure)

On an average apartment house often only, a few decorations can be observed. The main difference from Classicism is that the classic order of ornaments were exchanged to medieval, and the side bays of façade are emphasized rather than the centre. The apartment house layout has not changed significantly (Figure 20).

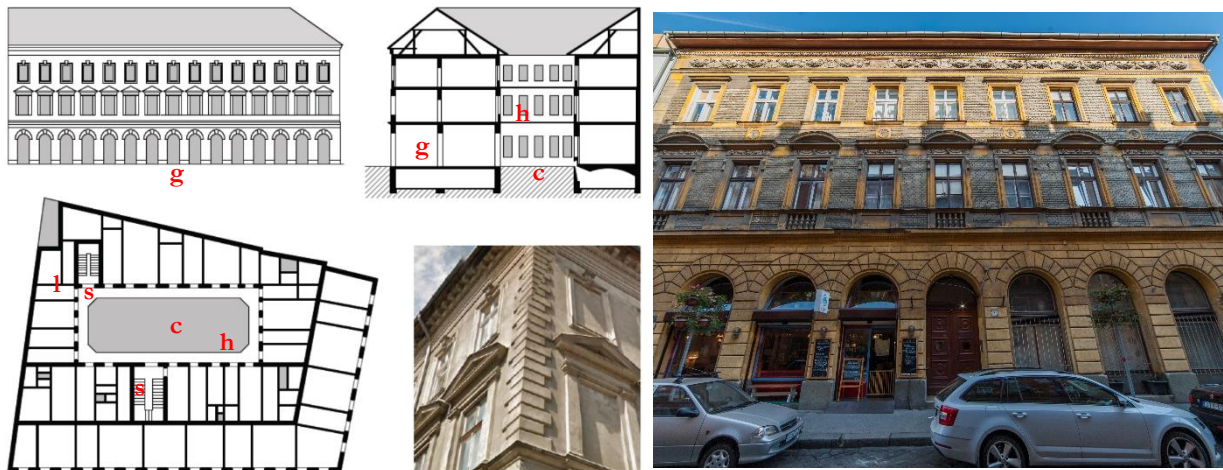
Figure 21: Left: Example of a Historicism building. Façade, layout, section and detail of a building. Right: Other example façades from the case study area. (c = courtyard, g = gate, h = hanging corridor, s = staircase, l = common lavatory) (source: Authors' own figure)

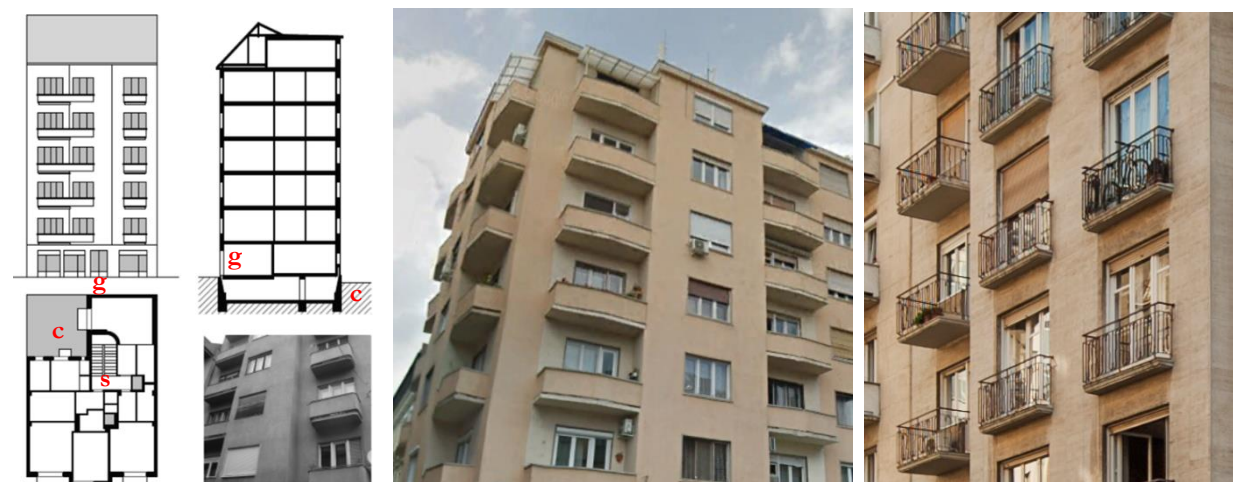
Figure 23: Left: Example of a Premodern building. Façade, layout, section and detail of a building. Middle and right: Other example façades from the case study area. (c = courtyard, backyard, g = gate, s = staircase) (source: Authors' own figure)

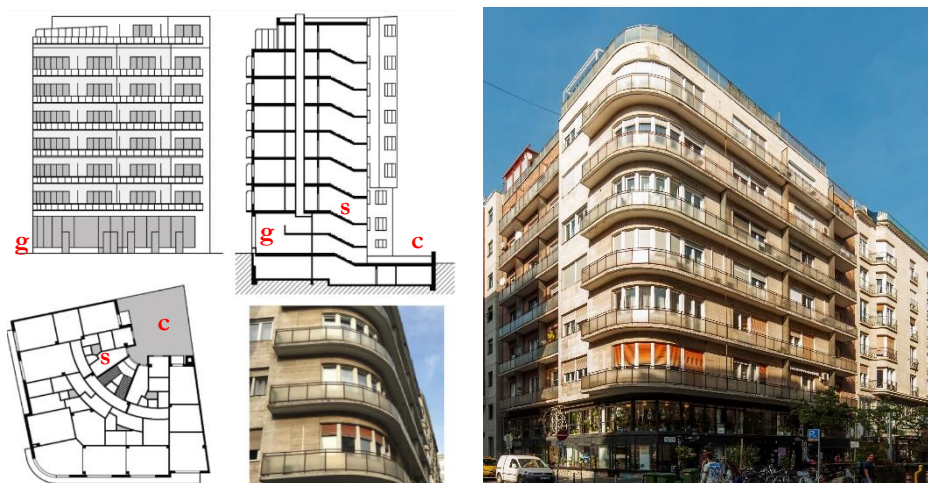
Figure 24: Example of a Modernist building. (c = courtyard, backyard, g = gate, s = staircase) (source: Authors' own figure)

Experimenting with new materials and exchanging the simple decoration of surfaces to the art of forming space itself, was also typical of the period. Using asymmetry, loosely designed layout, simple geometry and repetitive elements describe the style (Figure 24).

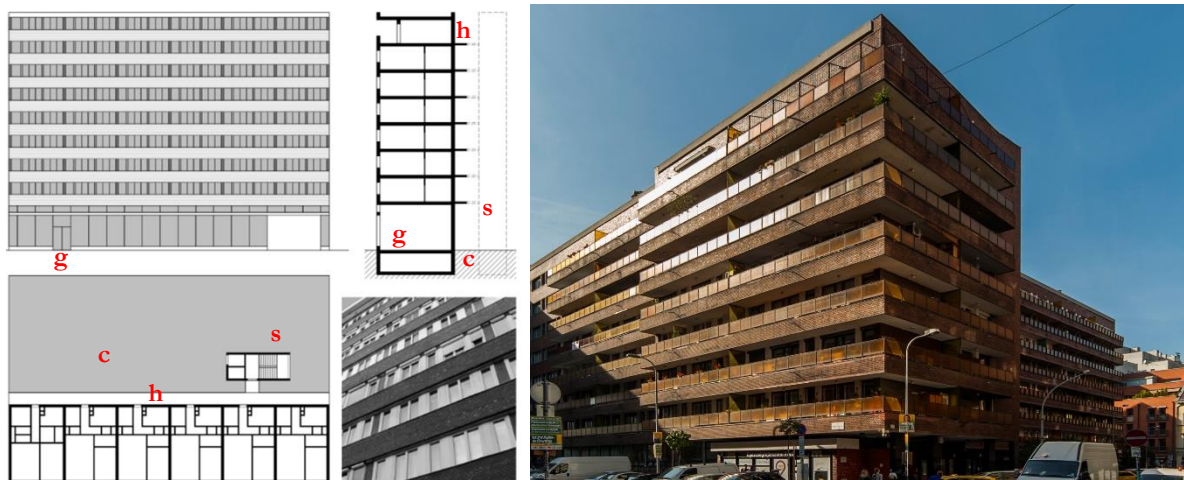
**Figure 25: Left: Example of a Socialist Modernist building. Façade, layout, section and detail of a building. Right: Another example façade from the case study area. (c = courtyard, backyard, g = gate, s = staircase, h = hanging corridor) (source: Authors' own figure)**

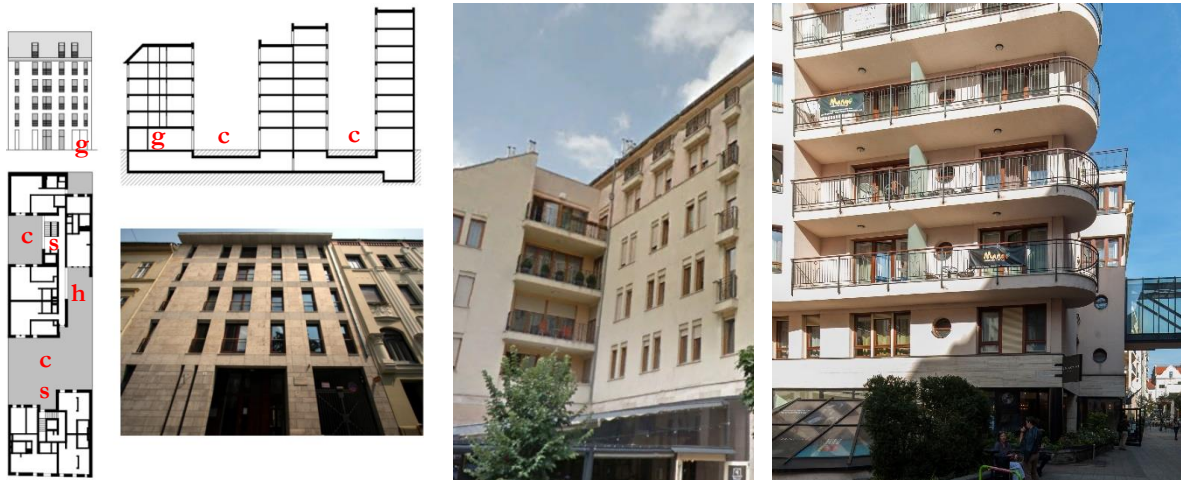
Figure 26: Left: Example of a Contemporary building. Façade, layout, section and detail of a building. Middle and right: Other example façades from the case study area. (c = courtyard, g = gate, s = staircase, h = hanging corridor) (source: Authors' own figure)

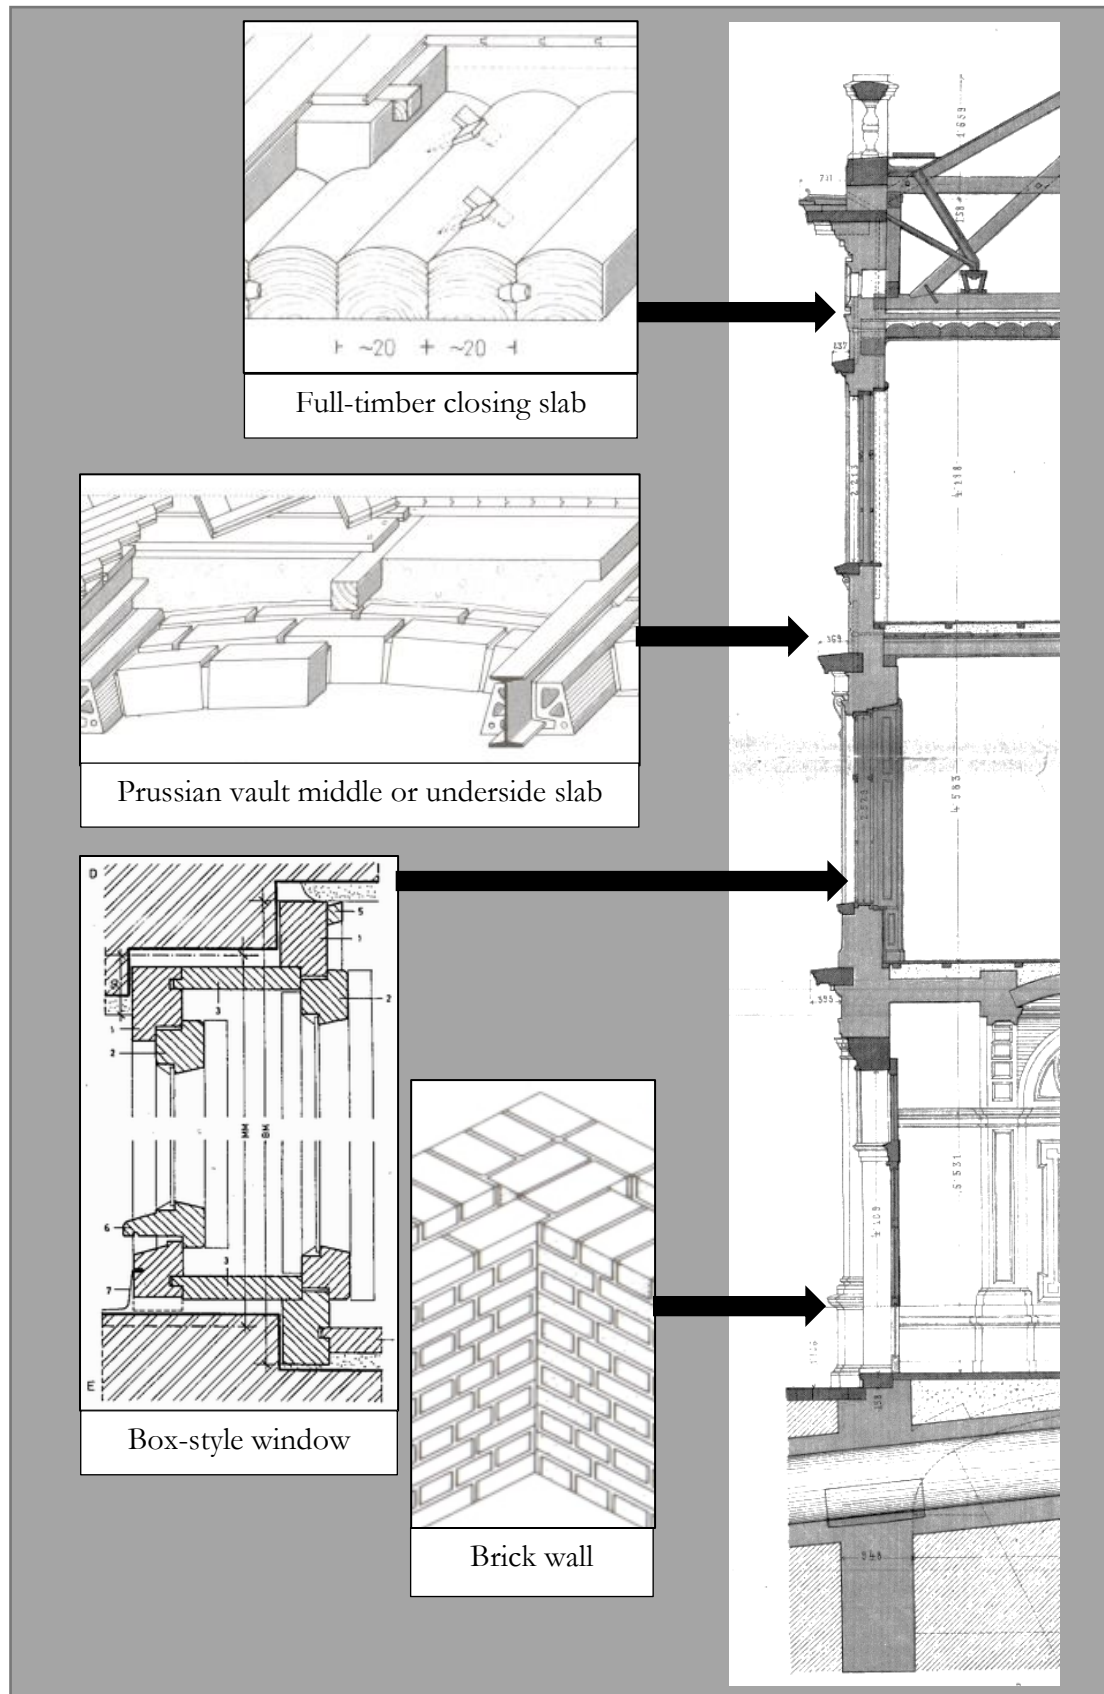
Figure 32: The most common structures in the area, part of Package 4. Source of the section is (Ritter von Riewel & Schmidt, 1881) the structural drawings are from (Bársony, 2008) and (Bársony, et al., 2008).

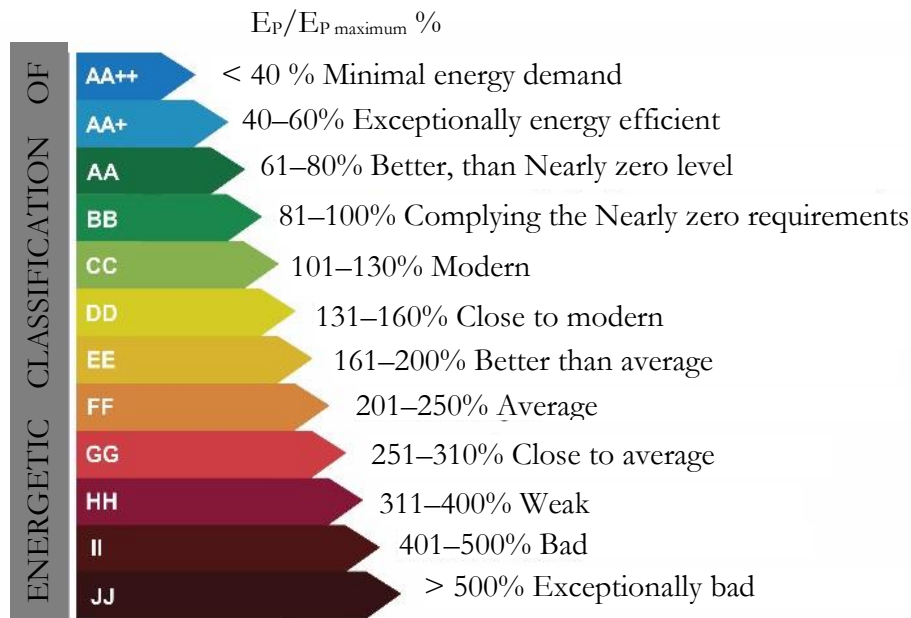
Figure 39: Classification of  $E_p$  compared to the Nearly Zero requirement level of 100 kWh/m<sup>2</sup>a to prove the compliance: Classification between AA++ and JJ (source: Authors' own figure)

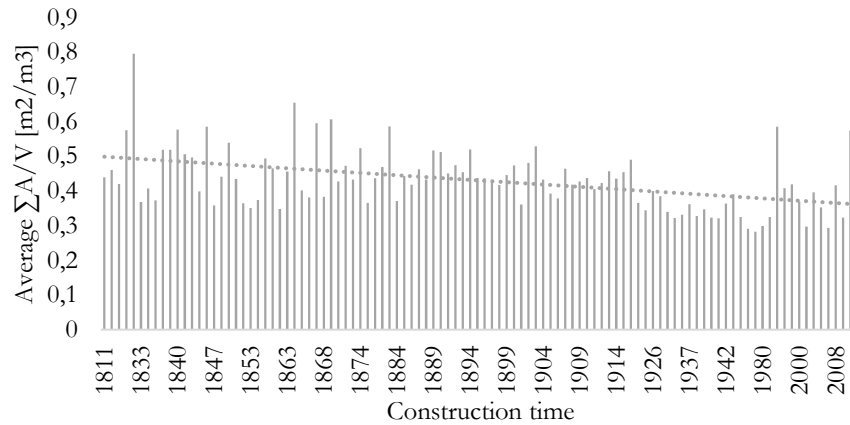
**Figure 41: The change of average total heated building envelope surface per volume ( $\Sigma A/V$  [m<sup>2</sup>/m<sup>3</sup>]) through the surveyed period (source: Authors' own figure)**

The change of average  $A$  and  $A_N$  through time is uneven. The average  $\Sigma A/V$  is decreasing, the unevenness of the 19<sup>th</sup> century becoming balanced decline showing that the buildings are eventually becoming more compact Figure 41.

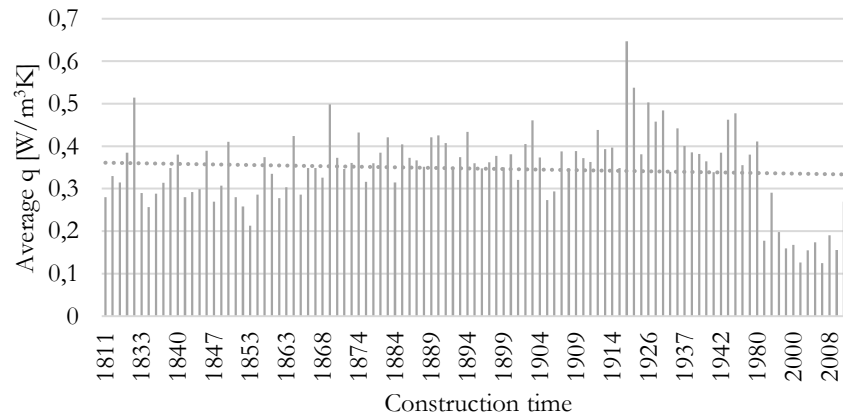
**Figure 43: Figure The change of the average heat loss coefficient ( $q$  [ $\text{W}/\text{m}^3\text{K}$ ]) through the surveyed period (source: Authors' own figure)**

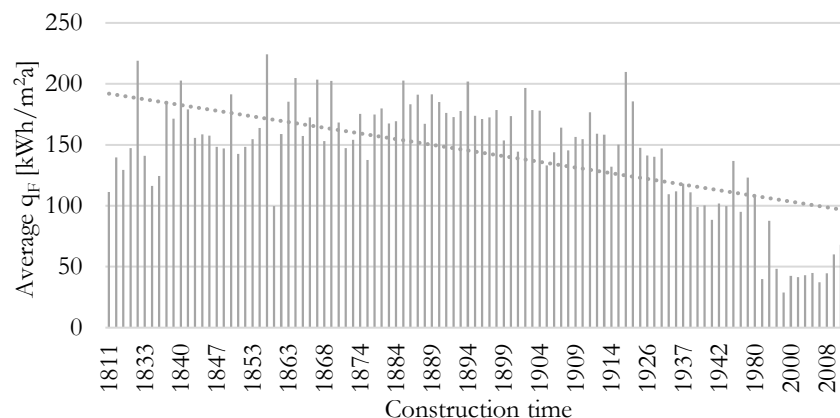
**Figure 44: The change of the average specific net energy demand value for heating ( $q_F$  [ $\text{kWh}/\text{m}^2\text{a}$ ]) through the surveyed period (source: Authors' own figure)**

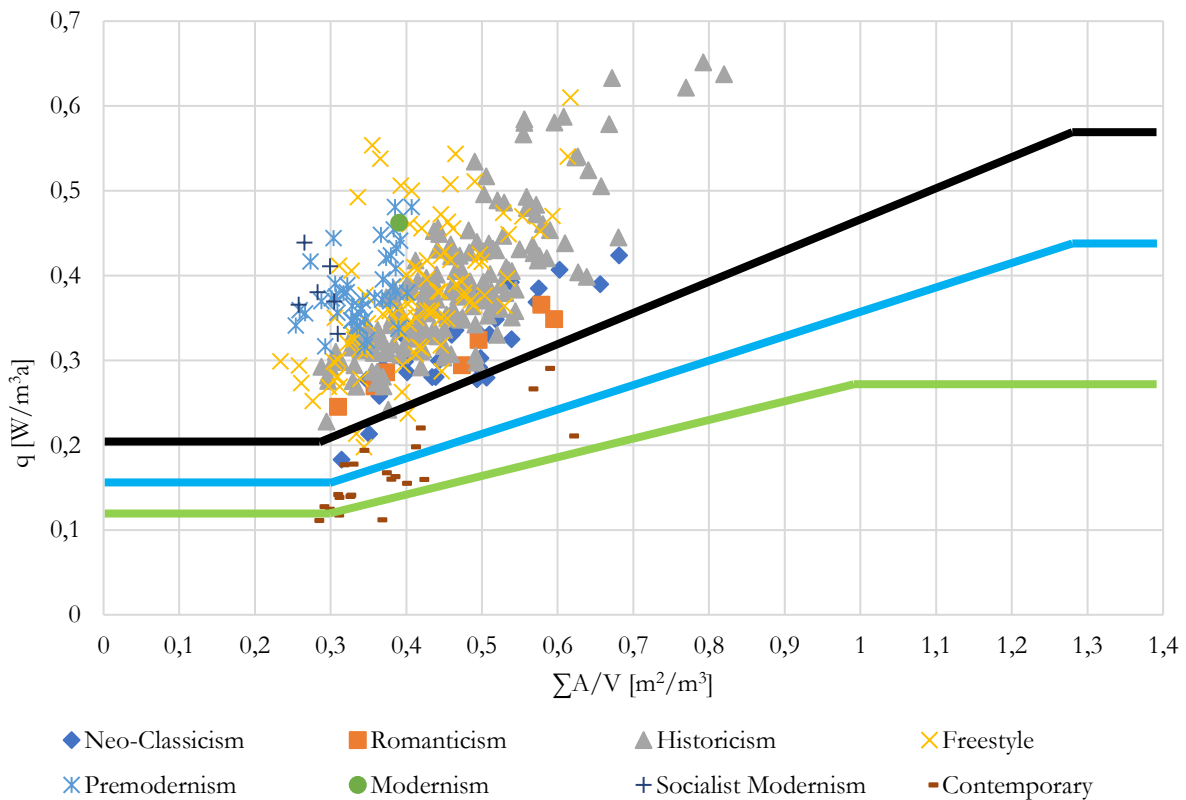
**Figure 48: Compliance of geometry of the buildings – the case study block. Black line: past compliance level, blue line: cost optimal level, green line: near zero level. The combined values of total heated building envelope surface per volume ( $\sum A/V$  [m<sup>2</sup>/m<sup>3</sup>]) and average heat loss coefficient ( $q$  [W/m<sup>3</sup>a]) are surveyed for each building to determine the compliance (source: Authors' own figure)**

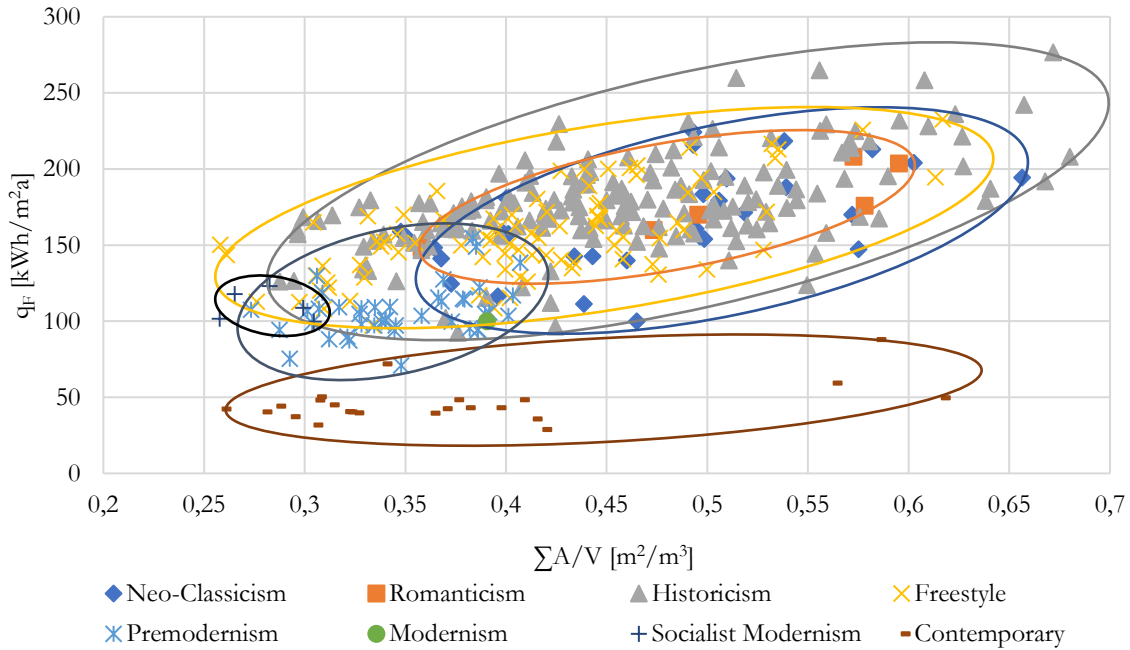
**Figure 50: Connection of total heated building envelope surface per volume ( $\sum A/V$  [m²/m³]) and specific net energy demand value for heating ( $q_F$  [kWh/m²a])** (source: Authors' own figure)

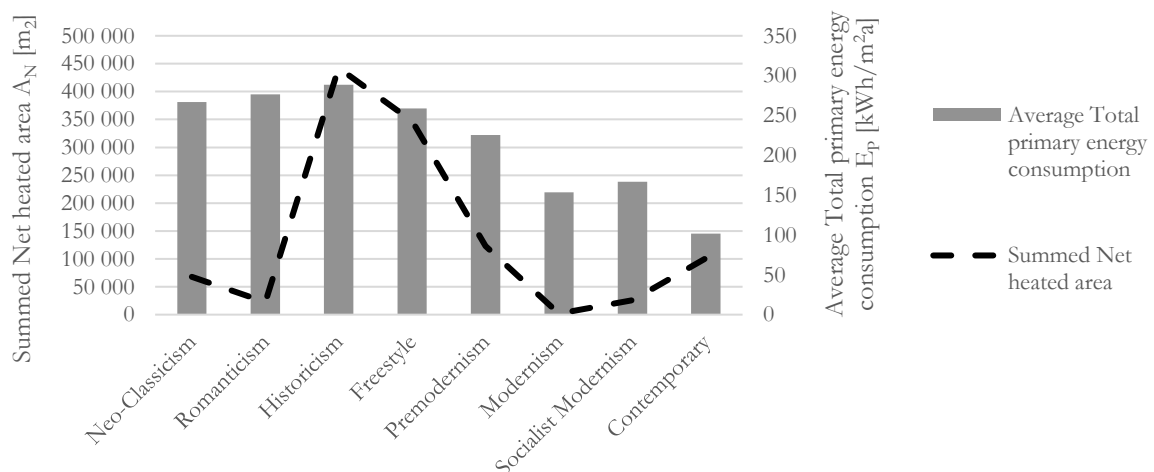
Figure 53: Connection between total primary energy consumption  $E_P$  [kWh/m<sup>2</sup>a] and summed net heated area ( $A_N$  [m<sup>2</sup>]) in case of each architectural style (source: Authors' own figure)

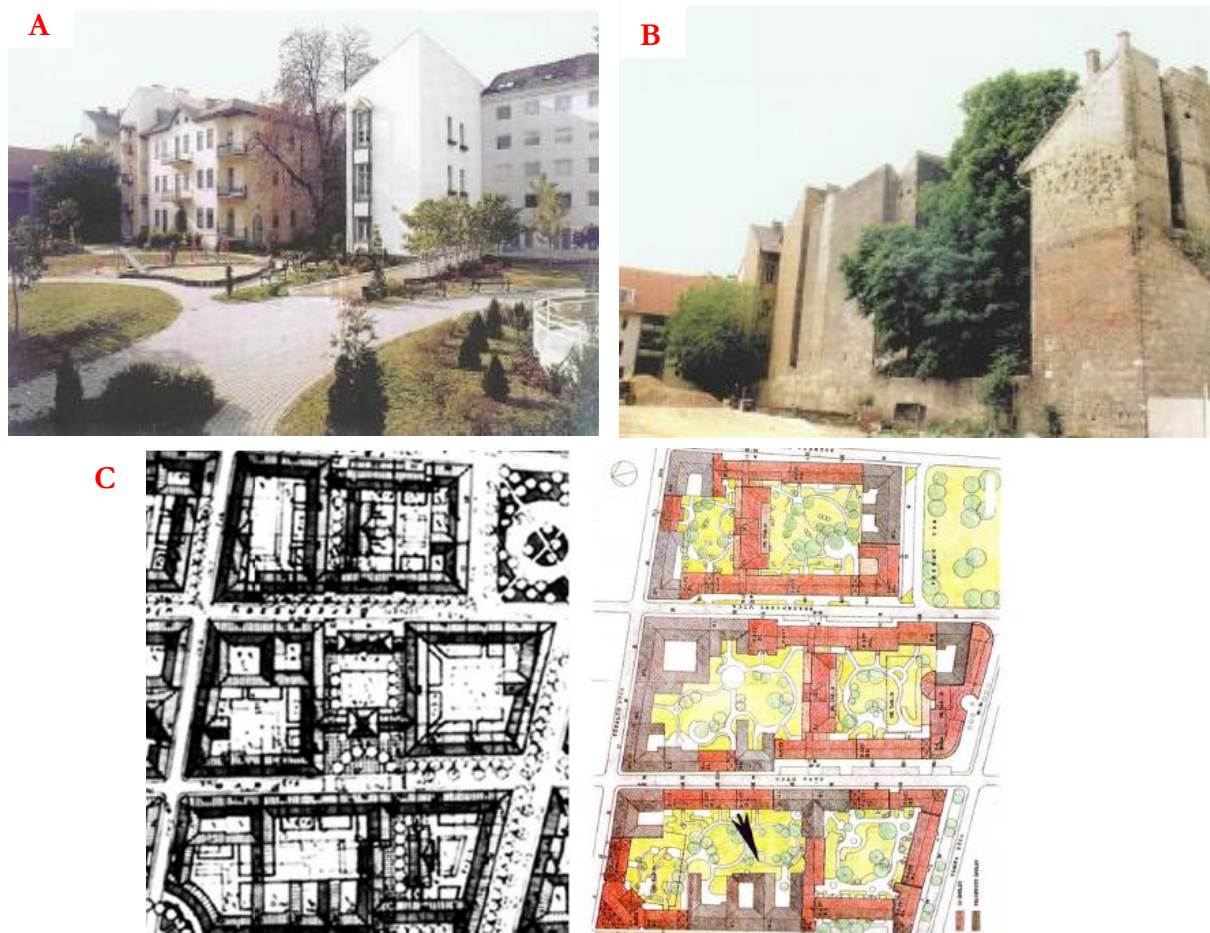
**Figure 58: Rehabilitation of Budapest 9th district. A: The new park inside of the block with new windows on firewalls. B: Same buildings as on A, before rehabilitation. C: The urban fabric before and after. The courtyard wings are mostly demolished. Source of A and B (Ertsey, et al., 2004), C (Körner & Varga, 2012)**

In case of the 9<sup>th</sup> district, the buildings were assessed, much of the wings inside the blocks were demolished. The remaining traditional buildings were upgraded, with new windows and other additions on firewalls, facing the newly opened parks inside the blocks (Körner & Varga, 2012). The plan resulted in a major development in the area; however, the exchange of population and the disappearance of the original historical streetscapes are still criticized (Figure 58).

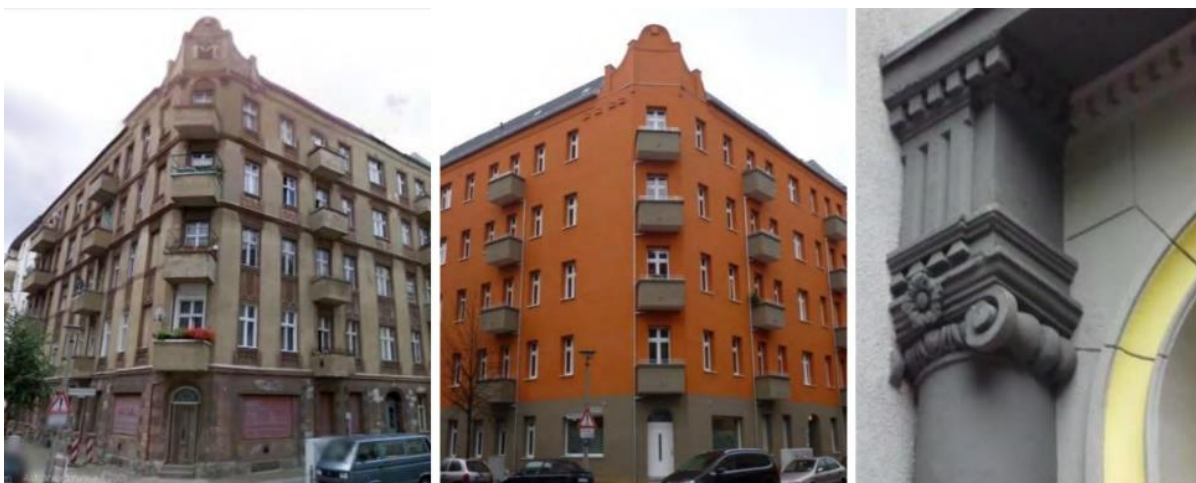
**Figure 59: Historical building heat insulated in Berlin. Left: the original façade; Middle: insulated façade; Right: the insulation damaging the historical decoration (Budapest University of Technology and Economics, Faculty of Architecture, 2016)**

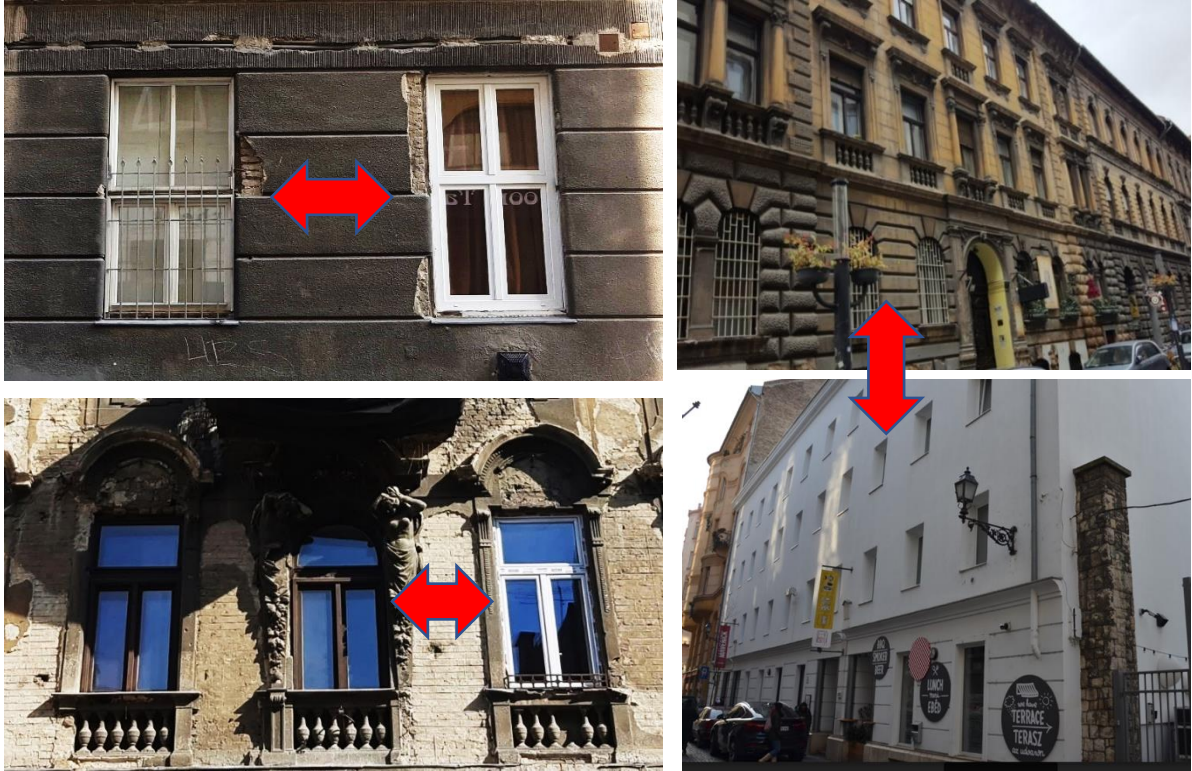
Figure 62: Individual, unprofessional window exchange or insulation causes uneven fa ades and loss of character. Pictures are Courtesy of Attila ZSOLDOS BSc Architect

Although there is a wide range of protection forms for built heritage in Hungary, their enforcement is mostly weak. As a very common example, the individually changed windows (Figure 62), or the destroyed ornamentation if an air conditioning device is installed are usually not reported and penalized, as these interventions are not bound by official permission. It is also a problem that though the characteristic elements of façade are deemed protected in many documents, these elements are not defined squarely (Budapest University of Technology and Economics, Faculty of Architecture, 2016).

The rehabilitation measures should consider the character of a building, to avoid the loss of values. To avoid the mistakes shown in Figure 62, the limits of the retrofit should be included. These contain the problems of the dense urban fabric, and also the monument protection guidelines, which should be applied to maintain the architectural values and character.

solutions, which changes the ratios of the window (Figure 62). There are, however, other heritage respecting solutions for modernising the original window structure fully or partially, cost effectively (stated also by Litti, et al. (2018) and Szalay, et al. (2016) dealing with historical fenestration). Some examples: fitting, Low-E glazing, replacement of inner wings with insulated wings etc. See more details in APPENDIX F.

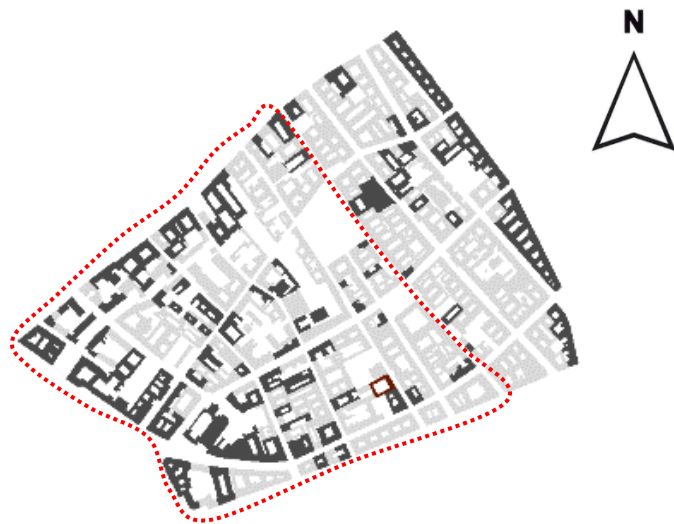
Figure 63: The National or local level protected buildings are marked in a darker shade. The red dotted line marks the border of the UNESCO protected World Heritage Buffer Zone (source: Authors' own figure)

The area is also internationally recognized value, as it is part of the UNESCO World Heritage Zone of Budapest, being a Buffer Zone of the Andr ssy Boulevard (Figure 63). Although several buildings in the area are not under monument protection, the author is considering the full building stock as protected in the following, to maintain the historical character of the district.

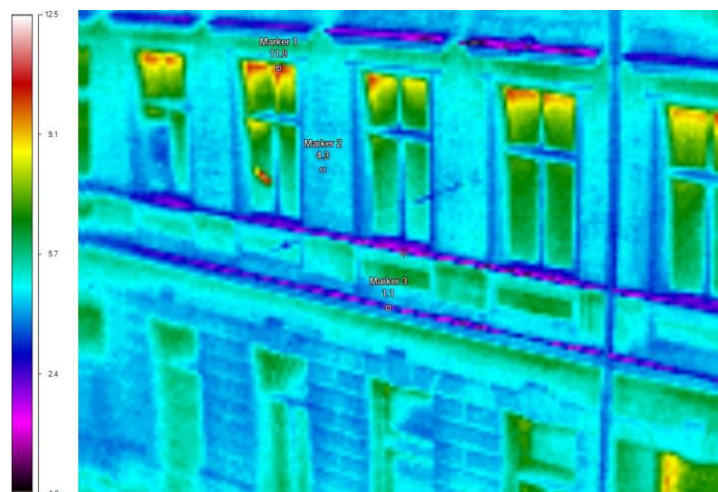
Figure 64: Thermal camera picture of a traditional apartment house (source: Authors' own figure)

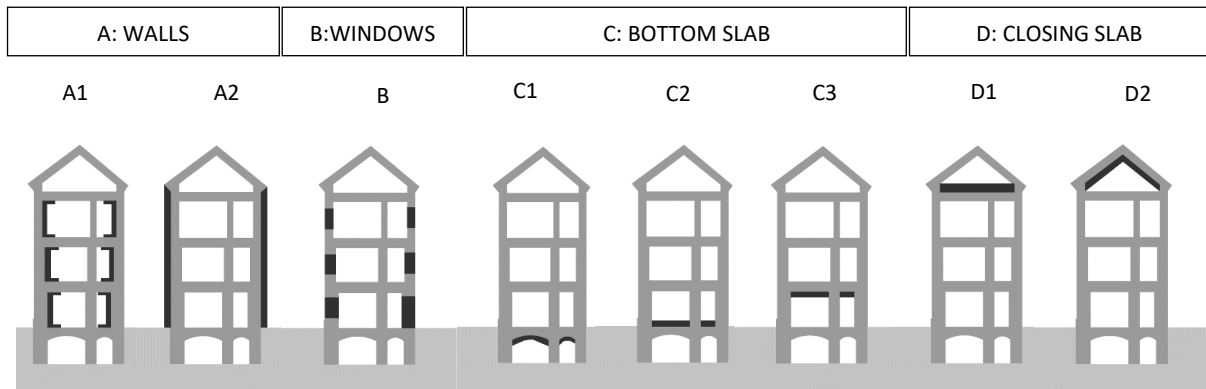
**Figure 65: Main heat insulation possibilities on enveloping structures in the case of heritage respecting modernization** A: Wall insulation: A1: Outside insulation of the façade, A2: Inside insulation of the façade; B: Window renovation; C: Bottom slab insulation: C1: Underside insulation of cellar vault, C2: Floor insulation, C3: Underside insulation in case of arcade; D: Roof insulation: D1: Closing slab insulation, D2: Pitched roof insulation (source: Authors' own figure)

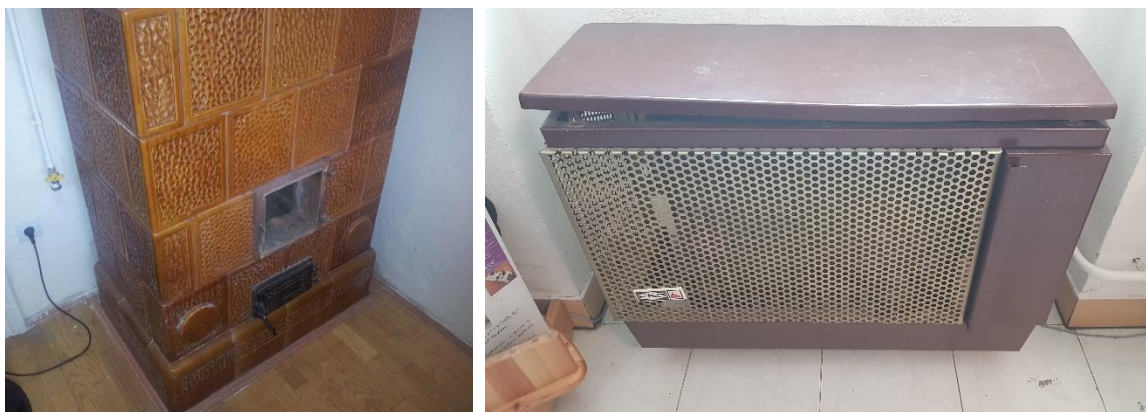
Figure 66: Presently, most flats are heated room-by-room with tile stove (left) or convector (right) (source: Authors' own figure)

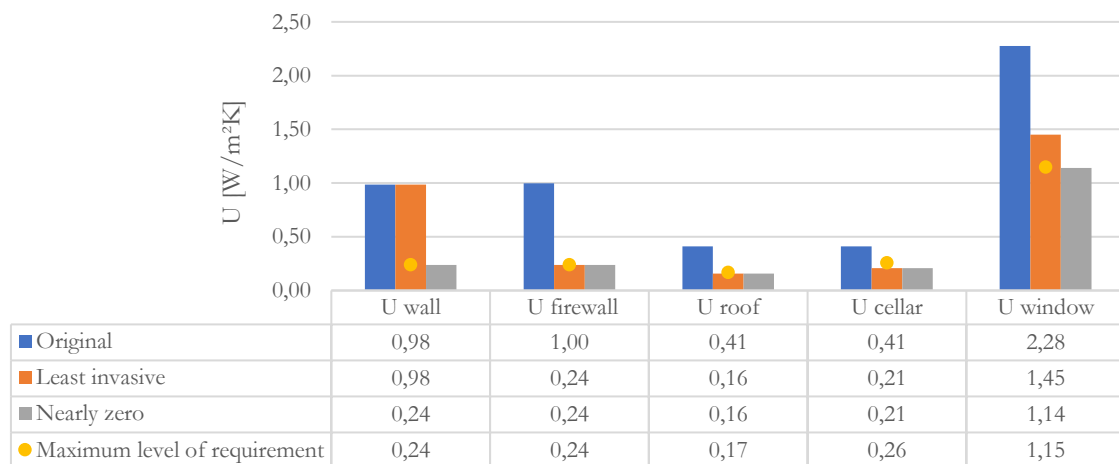
Figure 68:  $U$  values for each scenario in structural Package 1. (source: Authors' own figure)

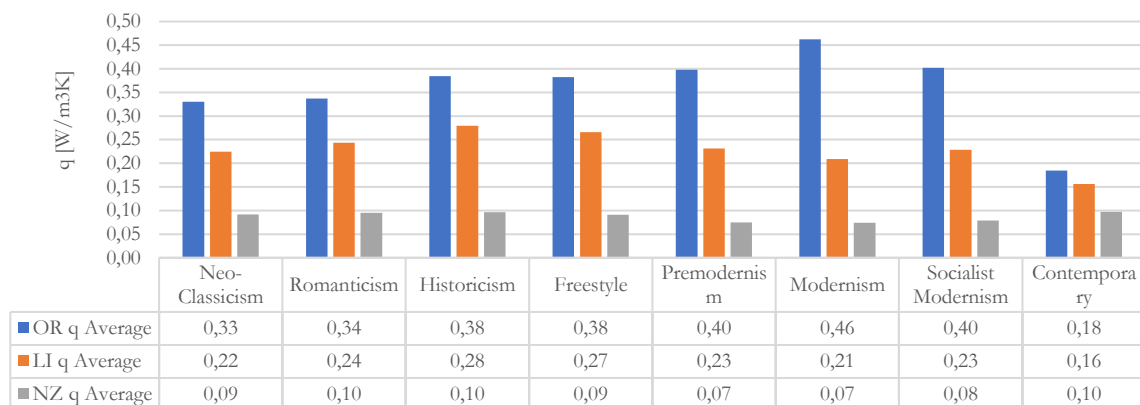
Figure 69: Heat loss coefficient values in each scenario for each architectural style. (source: Authors' own figure)

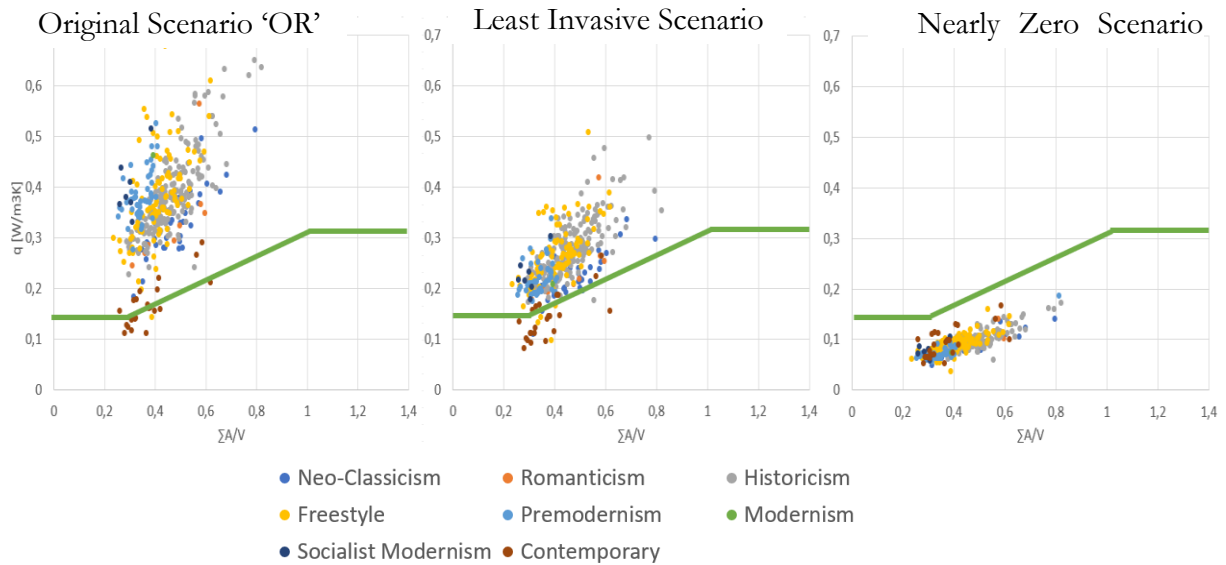
**Figure 70: Heat loss coefficient values in each scenario for each architectural style. The compliance of the limiting value of nearly zero-energy requirement level is shown by a green line. The heat loss coefficient is surveyed together with the respective buildings'  $\Sigma A/V$  (enveloping surface to heated volume) ratio. The building complies to the requirements if the dot is under the limiting line. (source: Authors' own figure)**

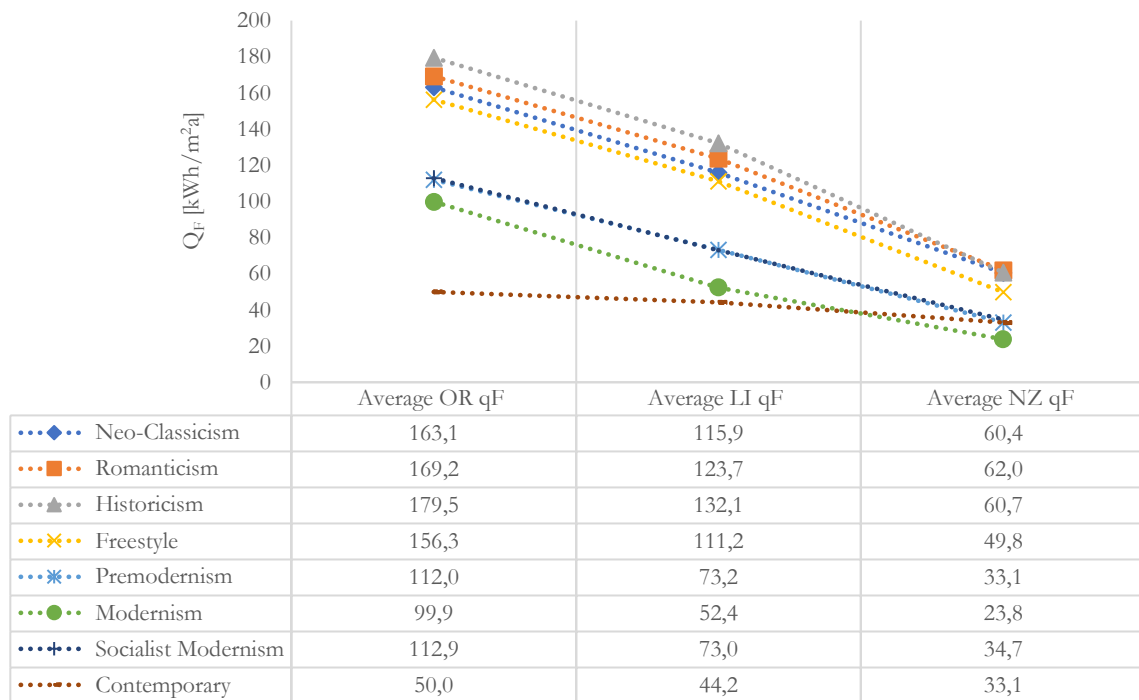
Figure 71: The change in the specific net heated energy demand  $q_F$  [kWh/m<sup>2</sup>a] per styles (source: Authors' own figure)

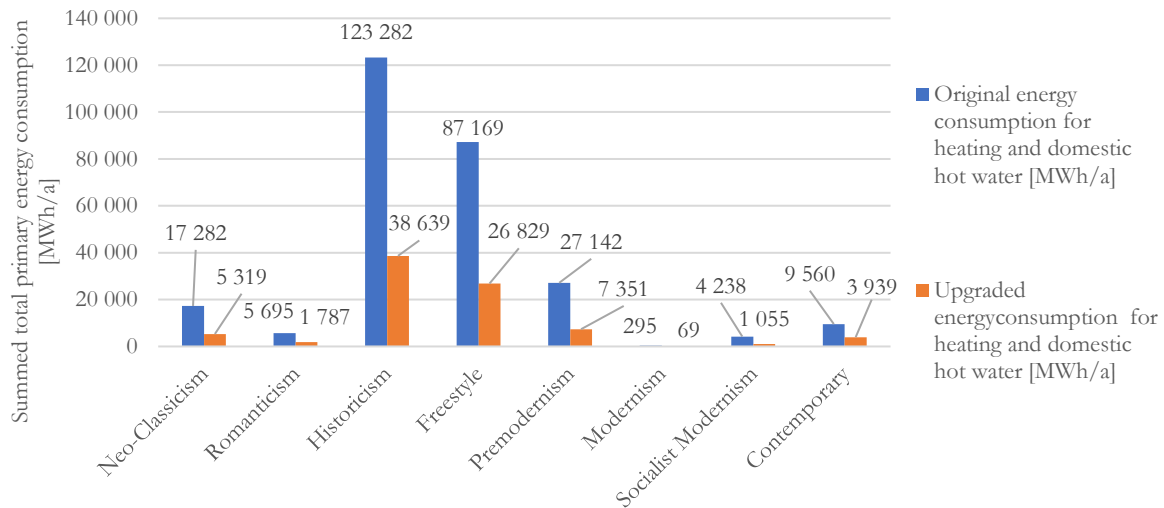
**Figure 73: The summed total primary energy consumption before and after renovation (source: Authors' own figure)**

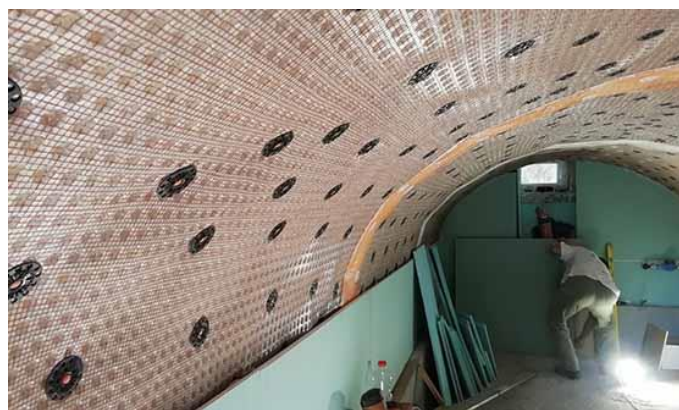
**Figure 80: Indoor insulation and renovation of a cellar with vault (StelBuild, 2019)**

As the average cellar is vaulted, bendable insulation can be installed (Figure 80). In this case also, mineral wool is applicable. There are preformed bended products foam made of polyurethane and polystyrene, but here also, the high concentration of vapour in the air and in the structures can cause problems if we use materials with closed system. For the current calculations, the Rockwool Fixrock product data were used.
