Mechano-Chemical Polishing of Alloy 600 for Accelerated Crack Initiation in Simulated PWR Primary Water Environment and Three-Dimensional Crystallographic Characterization

Ki-Taek Jung, Hiroaki Tsuchiya and Shinji Fujimoto

Division of Materials and Manufacturing Science, Graduate School of Engineering, Osaka University, Suita 565-0871, Japan

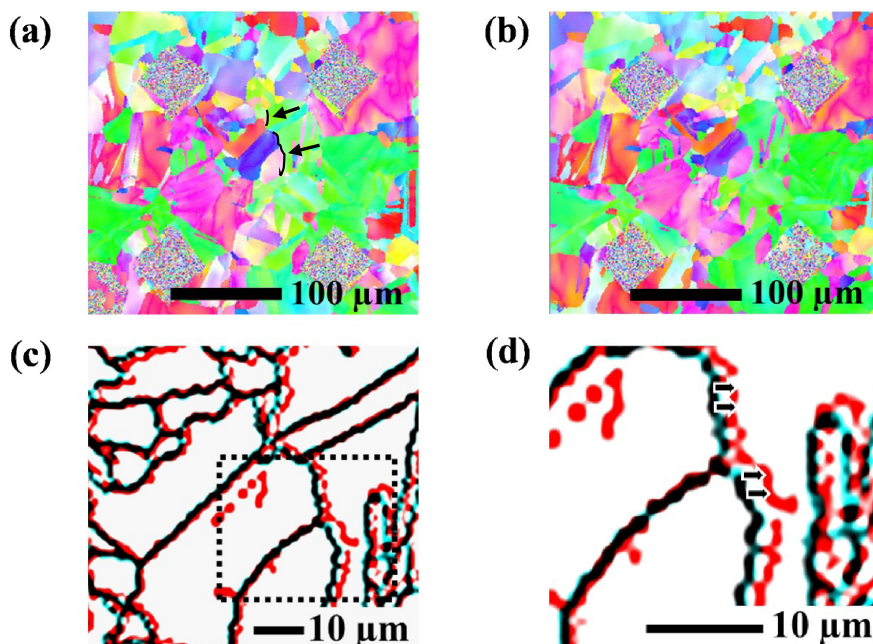
Fig. 7 IPF and grain-boundary maps obtained at the same location on the specimen before and after gentle polishing. The arrows in (a) indicate locations where crack initiated.

IPFs obtained at the same location on the specimen surface before and after gentle polishing are presented in Fig. 7. The grain boundary positions before and after gentle polishing were extracted from the IPFs and are shown to overlap in Fig. 7(c). Figure 7(d) presents a magnified image of the site indicated by the square in Fig. 7(c). The black and red lines in the images indicate the grain boundaries before and after gentle polishing, respectively. As can be seen, some red lines coincide with the black lines, whereas the other red lines deviate from the corresponding black lines. The distance between the lines reflects the displacement of the grain boundary. Using the displacement at each boundary and the removed thickness, we calculated the grain-boundary-plane angle, which is summarized in Fig. 8. Figure 8 presents correlation between the grain-boundary-plane angle and the misorientation angle described above. As presented, more cracks were recognized at the random boundary than at the CSL boundary. Lehockey *et al.* reported a similar result in which a crack appeared exclusively confined to the random boundary rather than at the CSL boundary.³¹⁾ Around the misorientation angle of 40° for the random boundary, cracks initiated within a wide range of grain-boundary-plane angle. For other misorientation angle ranges, cracks initiated at the grain-boundary-plane angles of approximately 40°. A similar trend was observed for the CSL boundary as shown in Fig. 8(b), that is, cracks initiated at the grain-boundary-plane angle of approximately 40°, independent of the CSL boundary. Alexandreanu *et al.* examined the stress corrosion cracking of Alloy 600 in a simulated PWR environment and the deformation behavior of the alloy in Ar environment at 633 K. They compared the distribution of calculated shear stress on grain boundary plane with the distributions of fraction of deformed as well as cracked high-angle boundary
