# Detection of a defect on the back of a pipe by non-contact remote measurements

**Takahiro Hayashi**

## ABSTRACT

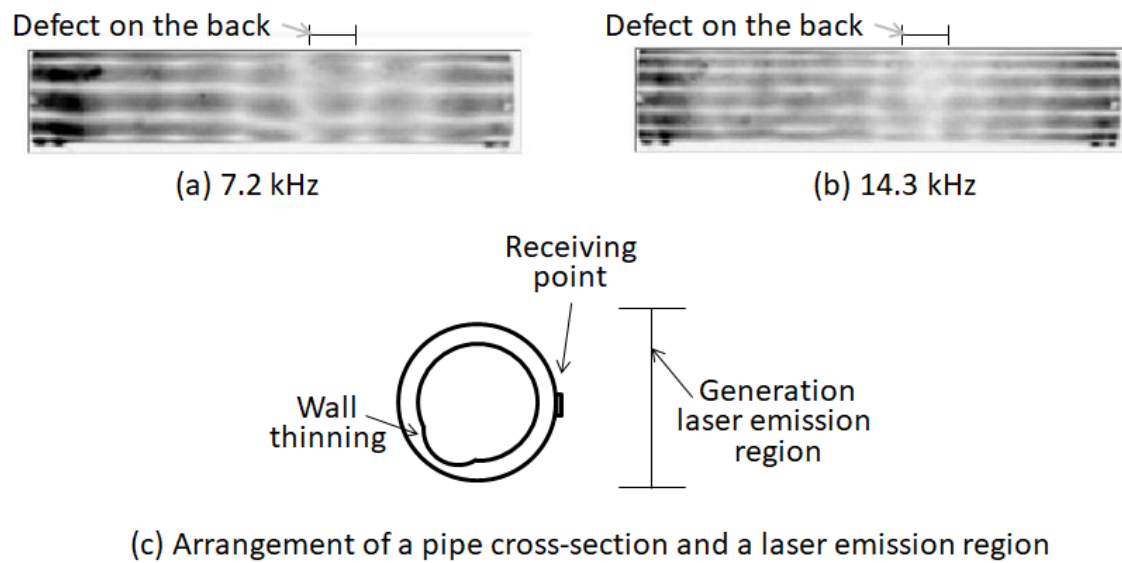
Fig. 12. Sum of distributions of frequency spectrum peak for left and right receiving positions when wall thinning is located at  $\theta=235^\circ$ .

Figures 12 (a) and (b) are the averaged distributions at 7.2 kHz and 14.3 kHz, respectively, when the defect is located at  $\theta = 235^\circ$ . These figures were obtained using the same procedures used to obtain Fig. 10 (c) and Fig. 11 (c); only the circumferential locations of the wall thinning were different. These figures show similar tendencies as Fig. 10 (c) and Fig. 11 (c); the vertical patterns are symmetrically distributed from the defect area at 7.2 kHz, and a small intensity region appears at the defect area at 14.3 kHz.
