Development of a High-Sensitivity Millimeter-Wave Radar Imaging System for Non-Destructive Testing

Hironaru Murakami ^{1,*}

, Taiga Fukuda ¹, Hiroshi Otera ¹, Hiroyuki Kamo ² and Akito Miyoshi ²¹ Institute of Laser Engineering, Osaka University, 2-6 Yamadaoka, Suita 565-0871, Osaka, Japan² TAIYO YUDEN CO., LTD., 8-1 Sakaemachi, Takasaki 370-8522, Gunma, Japan

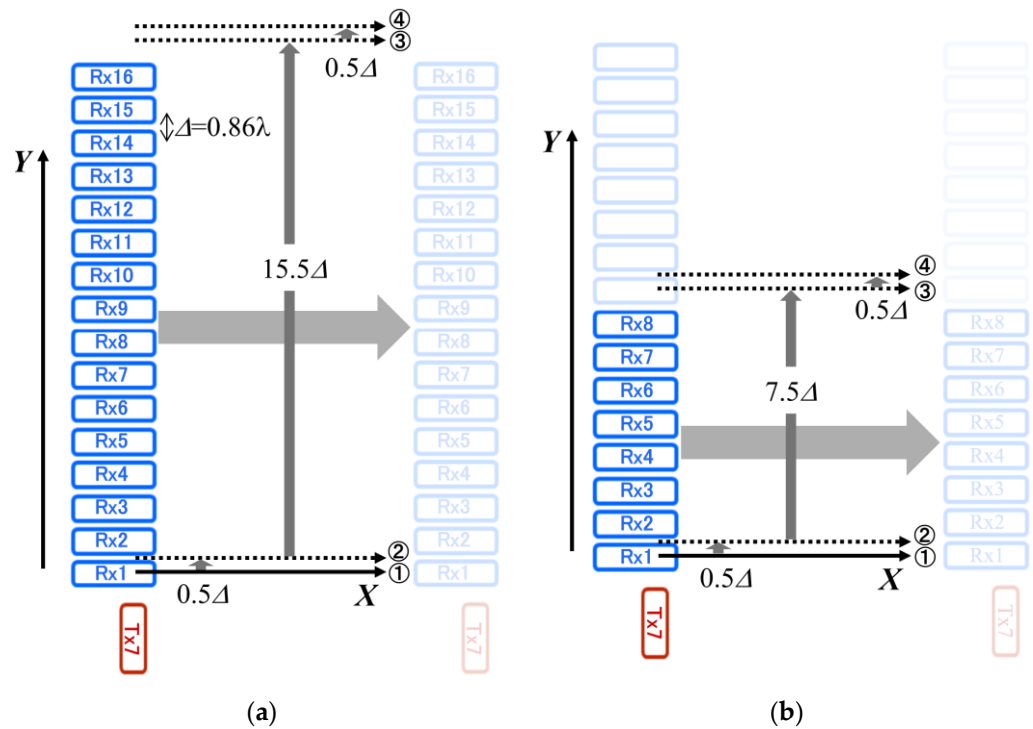
Figure 2. X-Y scanning method for antenna elements of the array. (a) Diagram of X-Y scanning using all Rx antennas from Rx1 to Rx16. (b) Diagram of X-Y scanning using eight Rx antennas from Rx1 to Rx8. Here, $\Delta = 0.86\lambda$ is the distance between adjacent receive antennas.

Since there is very little interference between the sixteen Rx antennas, even though the Rx spacing is very small, 16 rows of data in the Y-axis direction can be acquired in a single scan along the X-axis. However, for high-resolution imaging in the Y-axis direction, the X-axis scanner was shifted by 0.5Δ ($\Delta = 0.86 \lambda$: 3.25 mm) in the Y-axis direction and scanned again along the X-axis before the X-axis scanner was shifted by 15.5Δ in the Y-axis direction (see Figure 2a).

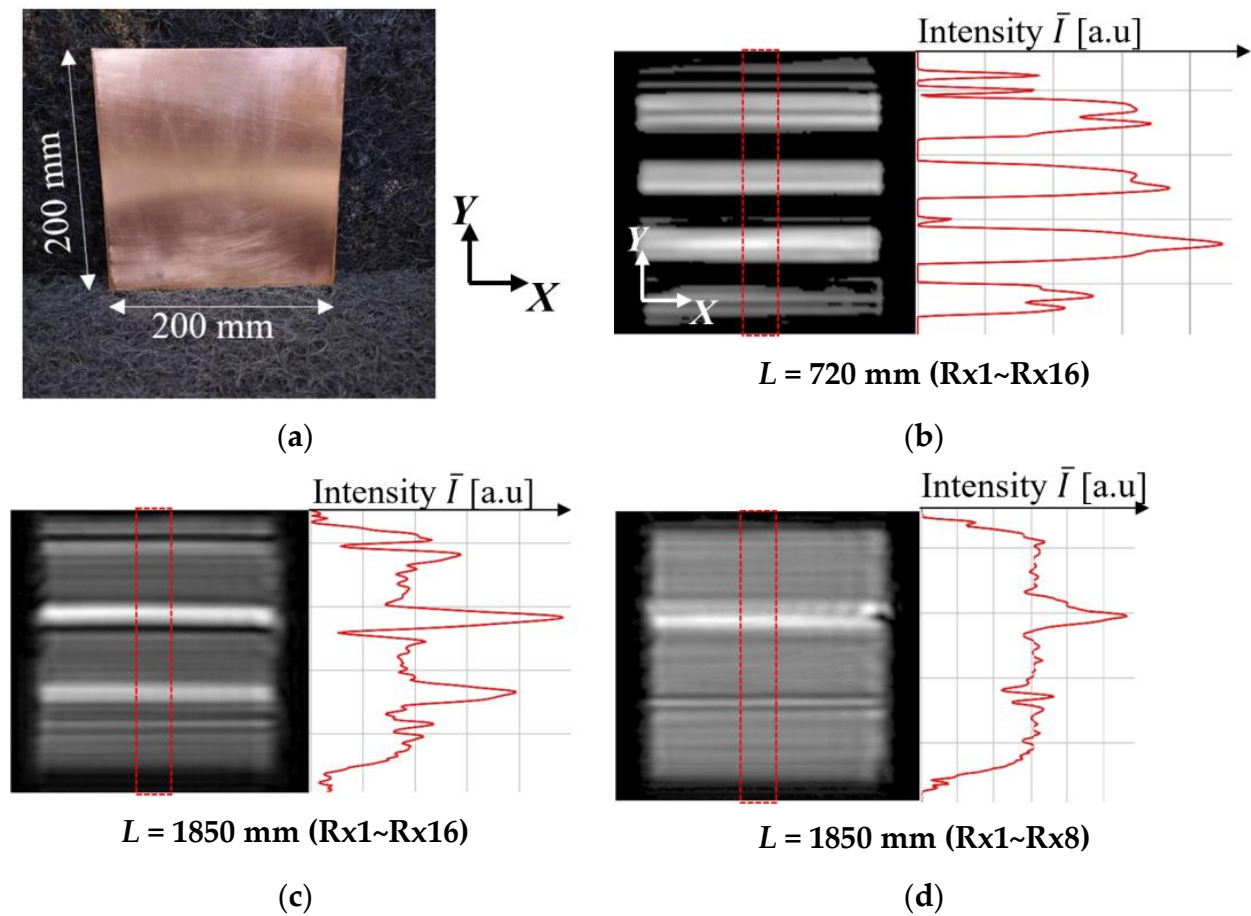
Figure 3. Influences of the distance L to the target and the number of receive antennas (Rx) used in the MM-wave image observations. (a) The 200 mm \times 200 mm flat copper plate for the measurements. (b) Condition of $L = 720$ mm with all receive antennas from Rx1 to Rx16. The left and the right figures show the observed MM-wave image and the distribution along the Y-axis of the averaged signal intensity \bar{I} within the red dotted rectangle inserted in the MM-wave image, respectively. (c) Result in the condition of $L = 1850$ mm with all receive antennas from Rx1 to Rx16. (d) Result in the condition of $L = 1850$ mm with 8 receive antennas from Rx1 to Rx8.

To investigate this point, we compared the MM-wave images of a copper plate placed at different distances. The results are shown in Figure 3. Figure 3a shows a $200\text{ mm} \times 200\text{ mm}$ copper plate used for this MM-wave imaging. This copper plate was placed in front of the constructed SIMO-SAR imaging system at different distances of $L = 720\text{ mm}$ and $L = 1850\text{ mm}$ in the measurements. The left sides of Figure 3b,c shows the MM-wave images observed when the copper plate was placed at $L = 720\text{ mm}$ and $L = 1850\text{ mm}$, respectively. The right sides of Figure 3a,b shows the Y-axis profile of the averaged intensity \bar{I} values within the red dotted rectangles inserted in the MM-wave images. The intensity (I) corresponds to the MM-wave power received by the receive antenna. All receive antennas of Rx1~Rx16 were used in the measurements. Here, the difference in the MM-wave images between Figure 3b,c clearly shows that the difference in the distance L from the transmit antenna Tx7 causes a significant difference in the signal intensities received by the Rx1~Rx16 antennas when observed at a short distance of $L = 720\text{ mm}$. In particular, the profile in Figure 3b shows apparent areas where the reflection signal from the target can hardly be received.

Another interesting result is that although the observation with system-A was made by placing the concrete blocks at a very close distance of $L_A = 780$ mm from the radar module, no significant difference in signal intensities appeared, as shown in the MM-wave images of a copper plate. Although a periodic dark and light wide stripe structure is observed approximately equal to the total length of the array of eight receiving antennas ($8\Delta = 26$ mm), the signal is not extremely weak, as shown in Figure 3b,c. This is because

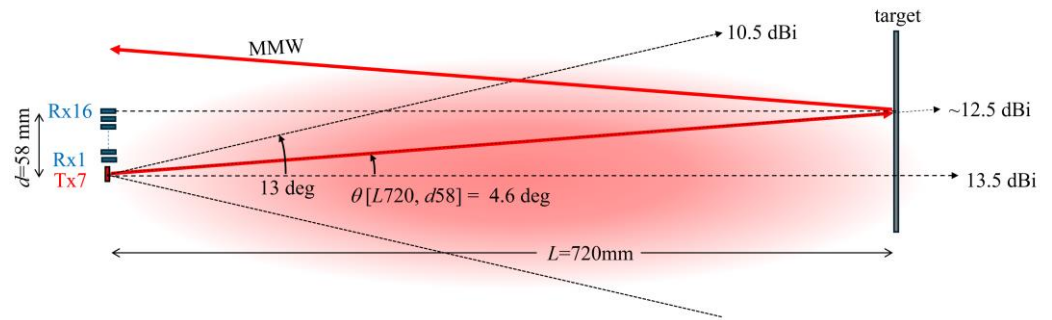
Figure 4. Estimation of MM-wave irradiation power on a target at a distance of $L = 720$ mm from the Tx antenna to the target. 4.1. Optimization of MM-wave imaging measurements.

The result obtained at $L = 720$ mm can be well explained by considering the situation as shown in Figure 4. When the distance $L = 720$ mm, the elevation angle $\theta[L720, d57]$ from Tx7 of the point on the target located in front of Rx16 (distance d between Tx7 and Rx16: 58 mm), which is the farthest from Tx7, is 4.6 degrees. Considering the beamwidth given in Table 1, the MM-wave power at the point on the target in front of Rx16 would be about 1 dB less than the absolute gain of 13.5 dB. In addition, MM waves are reflected from flat metal surfaces of copper plate with a reflection angle nearly equal to the angle of incidence. Therefore, it is expected that MM waves will hardly be received by the Rx16 antenna. Increasing the distance L improves this situation somewhat, but there should be still a significant difference in the received signal intensity between Rx1 and Rx16, as shown in Figure 3c. Based on these results, we decided to use only Rx1 to Rx8 antennas as the receive antennas in the present study, according to the diagram of the X-Y scanning diagram, as shown in Figure 2b. Figure 3d shows the result of the measurement with the number of antennas reduced while the distance L remains at 1820 mm. It can be seen that the change in the signal intensity is considerably improved. In addition, in the present study, the measurements were performed with distant targets as far as possible.

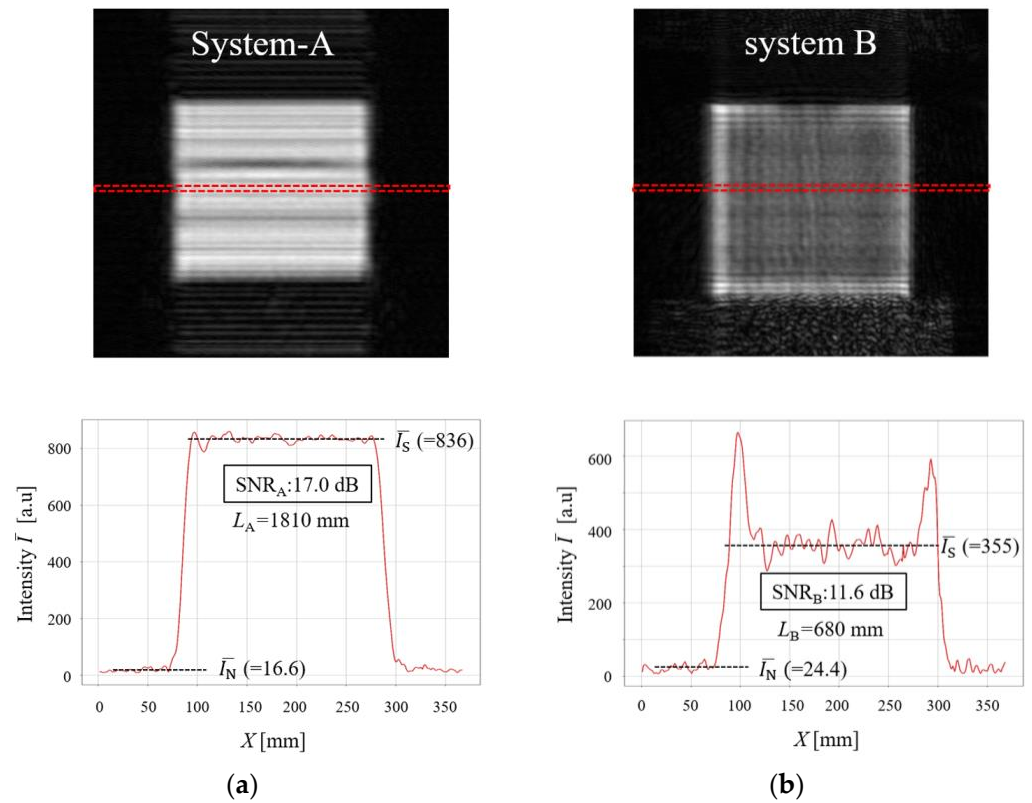
Figure 5. Comparison of SNR in the MM-wave images observed by (a) present SIMO-SAR imaging system (system-A) at $L_A = 1810$ mm and (b) previously constructed MIMO-SAR system using an IWR1443BOOST EVM (system-B) at $L_B = 680$ mm. The top figures show the MM-wave images, while the bottom figures show the profiles of the averaged signal intensity \bar{I} along the X -axis direction in the area indicated by the red dashed rectangle inserted in the MM-wave image.

Assume that the results of Figure 5 were obtained under the same condition of radar scattering cross section σ and the wavelength λ and that the difference in SNR values is considered to be given by the ratio of the maximum received power of each radar module of system-A and system-B. Therefore, the difference in the SNR value of 5.4 dB would be expressed by using the receive powers of P_{RA} and P_{RB} and the emission peak powers of P_{TA} and P_{TB} for system-A and system-B, respectively, as follows:

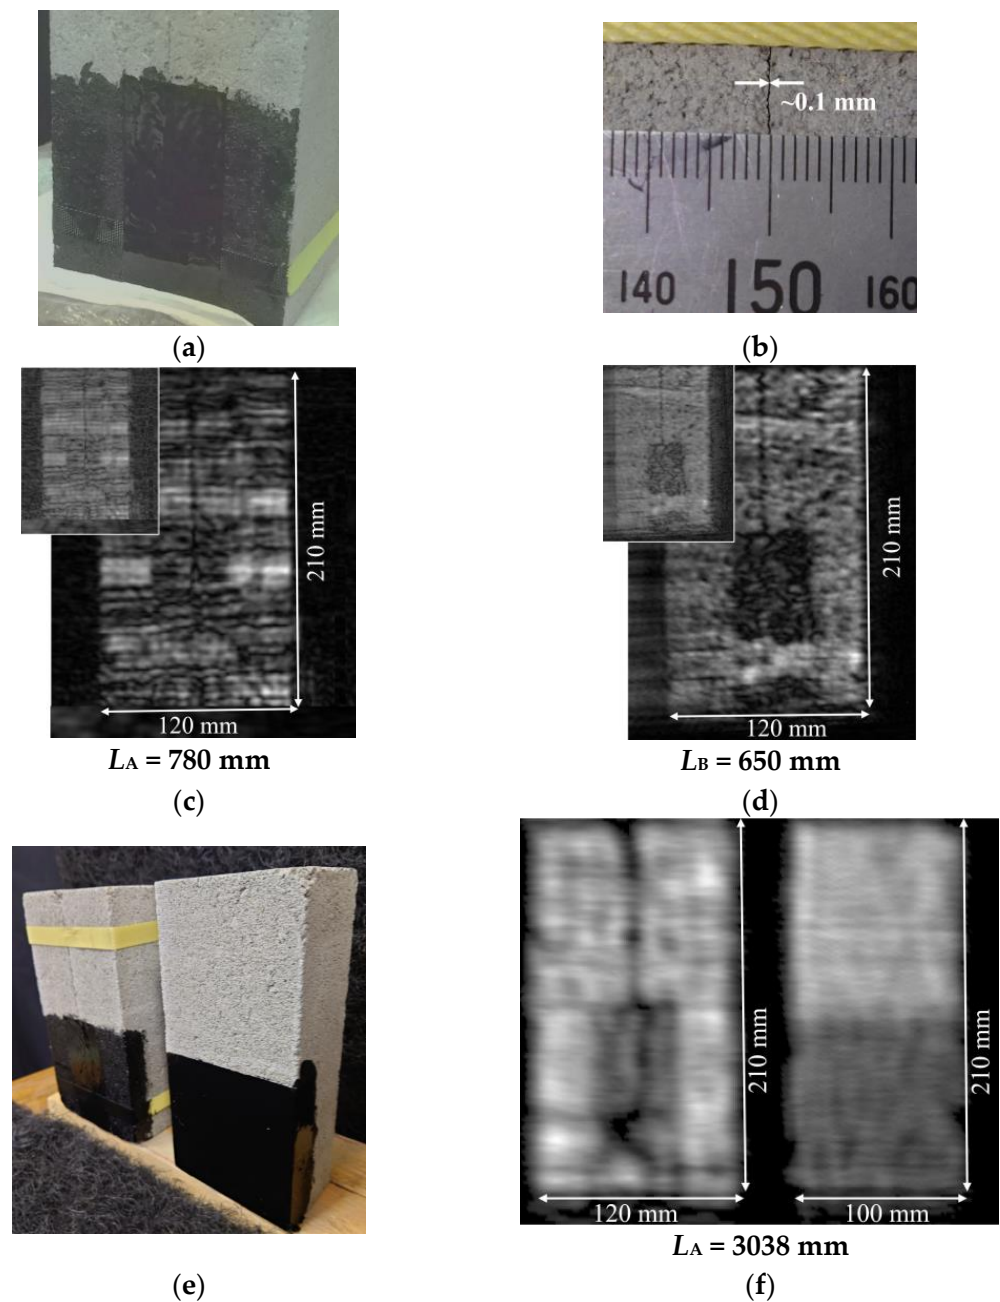
Figure 6. Comparison of MM-wave images of concrete blocks with GFR tape and black acrylic paint over the cracks. (a) Strongly bonded concrete blocks for observation. The contrast of the raw image is adjusted to show the position of the GFR tape under black acrylic paint. (b) Magnified view of the cracked area. It can be seen that the crack is about 0.1 mm wide. (c) MM-wave image observed at the target distance of $L_A = 780 \text{ mm}$ using system-A. (d) MM-wave image observed at the target distance of $L_B = 650 \text{ mm}$ using system-B. (e) Concrete blocks with (left) and without (right) cracks, thickly coated with acrylic paint over GFR tape. These were placed at a distance of $L_A = 3038 \text{ mm}$ from the radar module. (f) MM-wave images of concrete blocks with (left) or without (right) cracks.

The detection of cracks caused on the surface of concrete infrastructure facilities is one of the most important issues in NDT, and as shown in Figure 6c,d, we can observe the cracks on the exposed surface areas of concrete blocks. On the surface of the concrete blocks, which does not have a smooth surface like a copper plate, the incident MM waves are scattered uniformly in all directions and reflected with some intensity (backscattering) in the direction of incidence. As a result, unlike objects with smooth surfaces, an overall dark image is observed. However, in the areas with cracks, since the incident MM waves are scattered more strongly and irregularly, the intensity of refracted MM waves returning in the directions of the receive antennas would be much smaller, which would be reflected as darker lines in the MM-wave image.

On the other hand, in the area with GFR tape and black acrylic paint on the surface, we could see cracks hidden under these coverings only with the present system-A with high sensitivity. Incidentally, the contrast in the raw photographic data was adjusted so that the viewer could see where the GFR tape was applied in Figure 6a. From these two MM-wave images, there is almost no change in the received signal intensity for the black acrylic paint, but the signal intensities are weaker in the areas of the GFR tape, confirming that absorption by the GFR tape has occurred. To be sure, contrast-adjusted photographs are shown in the upper left corner of Figure 6c,d. Here, the contrast has been adjusted to show the crack structure most clearly. As can be seen from this photograph in Figure 6c, the MM wave image observed using system-B did not show the crack structure hidden under the GFR tape, no matter what adjustments were made.

The validity of such an idea is evident from the crack images in the MM-wave images in Figure 6c,f. Comparing the crack images in Figure 6c,f, it is obvious that the image in Figure 6c shows a finer crack structure. However, in terms of signal intensity and contrast of these images, the signal intensity is higher, and the presence of cracks can be observed more clearly in Figure 6f, even though the measurement distance is about four times longer. At a distance of $L = 3038$ mm, the elevation angle from the transmit antenna Tx7 to the point in front of the receive antenna Rx8 on the concrete surface is only 0.6 degrees. Thus, it can be seen that both transmission and reception are carried out using a signal of almost maximum gain. This indicates that the newly developed radar module with high directivity and high gain is very useful for non-destructive, non-contact, and safer remote inspection of concrete structures at risk of collapse due to aging or natural disasters. Furthermore, it can be seen that in this type of non-destructive testing using MM waves, it is necessary to develop a compact system with signal strength rather than resolution, i.e., high SNR.

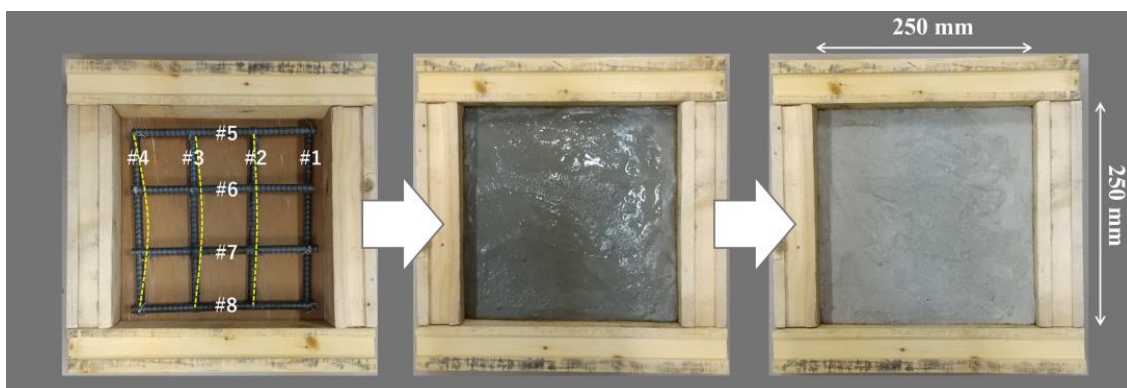
Figure 7. Reinforced concrete slab to investigate MM-wave transmission characteristics into concrete.

To evaluate the performance of MM-wave transmission to concrete, a reinforced concrete (RC) slab with a steel frame of D13 ($\phi 12.7$ mm) was prepared, as shown in Figure 7. It is difficult to see here, but steel frames #1 and #5~#8 are straight, and the other steel frames #2~#4 are bent near the center. The amount of bending increases from #2 to #4. The assembled steel frames were placed in wooden frames and poured with concrete, and this RC slab was removed and measured after the concrete had sufficiently dried and hardened.

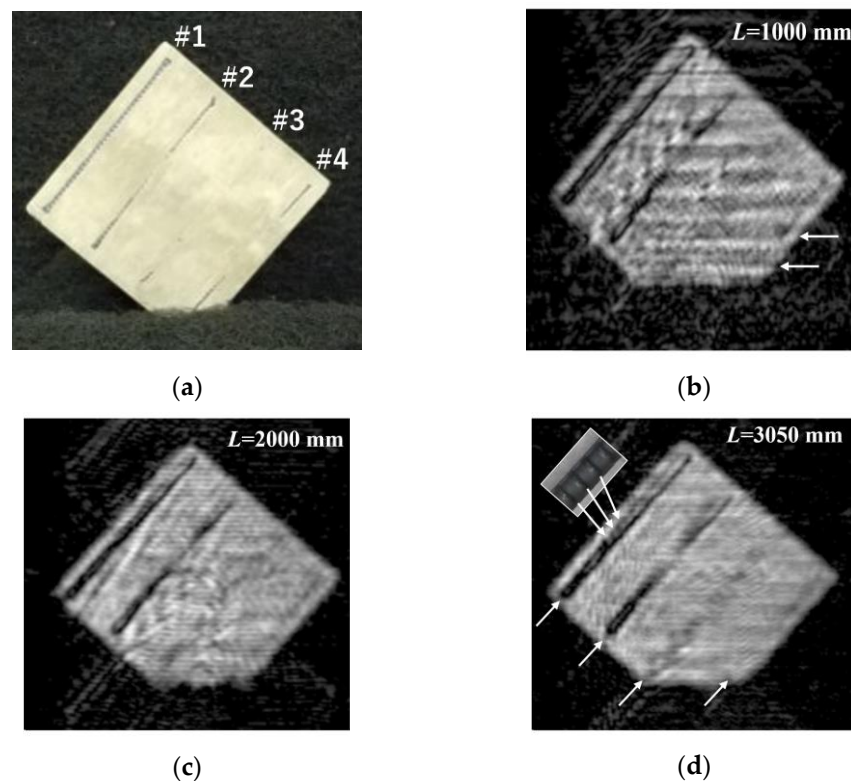
Figure 8. (a) Photograph of the prepared 33.4 mm thick concrete slab for MM-wave imaging. This surface was used for the measurement. (b) MM-wave image observed with the slab placed at a relatively short distance of $L = 1000$ mm. Below are MM-wave images observed at (c) $L = 2000$ mm and (d) $L = 3050$ mm.

Figure 8 shows the photograph of the RC slab and its MM-wave images. Figure 8a shows the surface of the measured RC slab. The measurements were made on the surface corresponding to the bottom of the RC slab in Figure 7. It can be seen that the entire steel frame of #1 is visible, while the central regions of steel frames #2~#4 are partially buried under the concrete. Figure 8b–d shows the MM-wave images observed at a distance of $L = 1000$ mm, $L = 2000$ mm, and $L = 3050$ mm, respectively. The horizontal stripe structure of light and dark observed at $L = 1000$ mm disappears as the distance L increases from $L = 1000$ mm to $L = 3050$ mm. In addition, the steel frame of #3, which is moderately bent among the steel frames of #2~#4, becomes more visible in the MM-wave images with increasing distance. However, only the two ends are weakly imaged for the steel frame of #4, which has the largest bending even at the distance of $L = 3050$ mm. This is because the incident waves are attenuated inside the concrete, and the reflected wave from the inclined targets hardly returns to the receive antenna. In addition, we could not observe anything at all about steel frames #5~#8, which are mounted under steel frames #1~#4 and buried at least 13 mm under the concrete surface. This is discussed in the next section by estimating the attenuation distance Λ of MM waves in concrete.

On the other hand, we can see more detailed structures of the steel frame of #1 in the MM-wave image, as shown in the inset photo of Figure 8d. The MM-wave image in Figure 8d shows the most sensitive and clear image, reflecting the steel frames inside the concrete. Calculating the elevation angle $\theta[L3050, d32]$ from Tx7 to the target in front of Rx8, it is about 0.6 degrees. This result indicates that the measurement was made using the central regions with the highest beam power. In general, non-destructive and non-contact inspection is highly desirable in any kind of inspection of infrastructure facilities and

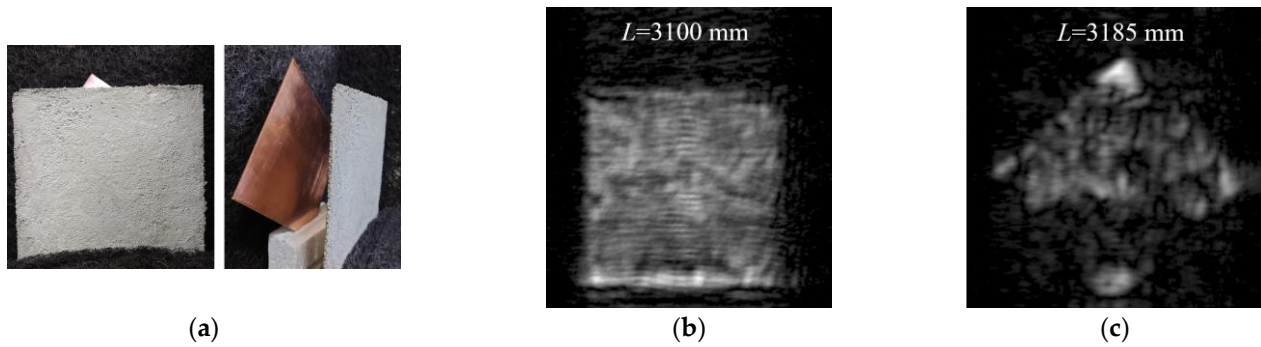
Figure 9. (a) Photographs of the thin concrete slab of 3.7 mm thickness placed at $L = 3100$ mm and the copper plate placed at $L = 3185$ mm behind it. (b) MM-wave image at position $L = 3100$ mm on the concrete surface and (c) MM-wave image at position $L = 3185$ mm on the copper plate surface.

with a thickness of 3.7 mm was prepared and placed at $L = 3100$ mm in front of the radar module, and a copper plate was placed at $L = 3185$ mm behind it, and the transmission performance of MM waves through concrete was investigated by observing the reflection image of the copper plate. Figure 9b shows the MM-wave image of the concrete surface at $L = 3100$ mm, and Figure 9c shows the MM-wave image at $L = 3185$ mm corresponding to the surface of the copper plate behind the concrete slab. As can be seen from Figure 9a, the uppermost part of the copper plate protrudes from the concrete slab and is exposed, so Figure 9c shows that the signal intensity in this exposed area is considerably higher than in other areas. Therefore, the attenuation distance of the concrete was calculated by comparing the received signal intensity from the uppermost part of the copper plate and the hidden part behind the concrete in this experiment.

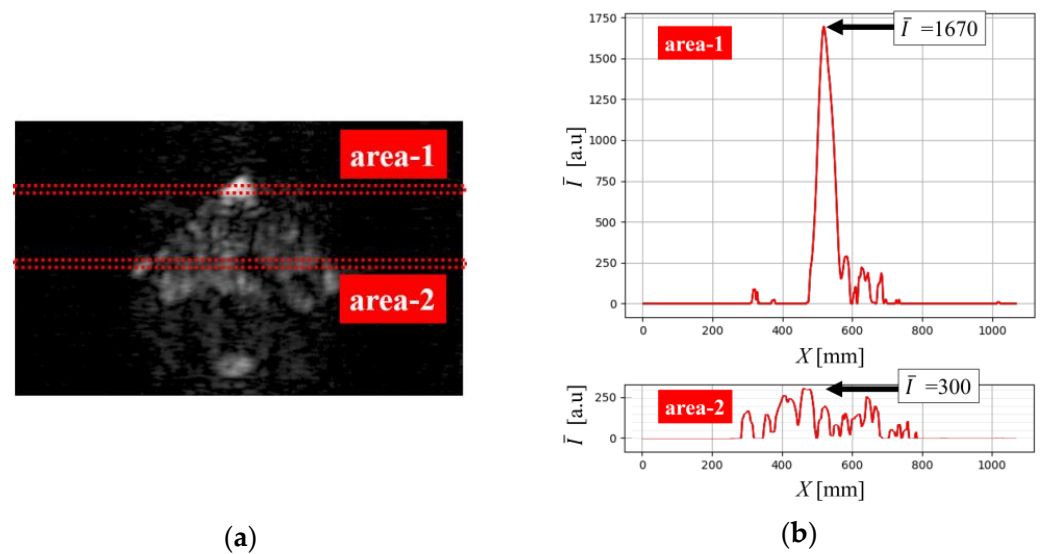
Figure 10. (a) area-1 and area-2 for comparing averaged signal intensity \bar{I} in the MM-wave image. (b) Distribution of the averaged intensity \bar{I} along the X-axis in area-1 and area-2.

To compare the signal intensities from both parts, the averaged signal intensities along the X-axis direction in area-1 and area-2 in Figure 10a were used. The distribution of the averaged intensity \bar{I} in area-1 and area-2 are shown in Figure 10b. The maximum averaged signal intensity in the area-1 (\bar{I}_{Cu}) was about 1670. On the other hand, that in area-2 (\bar{I}_{exp}) is about 300. We will use these values to determine the experimental attenuation distance Λ_{exp} in the prepared concrete slab. In determining the attenuation distance Λ_{exp} , let the reflectance R of MM waves on the concrete surface be 0.22 and the reflectance of MM waves on the copper plate surface be R_{Cu} . When the signal intensity transmitted from the Tx7 is I_0 , the received signal intensity \bar{I}_{Cu} reflected directly from the copper plate can be expressed as follows:

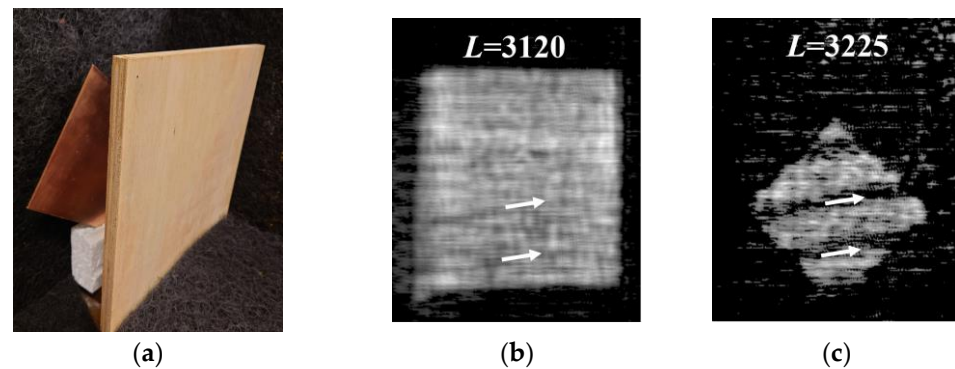
Figure 11. (a) A photograph of the composite plywood of 11.85 mm thickness placed at $L = 3110$ mm and the copper plate placed at $L = 3225$ mm behind it. (b) MM-wave image at position $L = 3120$ mm inside the composite plywood and (c) MM-wave image at position $L = 3225$ mm on the copper plate surface.

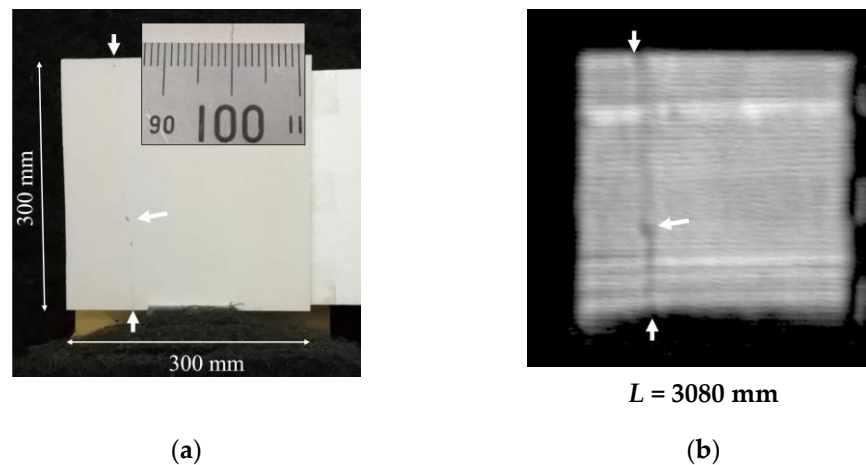
Figure 12. (a) A refractory board attached to a Styrofoam board with double-sided tape. It was pre-split and set at $L = 3080$ mm. The insert shows the cracks of tens of μm in width. The cracks cannot be seen from a distance. (b) MM-wave image of the refractory board at a distance of $L = 3080$ mm from the radar module. It can be seen that the crack streaks are imaged.

This result means that even if a 2D slice image corresponding to a distance of $L = 3080$ mm is cut out from the range FFT analysis results, it will also be affected by objects in the range of 16.5 mm in front and behind it. Therefore, if this refractory board were transparent to MM waves, it would be affected not only by MM-wave scattering due to surface cracks but also by scattering due to internal cracks. This could therefore be observed as a larger signal change. Considering this, the penetration length of the concrete slab obtained this time was only about 6 mm, but it would be possible to detect cracks with higher sensitivity if even such a small penetration could be achieved.

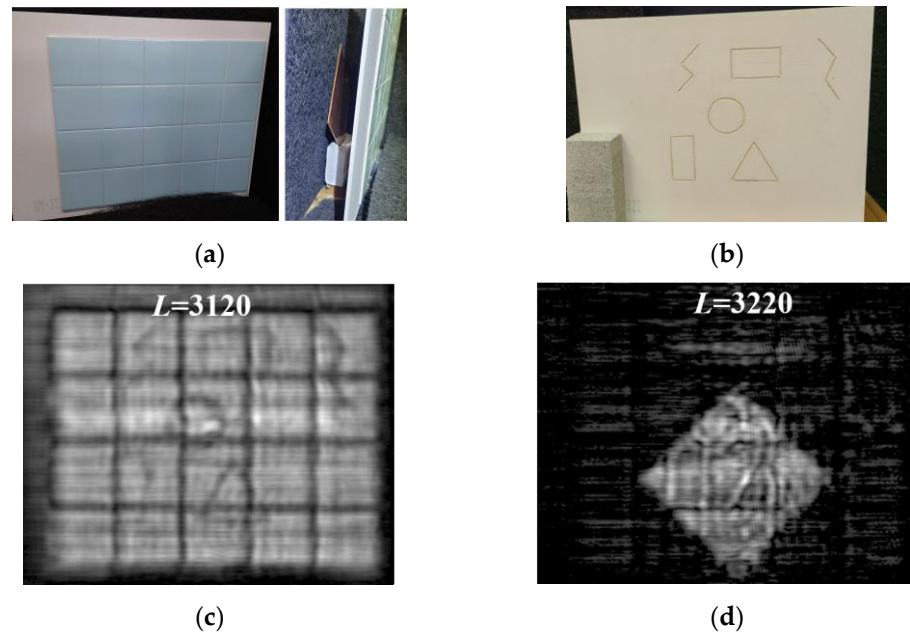
Figure 13. (a) Photograph of ceramic tiles and a refractory board attached with ceramic adhesives placed at $L = 3115$ mm and a copper plate placed at $L = 3220$ mm behind them for MM-wave transmission imaging. (b) Photograph of the pattern engraved on the surface of the refractory board bonded to the ceramic tile. (c) MM-wave image at the interface between ceramic tile and refractory board. The pattern engraved on the surface of the refractory board can be seen. (d) MM-wave image at $L = 3220$ mm on the copper plate surface.

Finally, the MM-wave transmission properties of ceramic materials such as ceramic tiles and a refractory board were investigated. Figure 13a,b show the photographs of 5 mm

thick ceramic tiles bonded to the surface of a 5 mm thick refractory board with ceramic adhesives. The surface of the refractory board was engraved with various patterns for the transmission imaging. Figure 13c shows the MM-wave image at the interface between the ceramic tiles and the refractory board. It can be seen that the patterns on the refractory board are observed by transmission MM-imaging through the ceramic tiles. In addition, Figure 13d shows the MM-wave image of the copper plate placed at $L = 3220$ mm behind the ceramic tiles and refractory board. It can be seen that although the combined thickness of the ceramic tiles and refractory board is 10 mm, the reflective image of the copper plate is well observed, which also reflects the boundary lines between the tile boards and the pattern engraved on the refractory board.
