Fatigne Behavior of Connection Plate between Main Girder and Cross Beam in Composite Plate Girder

Kohsuke HORIKAWA *, Shinji MATSUMOTO ** and Masahiko KITAZAWA ***

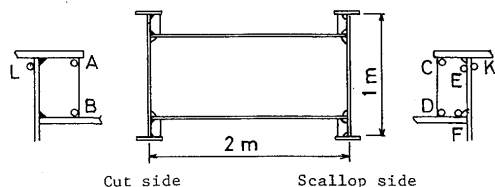
Fig. 2   A-1 test girder.

The results of stress measurement for test (1) and test (3) are shown in Fig. 8 and Fig. 9. For the results of fatigue test, the cracks were found in five points A, C, D, E, F for A-1 test girder. On the other hand no cracks were found even which the initial loads (13.4^{ton}) and increased loads 19^{ton} for B-1 test girder. The stress for the corner of web gap plates were that $\Delta\sigma = 47.$ kg/mm^2 at point A and $\Delta\sigma = 40.9$ kg/mm^2 at point C for A-1 test girder. The results of this test are agree well with the theoretical results for the stress analysis report.[4] The crack were found at the point of high stress zone. On the other hand for test girder B-1 of which the maximum stress (at gauge number 15) were $\Delta\sigma = 11.5$ kg/mm^2, and that was approximately 1/4 of the test girder A-1. Although the loads were increased up to 19 ton, the stress was $\Delta\sigma = 16.4$ kg/mm^2 at the same point. From the result of the calculations of the deflection angle it was imagined that the stress at web gap plate would become more high for type A rather than type B. The results of the calculation of the deflection angle shows that $\theta = 8.48 \times 10^{-3}$ rd for test girder A-1, and $\delta/l = 3.88 \times 10^{-4}$ rd for test girder B-1.

From the above we must consider that the reason of the fatigue crack for web gap plate will be the neck swing effect for top flange of main girder.

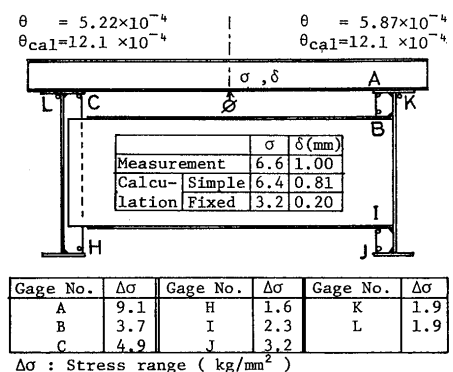
Fig. 10 Results of stress measurement for A-2 test girder (Pmax = 11.0 ton).

X 10⁶, in both of the initial loadings (11 ton) and the increased loads (19 ton) for the test girder A-2.

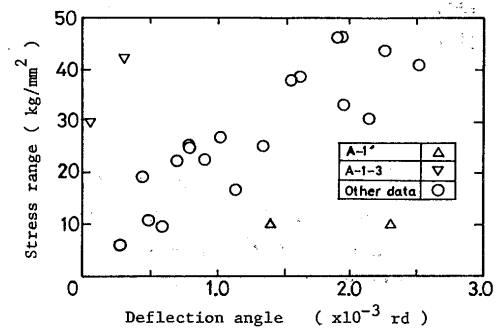
Fig. 13   Relation between deflection angle and stress at the corner.

In the figure all points of the test results are shown. Although some exception exist, the tendency are found by the figure that the deflection angle become bigger the stress at the corner of the web gap plate are increased, except the test results of test girder A-1' and A-1-3. It is considered that the stress are reduced approximately to 1/4 ~ 1/5 because of increment of the thickness for the web gap plate to 28 mm, and also the rigidity of the top flange of main girder were increased against to the Wide Flange Shape due to the reinforcement by two stiffners for test girder A-1-3. It was considered that the cracks were initiated for that the stress at the corner of the web gap plates were increased because of the less rigidity of the deck for test girder A-1, which was designed previous design standard.

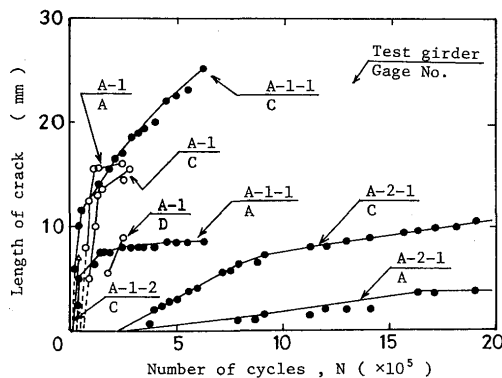
Fig. 15   Relation between length of crack and number of cycles.

The observation was made to the extension of the cracks. The results were shown in **Fig. 15**. For the extension of crack at point A in test girder A-1-1 shown in Fig. 15 the crack growth are found in three categories which are the range of rappid extension, the range of very slow growth and the range of arrest finally. The crack growth rates were calculated according to the above three categories. As the results, the rates for the range of rapid growth were the order of 10^{-4} mm/cycle and the next range were the order of 10^{-5} mm/cycle and range of arrest were the order of 10^{-6} mm/cycle.

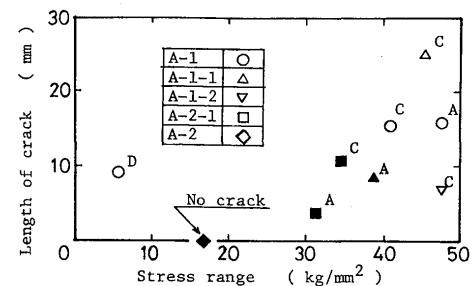
Fig. 16   Relation between length of crack and stress range.

was the maximum stress range within the point that cracks were not found was shown in the figure ($\Delta \sigma$ =16.8 kg/mm^2 at point A for A-2 test girder). In the figure the points of the solid mark are shown that the cracks seemed to arrest, which the order of crack growth rate were 10^{-6} mm/cycle. And for open mark it is indicated that the cracks were still seemed to growing. It seems the tendency to which if the stress range are increased the final crack is long. The average stress at point D were tension and all other cracks were born at compression zone. The average stress from external loading are compression at the corner of the web gap plates. In case of existence of tension residual stress at the corner of web gap plates the total stress are increased to the average stress. On the other hand, as crack growth goes further, residual stress is released, then average stress becomes small. Consequently the cracks were thought to arrest.

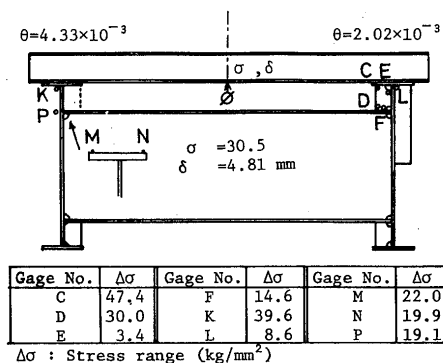
The results of stress measurements for test (7) are shown in **Fig. 17**. As the results of the fatigue test for test girder A-1-2, the cracks were found at point of C for web gap plate and at web-to-flange fillet weld of main girder for the removal of the web gap plates. The stress range (at point C) of the web gap plate, the stress (at points K and L) of the fillet weld for main girder and slope which indicated the rigidity of the deck are shown in **Table 4**. From Table 4 the deflection angle at the side of removal to web gap plate were increased to about two times comparing to A-1-1 test girder, and that the stress at web-to-flange fillet weld of main girder (point K) were 39.6 kg/mm² in tension side which was very high value. The cracks at the fillet weld for main girder were initiated in earlier stage of the tests affected by the above reason. The tensile stress 20 kg/mm² was found at the points (points M and N), for fillet weld for the top flange of cross beam because of which the large out-of-plane deformations were found at around the center of web plate and top flange cross beam where the web plates were the removal side of web gap plate. Although

the cracks were not found at points M and N by the tests the possibility for crack initiation would be considered the same points.

For the side reinforced by stiffner, deflection angle were not so much reduced comparing to A-1-1 test girder and the high stress range of initiation 47.4 kg/mm² were found at point C of the corner. As the result the cracks were initiated at point C. The cause of the crack initiation were considered that the rigidity were reduced by removal of the web gap plates and the reinforcement for the stiffner were not effective. The removal of web gap plates is considered little efficiency to prevent the fatigue crack because not only the reduction of total rigidity for removal side but also the other members are affected to worse influences.

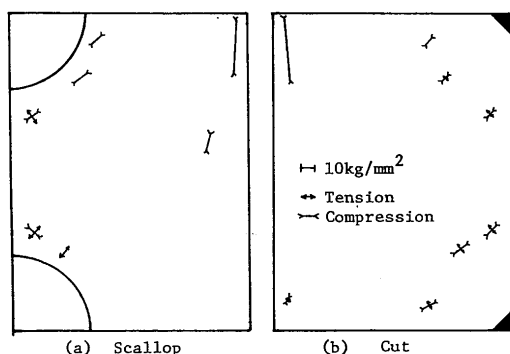
Fig. 19 Results of stress measurement of web gap plate.

The stresses in web gap plates are considered for A-1 test girder. The results for the stress measurement for web gap plate are shown in **Fig. 19**. From Fig. 19 the compressive stress due to the bending moment for the top flange of main girder are governed at the top of web gap plate, especially the compressive stress are very high at free edge (points A and C). And that approaching from the free edge to web plate the complex stress condition are found with sloping of the principle axis. This is also indicated in the results of test (11) (see **Fig. 20**). The tensile stress are high at the bottom of web gap plate which

tendencies are found in particular at scallop side. The cracks at points D, E and F are seemed to affect the above tensile stress. For the complex stress conditions at web gap plate, the stress are considered due to deformation the rotation of top flange of main girder and the out-of-plane deformation of web plate.

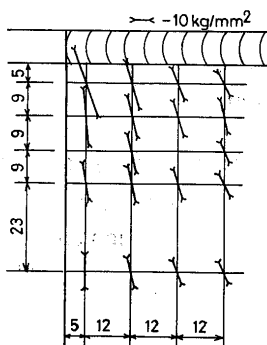
**Fig. 20** Results of stress measurement at near the corner.

From the results of test (11), the principal stress diagram at near the corner of web gap plate is shown in **Fig. 20** and the equal stress line diagram is shown in **Fig. 21**. From Fig. 21, the equal stress line are become the denser to approaching to the corner, especially the range of 30 kg/mm² to 45 kg/mm² are rather dense. They are considered when the stress under the 30 kg/mm² the equal stress line are rough and around $\sigma = 20$ kg/mm² value are indicated the average stress regardless to the corner effects.

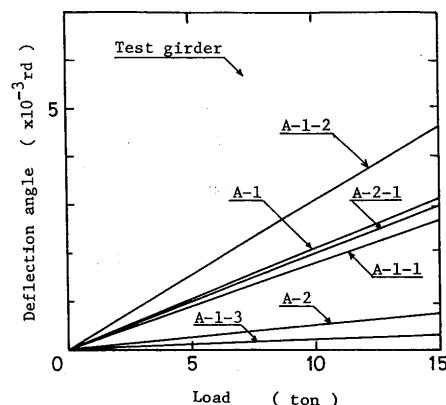
Fig. 22 Comparison of deflection angle for each test girder.

fillet weld toe propagated to the thickness direction for top flange, and the cracks at bottom of fillet weld toe extended in streight across the web thickness. For A-2 test girder which the cracks were not found, the stress range is low at 1.9 kg/mm². For the test girder which the cracks were found, the relation between load and deflection angle are shown in **Fig. 22**. In the figure the larger slope were shown for each test girders which has two slopes at left and right main girder. For the comparison the test girder A-2 without cracks and test girder A-1-3 less rotations were shown in the figure. From **Fig. 22** and **Table 5**, when the increments of the slope of line which indicates the rigidity of deck are becomming small, deflection angle increased, and then the stress of fillet weld are increased. For the out-of-plane deformation of web plate, as the rigidity of cross beam and deck are reduced, the deformations are increased.

As the above mentioned, the cracks at fillet weld for main girders are born by large deflection angle of deck and increments of out-of-plane deformation of web. This cracks for web-to-flange fillet weld of the main girders are considered to prevent by increasing of rigidity of the deck. Also, as no fatigue test are done the reinforcements by stiffner for A-1-3 test girder are considered to be effective.
