Real-time acoustic emission monitoring of wear-out failure in SiC power electronic devices during power cycling tests

Chanyang Choe, *Student Member, IEEE*, Chuantong Chen, *Member, IEEE*, Shijo Nagao, *Member, IEEE*, Katsuaki Suganuma, *Fellow, IEEE*

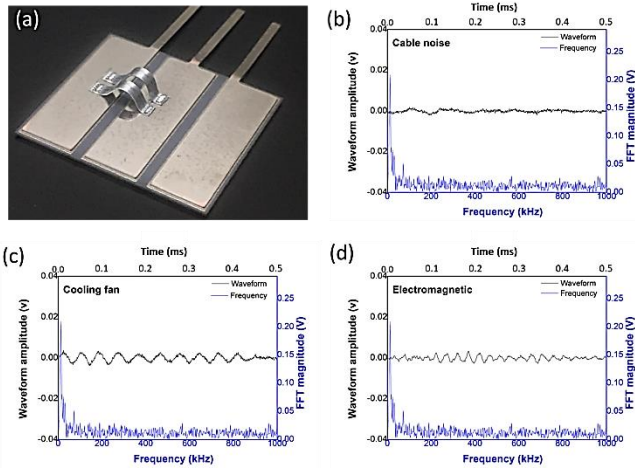
Fig. 6 (a) Dummy specimens designed for noise filtering and (b-d) Typical waveform and frequency spectrum of three types of collected noise; (b) cable noise, (c) cooling fan movement noise and (d) electromagnetic induction noise.

Figs. 6 (b), (c), and (d) show the representative surrounding noise signals from cables, a rotating fan, and switching on-off signals of high-current carrying circuits in the PCT system for the background AE noise filtering process, respectively. The recorded noise signals did not include AE signals from the damage of discrete devices because the used dummy specimen without a chip was not heated and damaged even under high current. The cables in AE system exhibited very low amplitude noise below 25 kHz. The mechanical vibration of a cooling fan (below 30 kHz) and the electromagnetic interference (EMI) of current switching (below 87 kHz) also generated noise signals. The frequency level of the collected AE noise ranged less than 87 kHz. Therefore, in order to more accurate signal measurement and meantime eliminate the noise, the high-pass frequency filter at 100 kHz was employed to eliminate noise in

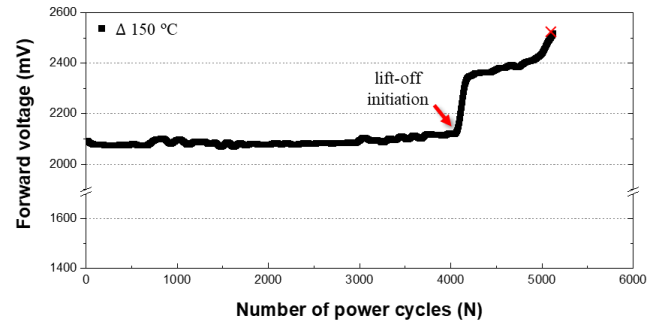
Fig. 7 Variation in forward voltage of a diode during PCT.

Fig. 7 shows the V_F measurement results of discrete SiC-SBD devices during the power cycling test under the test condition as listed in Table 1. After 4,060 cycles, a sudden increase was observed in V_F, and this increased by 20 % from its initial value after 5,123 cycles. Lifetime of devices could be determined based on the failure criteria of a V_F increase.

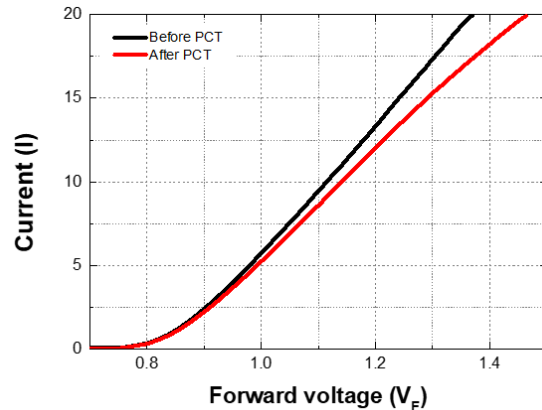
Fig. 8 I-V characteristics before and after PCT.

Fig. 8 shows a comparison of current–voltage (I–V) characteristics of discrete devices before and after PCT. The I-V curves were measured at room temperature via a curve tracer (CS-3200, IWATSU Co.). The electrical resistance (R_F) of the discrete devices was measured from I–V curves, and it was observed that it increased after PCT. The measured R_F corresponds to the sum of individual resistances in chip and packaging and is simply expressed as follows:

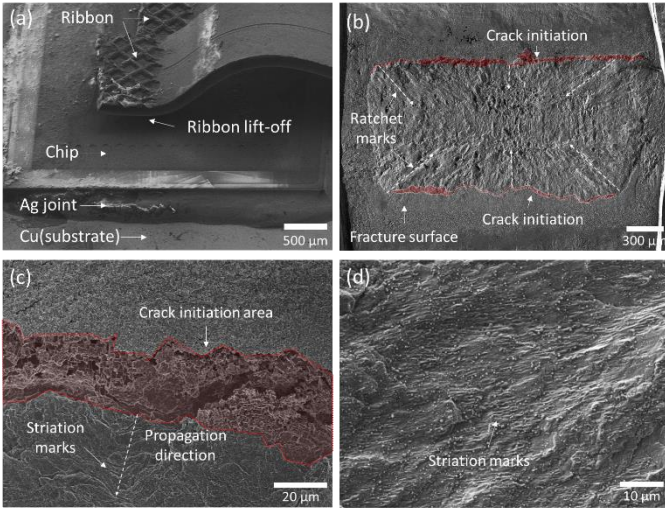
Fig. 9 Failure analysis results of failed discrete SiC-SBD devices after PCT; (a) lift-off failure of one Al ribbon, (b) fatigue fracture surface of lift-off ribbon, (c) magnified observation of crack initiation, and (d) magnified observation of fatigue fracture marks.

The failure mode of tested discrete devices was evaluated via FE-SEM observation and X-ray transmission inspection. Figs. 9 show the inspection results of the appearance and fracture surface of devices after PCT. One of the two Al ribbons is completely fractured by lift-off and the other ribbon is still bonded on a chip, as shown in Fig. 9 (a). Ratchet marks are observed on the fracture surface of the ribbon lift-off as shown in Fig. 9 (b). The marks, which are typically observed on a fatigue fracture surface, indicated that the lift-off failure was induced by fatigue. Generally, fatigue fracture involves three steps including crack initiation, crack propagation, and final fracture. The sharp and large fatigue cracks initially occur at the edge of Al ribbon bonding as shown in Fig. 9 (c). There is a large cracked region between the spot marked 'crack initiation area' and the area containing striations. The cracks propagated

into the center in the direction of ratchet marks as shown in Fig. 9 (b), and this is followed by the final lift-off failure. Striation marks in the vertical direction to ratchet marks are observed as shown in the magnified images of Fig. 9 (d), and this also indicates the propagation direction of fatigue cracks. Fig. 10 shows the micro-focused X-ray inspection (XVA-160N, Uni-Hite System Corporation, Japan) results of Ag sinter joints in the discrete device before and after PCT. It is found that some small voids in the Ag sinter joint structure after sintering process as shown in Fig.10 (a). After the power cycling test, the voids almost did not any change as shown in Fig.10 (b). Hence, it can be inferred that the sinter Ag joined structure had an appropriate interface bonding ratio during the sintering process and high power cycling reliability. Although the thermal shock resistance of Ag sinter joints depends on manufacturing conditions, chip size, and the used Ag paste [39] [40] [41], the results in the present study indicate that Ag sinter joints exhibit excellent high temperature reliability for PCT.

Based on the results of Al ribbons and Ag sinter joints after PCT, fatigue cracks and lift-off in Al ribbons corresponded to the dominant failure modes in the discrete devices used in the current study. The results were similar to those reported in previous studies wherein bond wire lift-off corresponds to the main failure mechanism. The V_F of diodes increases with the bond wire lift-off [42][43][44]. Therefore, Al ribbon's lift-off corresponds to the main reason for increases in V_F, as shown in Fig. 7, and it is evaluated via V_F measurement. However, although the observed fatigue cracks gradually propagated before final lift-off failure, V_F was not changed prior to the sudden increase that is caused by lift-off failure. In this case, the measurement of V_{F_ON} cannot be used to monitor the progress of fatigue cracks in the Al ribbon, and thereby resulting in the ribbon's final lift-off failure.

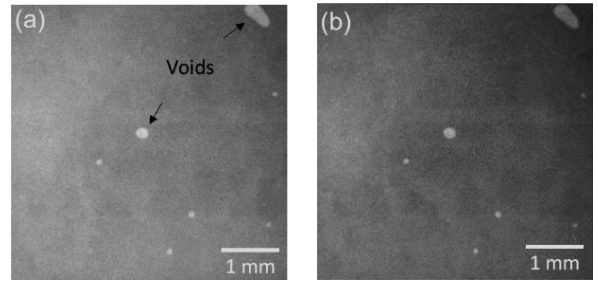
Fig. 10 Micro-focused X-ray inspection results of Ag sinter joints in discrete devices before PCT (a) and after PCT (b).

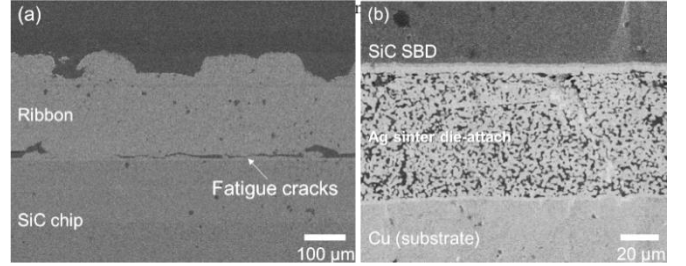
Fig. 11 Cross-section observation of (a) one unfeatured ribbon and (b) Ag sinter joint in the tested discrete SiC-SBD devices after PCT.

Fig. 11 shows the cross-section of one unfractured ribbon of the tested discrete device after PCT. More than half of the bonded interface between an Al ribbon and a SiC-SBD chip is

delaminated, and this is caused by fatigue cracks, as shown in Fig. 11 (a). Conversely, after PCT, any delamination did not occur at the interface between sintered Ag and the substrate or between sintered Ag and a SiC-SBD chip, as shown in Fig. 11 (b). The Ag sinter joints maintained a micro- porous network structure without any evident cracks, and this can be attributed to the robust die shear strength of approximately 40 MPa and a low resistivity of 3.9×10^{-6} Ω cm [26].

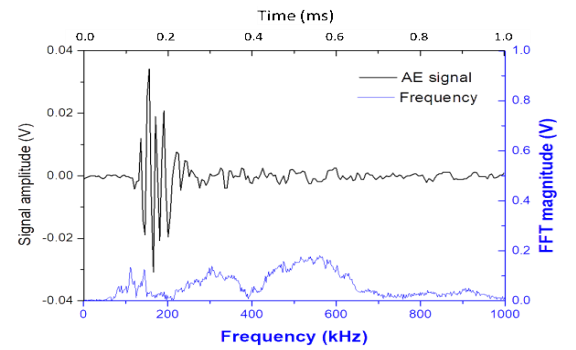
Fig. 12 Waveform and its corresponding frequency spectrum of typical AE signals collected during PCT.

Fig. 12 shows typical waveform and their frequency spectrum. They indicate that the collected AE signals were burst type waveforms, and this was completely different when compared to the noise signals shown in Fig. 6. It is known that the burst type signals are typically emitted via a sudden energy release when damage such as cracks and delamination occurs [45]. Based on the typical source of burst type and the observed fatigue cracks in Al ribbon bonding shown in Fig. 9, the source of collected AE signals from discrete devices during PCT is attributed to fatigue cracks in the Al ribbon bonding.

The frequency components of collected AE signals are estimated by FFT, as shown in Fig. 12. They were also completely different with that of noise signal as shown in Fig. 6. These FFT results clearly prove that noise signals were completely filtered. The signals were composed of various frequency components. A central frequency, defined by the arithmetic mean of frequency components in the spectrum, was used to characterize the representative frequency of each AE signal [46]. Fig. 13 shows the distribution of estimated central frequency. It corresponds to a bell-shaped curve. A peak in the distribution curve was approximately 500 kHz. The frequency component depends on the type of fracture, which denotes the source mechanism of AE signals [47]. The bell-shaped distribution with a single peak also supports the fact that the collected AE signals are emitted simply from the fatigue cracks in Al ribbon bonding.

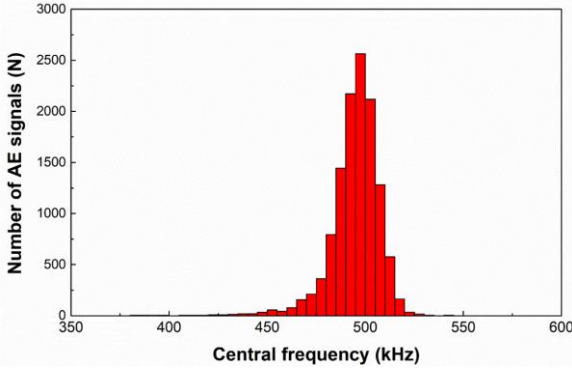
Fig. 13 Histogram of the measured central frequency of collected AE signals.

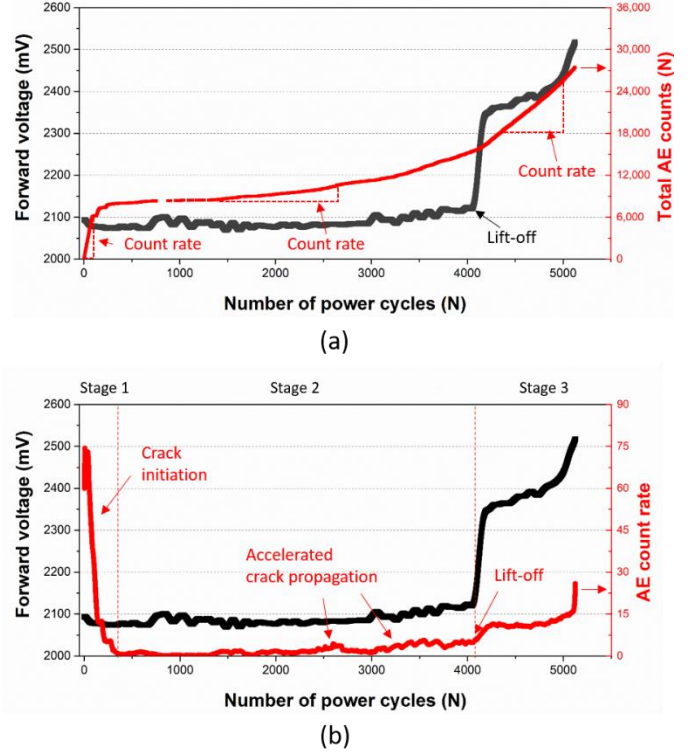
Fig. 14 Monitoring result of total AE counts (a) and AE count rate (b) during PCT with the monitoring results of forward voltage.

To clearly divide the progress of fatigue based on the AE count stage, an AE count rate was calculated as the total count number per cycle, as shown in Fig. 14 (b). The change in the count rate clearly indicates that the progress of fatigue crack is divided into three stages as indicated by a red dashed line. The three stages can be classified into the highest count rate during the early step of PCT (stage 1), low count rate (stage 2), and re-high-count rate (stage 3). Stage 2 and stage 3 were divided at approximately 4,060 cycles where the count rate started to increase again. In fatigue tests of bulk metals, high AE count

rates were observed when fatigue cracks were initiated, cracks were rapidly propagated, and metals were finally fractured [19][48][49][50]. Based on the results of the aforementioned previous studies, stage 1 is attributed to crack initiation, as shown in Fig. 9 (c). Specifically, AE signals in stage 2 occur from the crack extension at the crack tip during the crack propagation, as shown in Fig. 9 (d). In stage 3, crack propagation caused catastrophic fractures and increased the AE count rate. Based on the relationship between the AE count rate and fatigue progress, it was concluded that AE offers the ability to accurately detect fatigue crack initiation, crack propagation, and catastrophic fracture. It demonstrated that the monitoring of the AE count rate can provide an early warning before final lift-off fracture via evaluating the progress status of fatigue cracks. The early warning could be provided when AE count rate increased more than the determined level, which indicating that the power device reaches the accelerated stage of fatigue crack propagation before final lift-off failure.

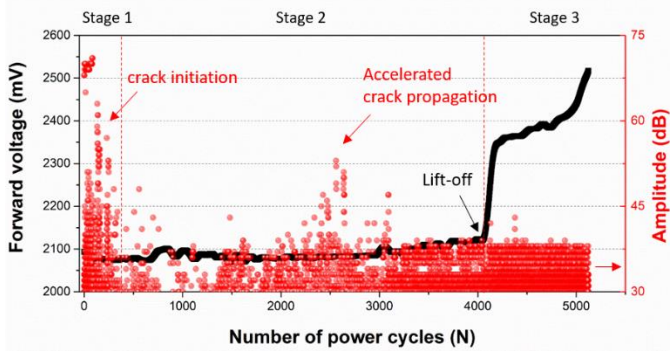
Fig. 15 Monitoring result of amplitude of collected AE signals during PCT with the monitoring results of forward voltage.

Fig. 15 shows the variation in the amplitude of collected signals during power cycling. One dot denotes the amplitude of one AE signal, and many AE signals with amplitude ranging from 30 dB to 71 dB occurred prior to lift-off failure. Low amplitude signals below 40 dB occurred throughout the whole process of fatigue damage although high amplitude signals ranging from 41 to 71 dB were emitted in the early and middle stages of total power cycling. In a bulk metal, it was reported that high amplitude signals are generated due to plastic activities ahead of a crack tip when fatigue cracks initiate and rapidly propagate [51][52][53]. Thus, high amplitude signals in stage 1 occurred due to crack initiation in Al ribbons and those in stage 2 were attributed to the accelerated crack propagation before ribbon's lift-off failure. Hence, the observations support the relationship between AE count rate and fatigue progress.

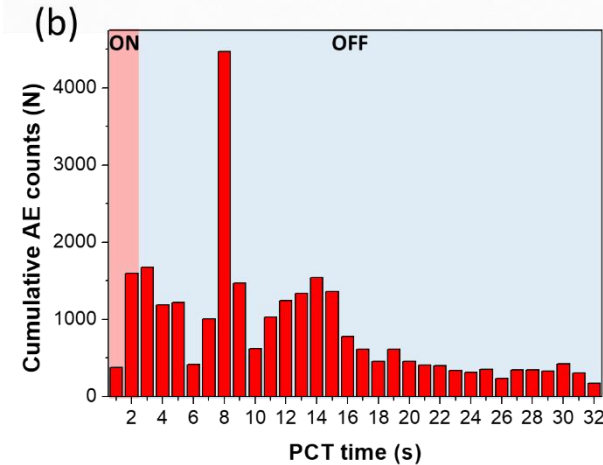
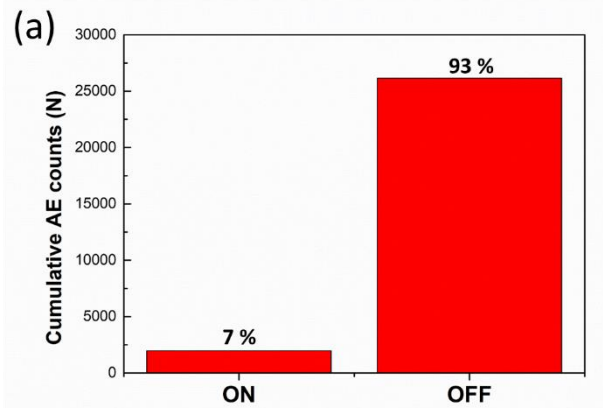
Fig. 16 (a) cumulative counts of collected AE signals during switching ON and OFF period of PCT and (b) cumulative AE counts according to cycling time of PCT test.

Fig. 16(a) shows the cumulative counts of collected AE signals during switching ON and OFF period in PCT. The number of cumulative AE counts during the ON period of power cycling, which is defined as the total amount of fatigue crack initiation and propagation, was significantly lower than that during the OFF period. The AE occurrence suggested that fatigue cracks of Al ribbon bonding almost nucleated and grew during the cooling stage in power cycling. Fig. 16 (b) shows the cumulative AE counts according to cycling time during PCT test in a detail. The cracking takes place more during the cooling period. In addition, the AE counts increased in the certain temperature range (at 8s) and decreased when the temperature significantly reduced (after 20s) during cooling period. This indicated that more AE counts were caused not just because of longer time. Although a detail experiment or simulation need to support, the fatigue crack looks more easily extended during the cooling process, which may be related with the change of thermal stress direction and distribution in the certain temperature range during cooling period. Recently, it was reported while the Al alloy was obviously damaged, a fast stress relief was evidenced after unloading from the tension, especially at the beginning of unloading [54]. In this study, we proposed that the cooling period lead to a fast stress relief

generated at the heating period, and then leads to many cracks generation.
