# Review of Damage in Welded Joints Caused by The Kobe Earthquake†

Kousuke HORIKAWA\* and Yoshihiro SAKINO\*\*

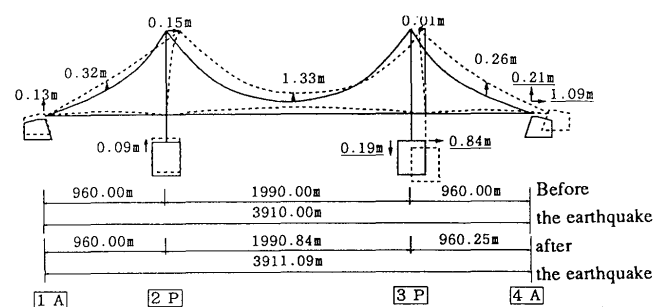
experienced due to the earthquake. After the earthquake, the relative displacements of the bridge were measured. As the result of the measurement, the Awaji Island side tower and anchorage moved about 1.3m relative to the Kobe side tower and anchorage. Then the center span length, originally 1,990m, was increased to 1,990.8m (Fig.7). But, it was fortunately found that the earthquake caused no critical damage to the bridge. The elongation of the span will be accomplished by adjusting the length of some panels of the stiffening girder.

Fig. 7 The relative displacement of "Akashi-Kaikyo Bridge".<sup>9)</sup>

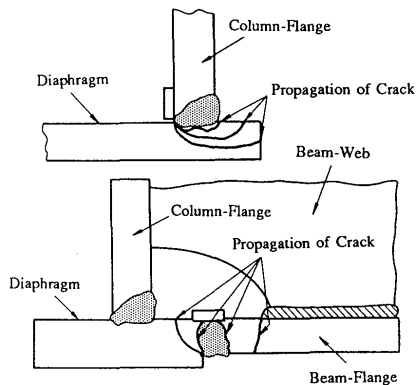
Brittle fractures were observed in beam-column connections, which were welded according to the present design standard. As Fig.13 shows diagrammatically, typical modes of fractures are divided as follows.

- (a) Brittle fractures in beam-flanges, started from the toe of the scallop in the web.(Fig.14).
- (b) Brittle fractures at heat-affected zones in the beam-flange or the diaphragm, started from the backing strip or the end tab (Fig.15).
- (c) Brittle fractures at heat-affected zones or base metal of the diaphragm in the column-diaphragm connections (Fig.16,17).

Fig.13 Typical modes of fracture at the beam-column connection in the Kobe earthquake.<sup>1)</sup>

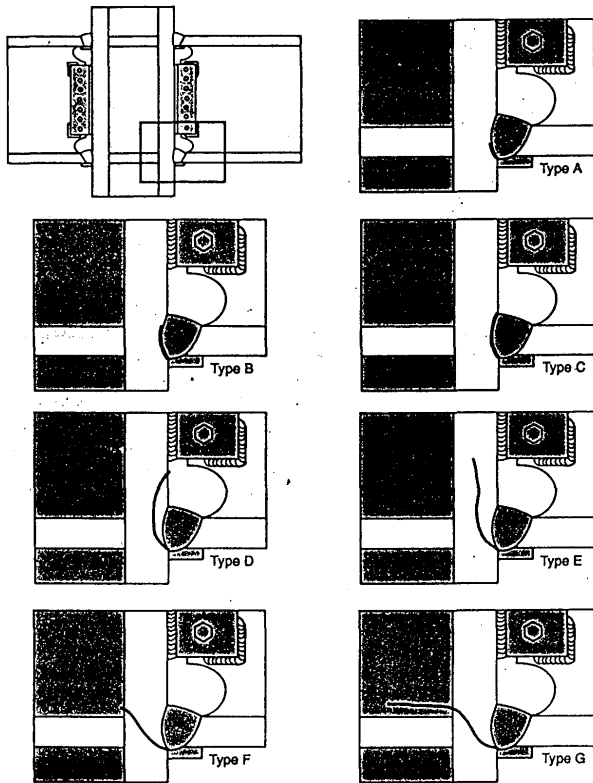
The Northridge Earthquake (magnitude of 6.8), which struck the Los Angeles area on January 17, 1994, just the same day one year before the Kobe Earthquake occurred, was an impulse type of epicentral earthquake, too. Also in the Northridge, brittle fractures were observed in many of the beam-column connections of steel buildings (Fig.21), called "Steel Moment Resisting Frame (SMRF)". Fig.22 shows the typical mode of cracking in the Northridge incident. But these fractures are differ from those in the Kobe.

Fig.2.2 Typical modes of crack due to the Northridge Earthquake.<sup>14)</sup>

In the Northridge, these connections were fractured without absorption of seismic energy by plastic deformation, against those in Kobe which were fractured with them, except mega-structures as mentioned above.
