Title	Review of Damage in Welded Joints Caused by The Kobe Earthquake
Author(s)	Horikawa, Kohsuke; Sakino, Yoshihiro
Citation	Transactions of JWRI. 1995, 24(2), p. 1-10
Version Type	VoR
URL	https://doi.org/10.18910/10043
rights	
Note

Review of Damage in Welded Joints Caused by The Kobe Earthquake[†]

Kousuke HORIKAWA* and Yoshihiro SAKINO**

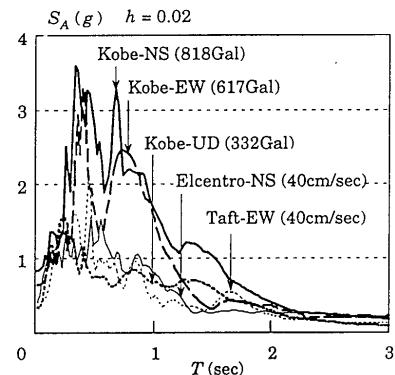
Fig.3(a) The acceleration response spectrum.⁶⁾

Kobe Meteorological Observatory (about 15km away from the epicenter), is shown in Fig.2. Fig.3(a)(b) show the acceleration response spectrum and the pseudo velocity response spectrum calculated from the record. The peak acceleration is over 800 gal, and strong shaking lasted only 10 seconds. These indicate that the seismic force was large and could cause damage to structures within one cycle of vibration. The acceleration response spectrum of the El-Centro (NS 1940) and Taft (EW 1952) are also shown in Fig.2, both of which are usually used as the structural design spectrum for high-rise buildings in Japan. It suggests that the acceleration response spectrum and the pseudo velocity response spectrum of the Kobe Earthquake are much larger than these design spectrum. The maximum velocity and displacement are reported as 104kine and 27cm. In spite of these large records of vibration, the surroundings of the Kobe Meteorological Observatory had little damage.
