Title	Microbiologically Influenced Corrosion (MIC) of Stainless Steel Weldments on the Pipe Line in the Sewage Treatment Plant(Materials, Metallurgy & Weldability)
Author(s)	Kikuchi, Yasushi; Matsuda, Fukuhisa; Tomoto, Kenji et al.
Citation	Transactions of JWRI. 1995, 24(1), p. 63-67
Version Type	VoR
URL	<a href="https://doi.org/10.18910/7825">https://doi.org/10.18910/7825</a>
rights	
Note

# Microbiologically Influenced Corrosion (MIC) of Stainless Steel Weldments on the Pipe Line in the Sewage Treatment Plant†

Leaking was found from several welded joints on a 3mm wall thickness, 304 stainless steel pipe line system. This pipe line system is one of the important components in an activated carbon waste water treatment plant. The failures in weld joints occurred within two months from the start up of the plant.

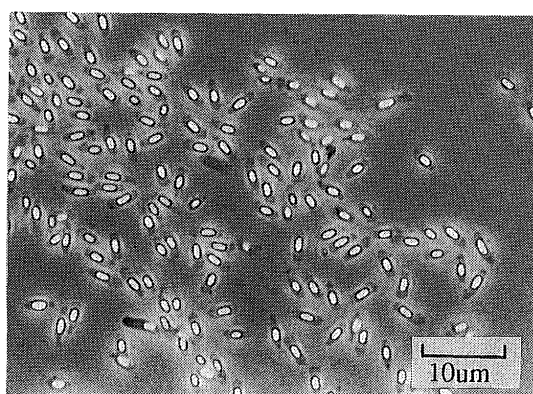
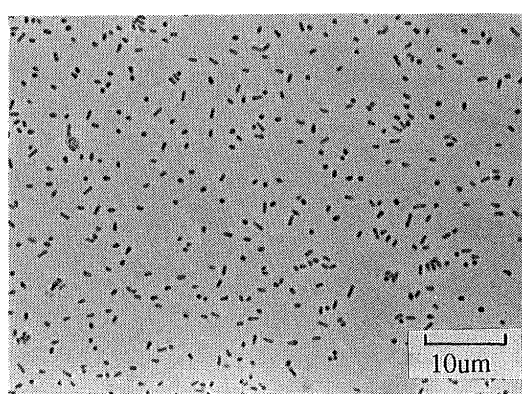
**Fig. 1** Bacteria by light microscope

Bacteria in the solution were detected by cultivation. Agars(Nutrient broth 8g, agar 25g and distilled water)inoculated were kept at the room temperature. By light microscopy , several types of bacterias which have different shapes were observed. Some of examples are shown in Figure 1.
