# Some Fractographic Features of Various Weld Cracking and Fracture Surfaces with Scanning Electron Microscope†

—Studies on Fractography of Welded Zone (I)—

Fukuhisa MATSUDA\* and Hiroji NAKAGAWA\*\*

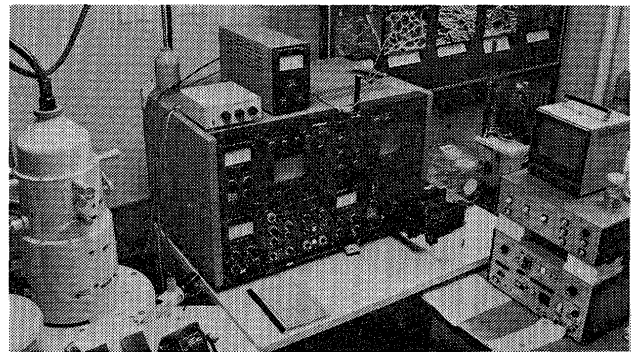
Photo. 1 General appearance of the scanning electron microscope in JWRI

From these viewpoints the authors have been investigating the various cracked and fractured surfaces in welded joint. For the observation a scanning electron microscope (SEM, HITACHI HSM-2B type), which was set up in 1975, has been used, the general view of which is shown in **Photo. 1**. The magnification is continuously variable from  $\times 12$  up to  $\times 100,000$ . Moreover this SEM contains two kinds of microanalyzer. One is a wave dispersive type analyzer (EPMA) composed of two channels and six analyzing crystals, with which analysis from boron to uranium is possible. The other is an energy dispersive type analyzer (EDX), with which analysis from sodium to uranium is possible. These microanalyses offer very important information for the fracture analyses.

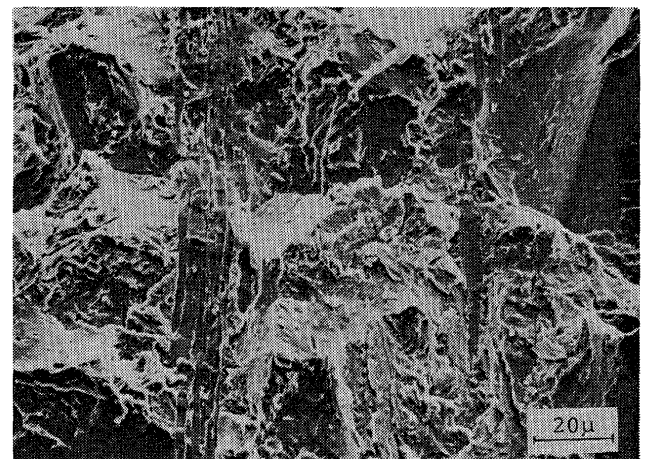
(d) elongated manganese sulphides on the cracked surface

**Photo. 9** Heel cracked surface occurred with Non-restraint *T* type cracking test<sup>5)</sup>. material; HT50 (16 mm thickness), electrode; D5016 (hydrogen; 4 cc/100 g), heat input; 17,000 J/cm, non-preheating

Except the extreme vicinity of the root, the cracked surface is composed of a mixture of intergranular and quasi-cleavage fracture mode, as shown in **Photo. 9(c)**. By the way, the sulphur content of this HT50 is 0.009% and thus the inclusions which were mainly composed of manganese sulphides elongated along the rolling direction were sometimes observed as shown in **Photo. 9(d)**.

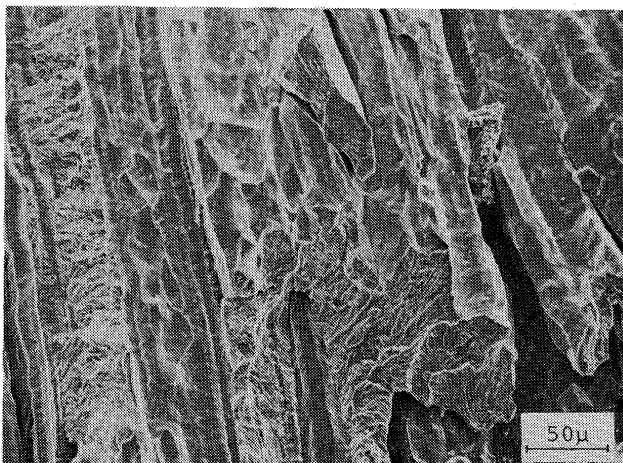
**Photo. 14** Cracked surface occurred in electron beam weld metal of SUJ2 bearing steel. thickness; 30 mm, welding condition; 150 kV, 40 mA, 1,000 mm/min

It was reported by Kobayashi et al.<sup>7)</sup> that another type of cold cracking, that is, a kind of quenching crack during martensitic transformation occurs in hardenable steels. **Photograph 13** shows a toe crack in a SAE4340 steel occurred by the same method as Kobayashi et al.<sup>7)</sup>. **Photograph 14** shows a similar crack occurred in an electron beam weld metal of a high

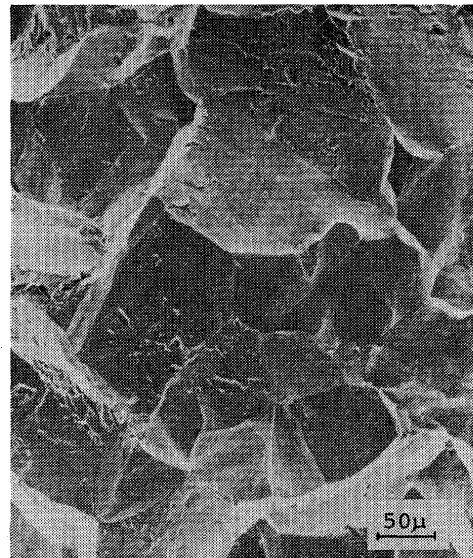
(a) lower magnification

**Photo. 16** Under-clad cracked surface occurred in Ni-Cr-Mo low alloy steel overlaid with stainless steel electrode, annealing temperature; 620°C

**Photograph 16** shows an example of the cracked surface of a Ni-Cr-Mo low alloy steel which was overlaid with a stainless steel electrode and then annealed at 620°C as the stress-relief. This crack is called as under-clad crack in Japan. The cracked surface also shows the intergranular fracture, and the observation of a higher magnification often revealed many and small voids as seen in Photo. 16(b).

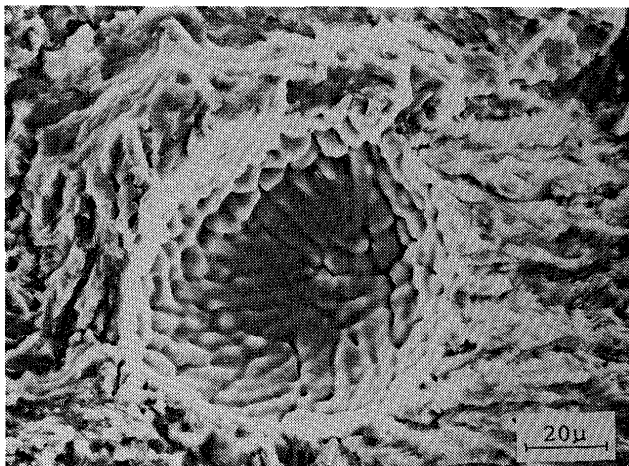
(b) higher magnification

**Photo. 17** Blowhole observed on a fatigue fractured surface of 5083 aluminum alloy welds.

Many and small blowholes were sometimes observed on a fatigue fracture surface of MIG weld metal of aluminum alloy, as shown in **Photo. 17(a)**. The observation of a higher magnification revealed a feature of dendritic protuberances inside the blowhole, as shown in **Photo. 17(b)**. The feature of blowholes of another materials was the same.
