Measurement of fracture behavior of Zr-based metallic glass by thermography[†]

SAKINO Yoshihiro ^{*}, IZUMI Yui ^{**}, KURODA Toshio ^{*}, SAKAGAMI Takahide ^{***}
and KIM You-Chul ^{*}

KEY WORDS: (Zr-based metallic glass) (High speed tensile test) (Thermography) (Fracture) (Spark) (Hot oxide particle) (Liquid droplet)

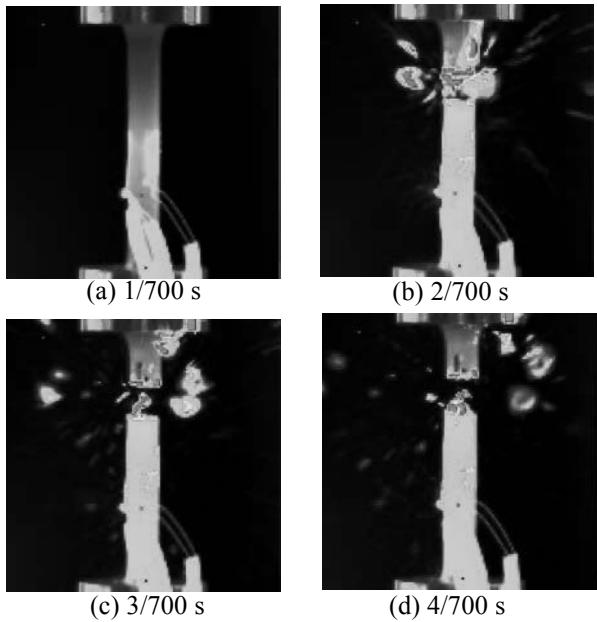
Fig. 2 Moment of fracturing of $Zr_{48}Cu_{36}Al_8Ag_8$ metallic glass (Crosshead speed 10 mm/s).

Figure 2 shows IR thermograph camera photographs of high-speed tensile fracture of $Zr_{48}Cu_{36}Al_8Ag_8$ metallic glass at 10 mm/s crosshead speed. It was detected at 1/700 second per frame. While fracture has not yet started in (a), the fracture section is indicated in red by the sparks in (b), and rough flying particles are seen at the moment of fracture. Particles are also seen in (c) and (d). This indicates that the fracture occurred instantaneously and that the oxide particles or liquid droplets appear as particles. Although this can only be seen as a momentary spark when observed visually, it could be detected with an IR thermograph camera.

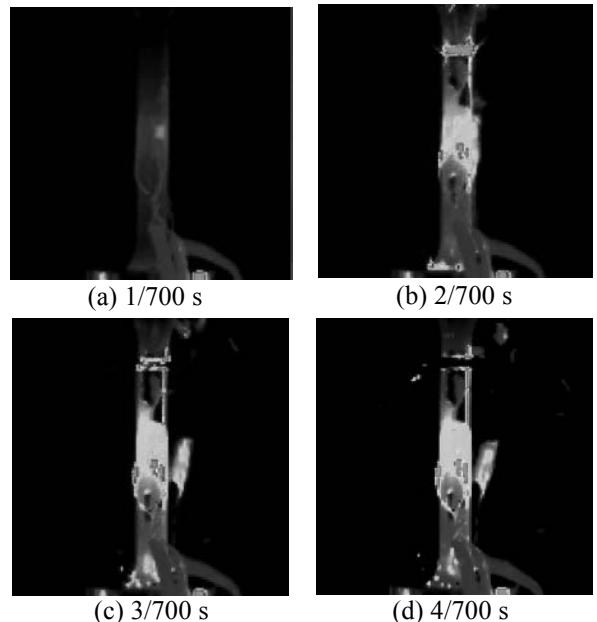
Fig. 3 Moment of fracturing of $Zr_{55}Cu_{30}Al_{10}Ni_5$ metallic glass (Crosshead speed 1200 mm/s.)

Figure 3 shows IR thermograph camera photographs of high-speed tensile fracture of $Zr_{55}Cu_{30}Al_{10}Ni_5$ metallic glass at 1200 mm/s crosshead speed. While fracture has not yet started in (a), the fracture section is indicated in red. Particles are seen in (c) and (d) as same as $Zr_{48}Cu_{36}Al_8Ag_8$, but the size of particles is very small, and they are few in number compared to those for $Zr_{48}Cu_{36}Al_8Ag_8$ metallic glass.

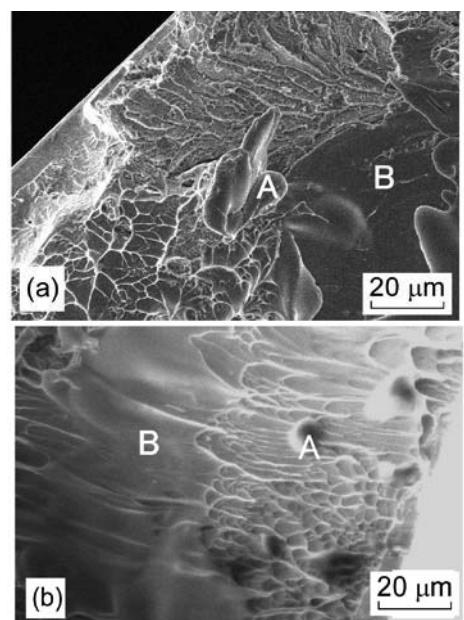
Fig. 4 Fracture surfaces of tensile test. (a) Crosshead speed 0.001 mm/s. (b) Crosshead speed 1200 mm/s.

Considering that the flying particles are also attached to the fracture surface, we examined the fracture surface using SEM observation and XRD analysis. **Figure 4** (a) and (b) shows the fracture surface of $Zr_{48}Cu_{36}Al_8Ag_8$ metallic glass in the tensile test at a low and high strain rate. Regardless of the strain rate, smooth dimples (A) and smooth areas (B) are observed, in addition to the rough dimple fractures normally observed that indicate ductile fracture. The smooth dimples (A) are regarded as attached marks of flying particles due to sparking. These indicate that the hot oxide particles collided with the fracture surface and become attached. The smooth areas (B) are regarded as melting and solidification cracking. This indicates that it was heated to the melting temperature of metallic glass, which is 900°C or higher, by thermal insulation change, etc., during the tensile fracture of the metallic glass, causing it to melt, and then generate high-temperature cracks during cooling. The large localized deformation and the remelting feature are believed to be due to the high strength, large elastic energy and low melting temperature of the alloy, which are common characteristics of bulk metallic glass.
