# Proposal of Hydrogen Blistering Mechanism Associated with Disbonding between 2·1/4Cr-1Mo Steel and Type 309 Overlaid Metal

Fukuhisa MATSUDA \*, Hiroji NAKAGAWA \*\* and Sanae TSURUTA \*\*\*

KEY WORDS: (Austenitic Stainless Steel) (Heat Resistant Materials) (Hydrogen Embrittlement) (Cracking)

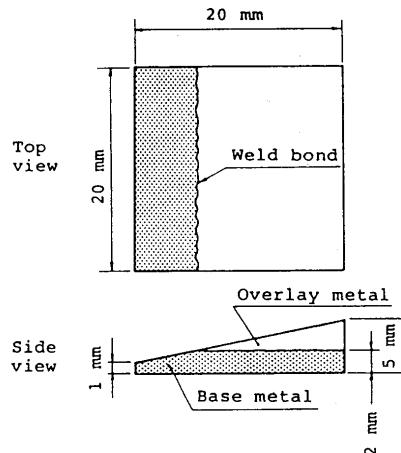
Fig. 1 Specimen configuration for direct observation of hydrogen gas bubbling and blistering with electrolytic hydrogen charge.

Disbonding test was done by electrolytic hydrogen charging technique and autoclave. For the electrolytic hydrogen charging test, tapered specimen shown in Fig. 1 was used. The specimen was set to the small electrolytic vessel shown in Fig. 2 that was designed so as to be mounted on the stage of optical microscope. Glycerine was applied on the top surface, and the bubbling of hydrogen gas and the blistering were observed through microscope. The Electrolyte used was aqueous solution of 5% sulfuric acid to which phosphorus was added. Current density used was 0.1 A/cm<sup>2</sup>.

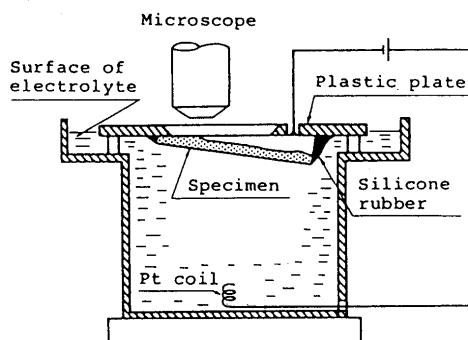
Fig. 2 Direct observation technique during electrolytic hydrogen charge.

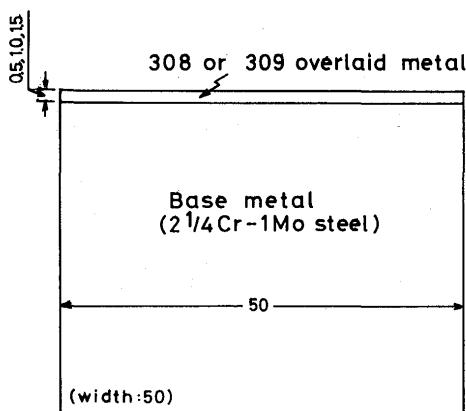
Fig. 3 Specimen configuration for the test in autoclave.

The specimen configuration for autoclave testing is shown in Fig. 3. The surface of overlaid metal was ground

to the thickness of 0.5, 1.0 and 1.5 mm to make the blistering noticeable, if it occurred. The conditions of autoclave were hydrogen pressure of 220 kgf/cm<sup>2</sup>, temperature of 450°C, holding time of 48 hr and cooling rate of about 350°C/hr to minimize the escape of hydrogen through thin overlaid metal.

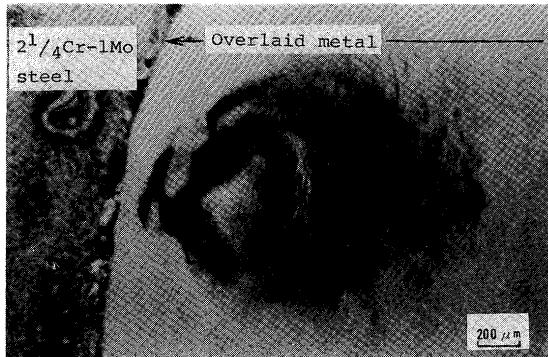
Fig. 4 Blistering in overlaid metal near carbide layer during electrolytic hydrogen charge.

interface, coinciding the change in the thickness. After about 50 min from the start, the bubbling was observed at the tip of carbide layer in the overlaid metal that was highly hardened zone. In the region composed of austenite and several percent of delta, however, no bubbling was observed even after six hour and even near the carbide layer. Instead the blistering was observed from about 3 hr as shown in Fig. 4.

Both Figs. 4 and 5 strongly suggests that very high pressure of hydrogen gas causes the disbonding. The maximum hydrogen content accumulated at the bonding interface during the shutdown reaches about 300 ppm as mentioned. This equilibrates with about 60,000 MPa of hydrogen gas according to Sievert's law.<sup>5)</sup> Of course, this pressure may be overestimated because fugacity correction<sup>6)</sup> was not done. Nevertheless, this estimation means that hydrogen gas once precipitated has sufficiently high pressure to cause blistering. This behavior is the same as hydrogen blistering in HIC in principle. The difference between them is that the hydrogen gas in the disbonding tends to occur at matrix-carbide interface along grain-boundary, while usual blistering in HIC occurs at matrix-inclusion interface irrespective grain-boundary.

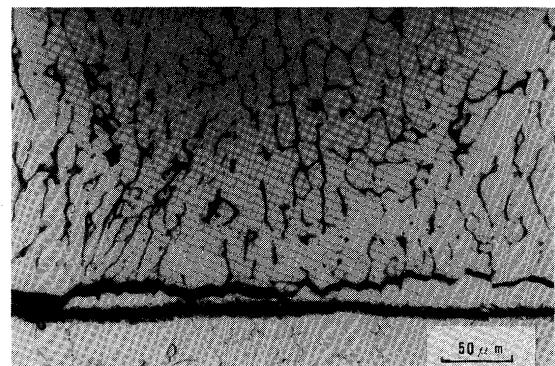
Fig. 6 Microstructure near disbonding associated with blistering.

0.08 mm in the specimen which had overlaid metal of 0.5 mm thickness. Figure 6 shows the microstructures around the disbonding associated with the blistering, which gives the same feature as that in usual testing.<sup>1)</sup>
