| Citation | Transactions of JWRI. 31(2) P.229-P.232 |

Atmospheric Exposure Test Results of Lap Joints Fixed by Epoxy Adhesive†

NAKATSUJI Yoshihiro*, HORIKAWA Kohsuke** and SAKINO Yoshihiro***

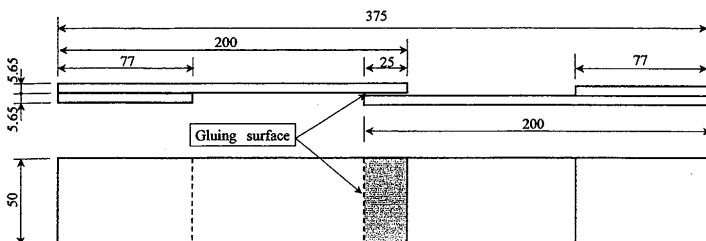
Fig.1 shows the shape and size of specimens. The steel type for all tests was mild steel (SS400). The gluing area was 12.5cm^2 ($25 \times 50\text{mm}$). To load pure shearing stress in the lap area, splice plates were fixed in the grip areas.

Fig. 1 Shape and size of atmospheric exposure specimen

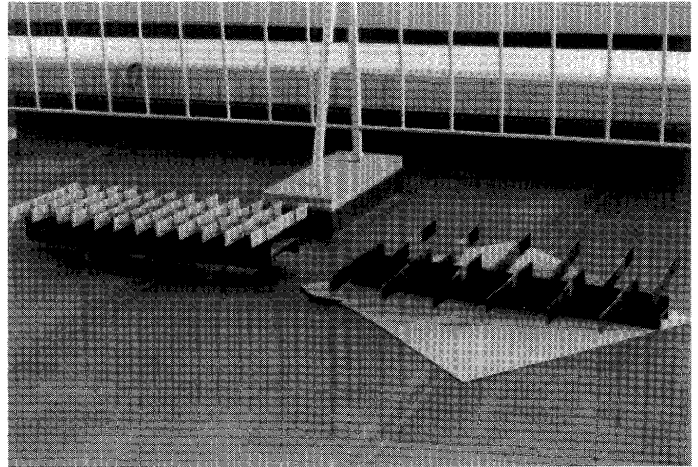
24 specimens were exposed on the roof of the main building of JWRI (lat. $34^\circ 45' \text{ N}$, long. $135^\circ 30' \text{ E}$, altitude 100m). Fig. 2 shows a photo of atmospheric

Fig. 2 Photo of atmospheric exposure test

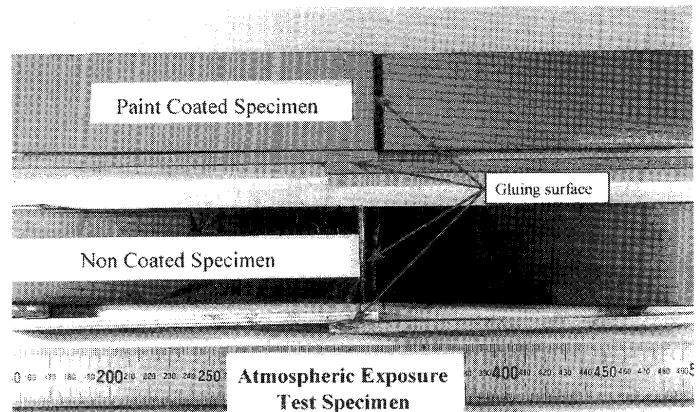
In this research, we made two series of specimen, non coated and paint coated. Since steel structures are usually painted to prevent rust. It seems that the paint layer can weaken the effect of the environment.

Both series of specimen are shown in **Fig. 3**.

Fig. 3 Atmospheric exposure test specimens

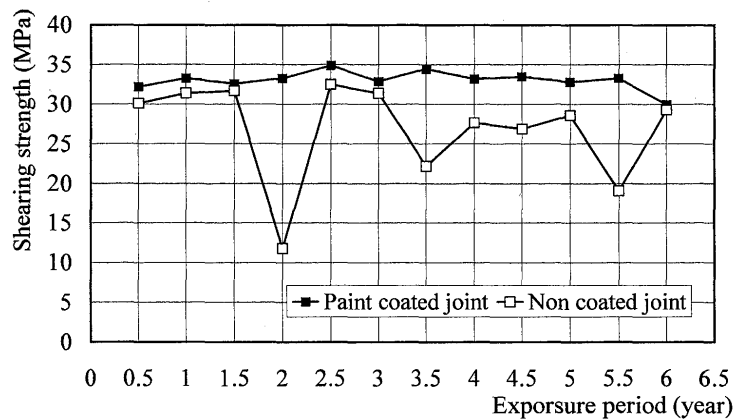
Shearing stress – cross-head displacement relationships are shown in Fig. 5 and shearing strength – exposure period relationship are shown in Fig. 6.

Fig. 6 Shearing strength – exposure period relationships

The paint coated specimens showed only shear fracture, with very small delamination. In non coated specimens, exposed for 2 years (right side specimen in Fig. 6) and 5.5 years specimens had delaminated surfaces, over more than half the adhesive area. As one can see from Fig. 5, the shearing strength of these two specimens were very small compared to other specimens. So it is concluded that the surface of delaminated adhesive can not stand large shearing stress. But it is not clear what the cause of delamination is in this research. Because it seems that the appearance of delaminations showed only a low correlation with exposure periods.

As shown in Fig 6, the shearing strengths of the

paint coated specimens were stable over all period up to 6 years. So the paint coated joints can be used for large steel structures without considering the effects of the environment for least 6 years.

In case of the non coated epoxy specimens, which fractured because of shear of adhesive, shearing strengths are stable for 3 years. But after 3 years, shearing strength of the non coated joints become small because of the effects of the environment. So it can be said that epoxy adhesive joints can not be used for large steel structures without paint coating beyond 3 years.
