# Experimental Study on the Reshape of a Plate Girder under Loading

Kohsuke HORIKAWA\* and Hiroyuki SUZUKI\*\*

*This paper describes reshape works of a plate girder from uniform section to non-uniform section using gas cutting and welding under loading.*

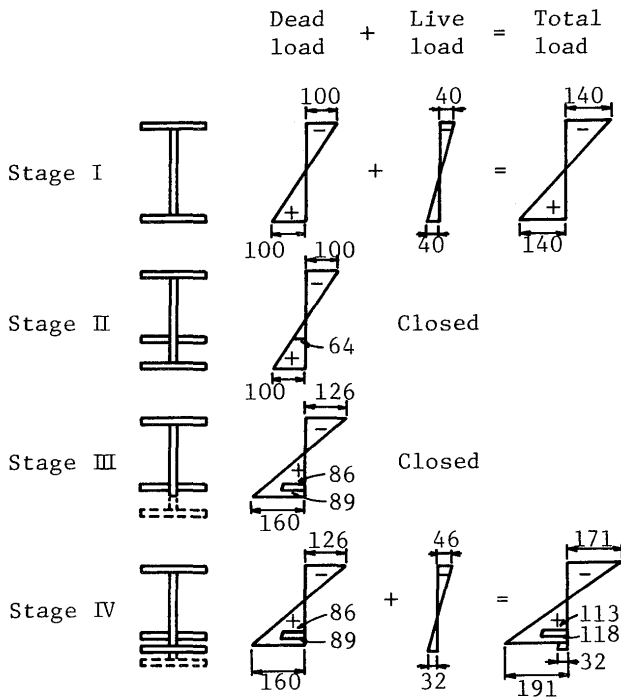
Fig. 12 Schematic example of stress in existing bridges (MPa)

Stress on each stage in this procedure is different from one in Fig. 10. It is a matter of course that it depends on section in existing bridges. Assuming a girder with the same proportion as specimen, stress on each stage is considered to become one shown in Fig. 12.

Stress induced in cut off section is redistributed. At this time, stiffeners contribute to section. This is a great difference from Fig. 10. Stress after redistribution can be obtained from following three conditions.
