Visualization and Modal Analysis of Guided Waves from a Defect in a Pipe Muhammad NOR SALIM, Takahiro HAYASHI, Morimasa MURASE, and Shoji KAMIYA Department of Mechanical Engineering, Nagoya Institute of Technology, Nagoya, 466-8555, Japan

Keywords: Visualization, Mode conversion, Curved surfaces scanning, Guided wave, Laser Doppler Vibrometer

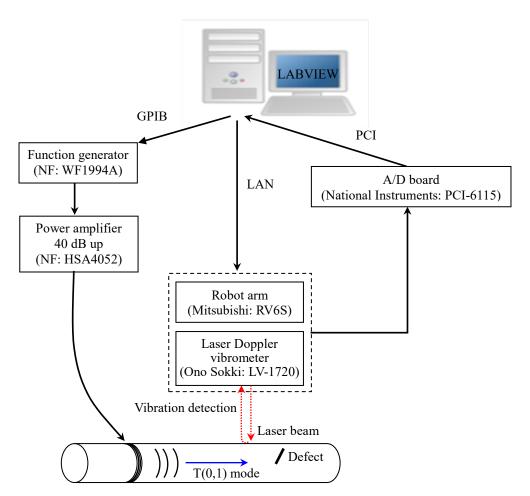
Figure 1 shows the entire laser scanning system that excites axisymmetric mode T(0,1) at central frequency of 70 kHz from a magnetostrictive sensor attached around the

pipe and measured the guided wave around defect in the pipe using a LDV.^{15,16)} This measurement were made for two test pipes with different artificial defects in aluminum pipes with dimension of 4 m in length, 110 mm in outer diameter and 3.5 mm in thickness. The artificial defects were made on the pipe surfaces stretching in the circumferential direction as Fig. 2(a) and in the oblique direction at angle of about 45° to the horizontal direction as Fig. 2(b). Both defects were scratched by a round file in size of about 40 mm in length, 10 mm in width and 2 mm in depth at 500 mm from a pipe end.

Magnetostrictive sensor

- Fig. 1 Scanning system of guided wave propagation on pipe surface.
- Fig. 2 Artificial defects made on pipe surfaces.
- Fig. 3 Test pipe and visualization regions.
- Fig. 4 Measurement of both in-plane and out-of-plane vibrations at angle θ of incident beam.
- Fig. 5 In-plane mode vibration of circumferential defect in pipe.
- Fig. 6 Out-of-plane vibration of circumferential defect in pipe.
- Fig. 7 In-plane mode vibration of oblique defect in pipe.
- Fig. 8 Out-of-plane vibration of oblique defect in pipe.
