Bond Coat Oxidation and Hot Corrosion Behavior of Plasma

Sprayed YSZ Coating on Ni Superalloy †

SAREMI Mohsen * AFRASIABI Abbas ** and KOBAYASHI Akira ***

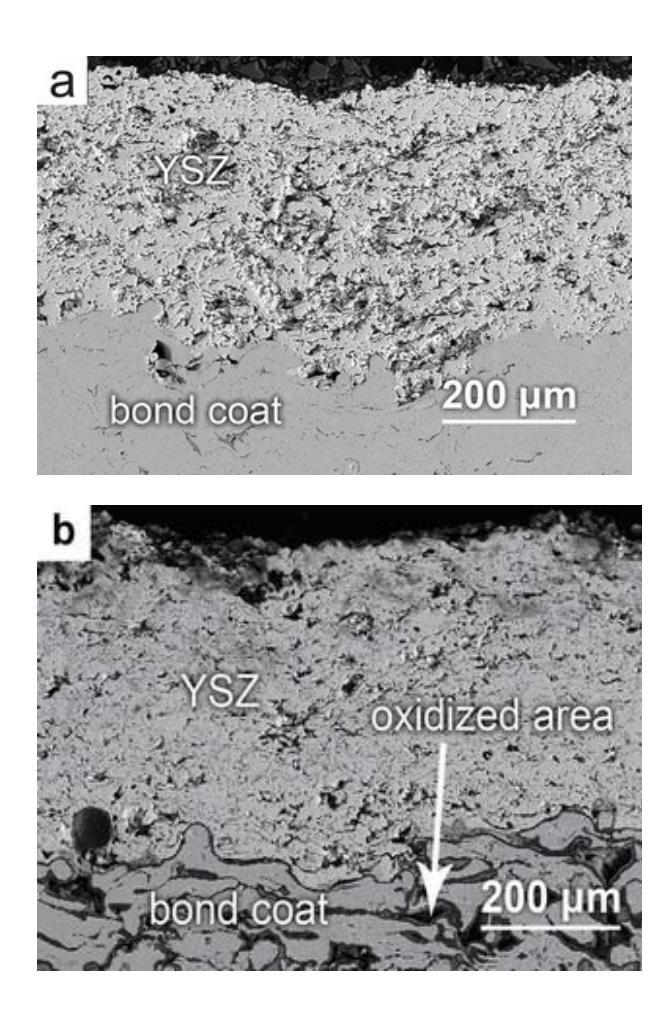
Fig. 1 SEM images showing the cross section of coating: (a) as sprayed; (b) after oxidation at $1100 \,^{\circ}$ C for 100 h.

Figure 1a shows the cross section of the YSZ layer and bond coat. The coating showed the lamellar structure which is the characteristic of plasma sprayed coatings. **Figure 1b** shows the cross section of YSZ coating after 100 h oxidation at 1100 °C. An oxide scale (TGO) was formed on the bond coat, due to oxygen penetration through the ceramic layer. TGO scale has been exhibited with high magnification in Fig. 4. In addition, oxygen penetrated through open porosities of NiCrAIY layer, so oxide scales were formed within bond.

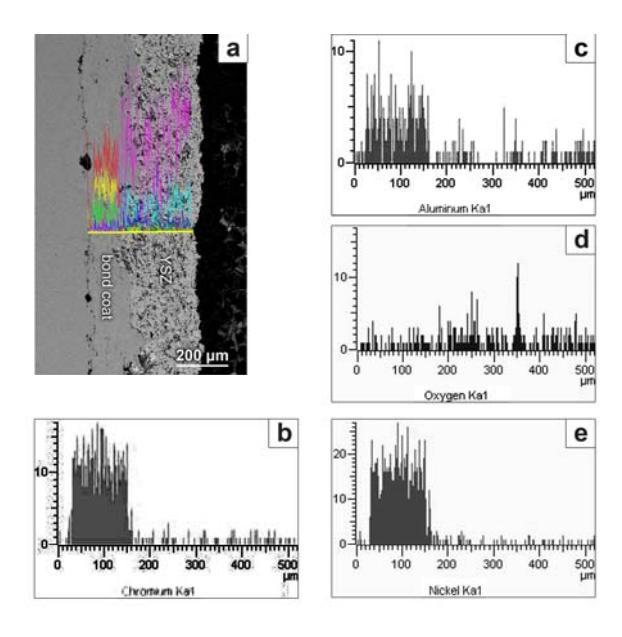
Fig. 2 Cross sectional line scan images from as-sprayed coating: (a) SEM image; (b) Cr; (c) Al; (d) O; (e) Ni line scans of (a).

Figures 2 and 3 exhibit the cross sectional line scan before and after oxidation at 1100 °C for 100 h. The comparison of the line-scanned images demonstrates the concentration and distribution of Ni and Cr have no substantial changes before and after oxidation, while the concentration of O and Al increased at the interface of bond coat/YSZ after oxidation, which indicates the presence of Al_2O_3 at the mentioned interface. In addition, the amount of Al decreased in internal zones of the bond coat.

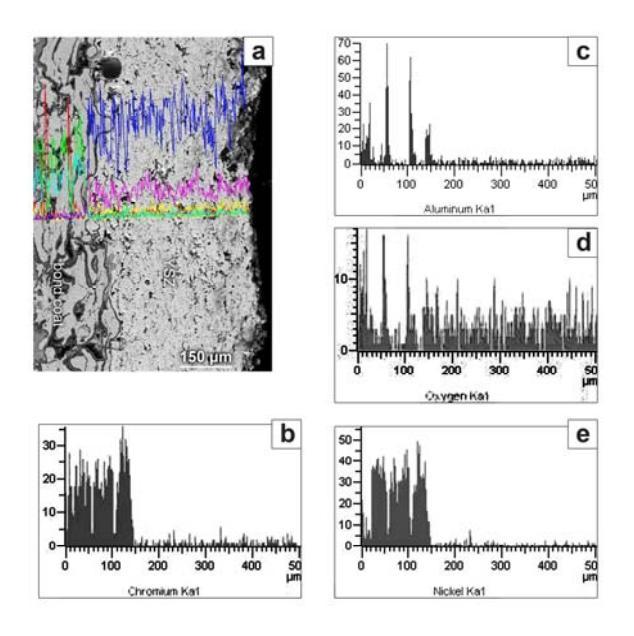
Fig. 3 Cross sectional line scan images from coating after oxidation at 1100 °C for 100 h: (a) SEM image; (b) Cr; (c) Al; (d) O; (e) Ni line scans of (a).

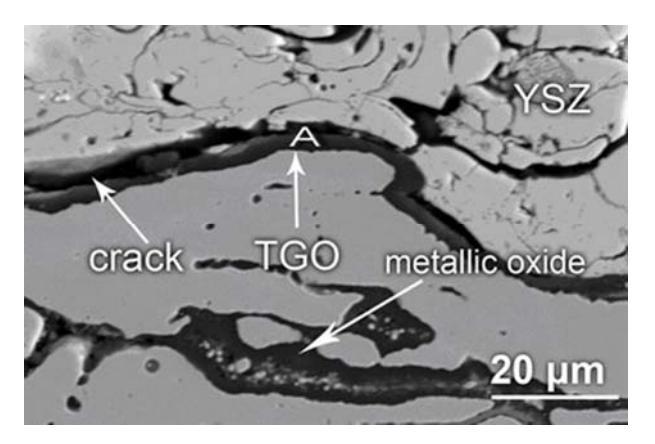
Fig. 4 Microstructure at the bond coat /YSZ interface after oxidation at 1100 °C for 100 h, showing spallation at TGO/YSZ interface.

Figure 4 shows the thermally grown oxide (TGO) after oxidation at 1100 °C. According to thermodynamic considerations, Al has high affinity for reaction with O, so Al diffusion and O penetration lead to Al_2O_3 formation at the interface of bond coat/YSZ ²²⁻²³⁾.

and Cr elements, Thus the TGO comprises mainly Al_2O_3 . As shown in Fig. 4, crack and spallation occurred at the TGO/YSZ interface due to grown oxide. As mentioned above, oxygen penetrated through interconnected porosities and the internal areas within the bond coat were oxidized. The EDS analysis from different points of these oxides showed the presence of Ni, Cr, Al and O elements. X-ray diffraction (XRD) analysis from the surface of the as-sprayed bond coat has been presented in **Fig. 6** which shows the NiAl (β) and Ni₃Al (γ [°]) phases. **Figure 7** exhibits the cross sectional micro-XRD analysis from the bond coat after oxidation

According to previous investigations, the formation of NiCr₂O₄, NiCrO₃, NiCrO₄ oxides is accompanied with rapid volume increase²⁴⁾ which generates localized stress and leads to spallation of the ceramic layer from the bond coat (Fig. 4).

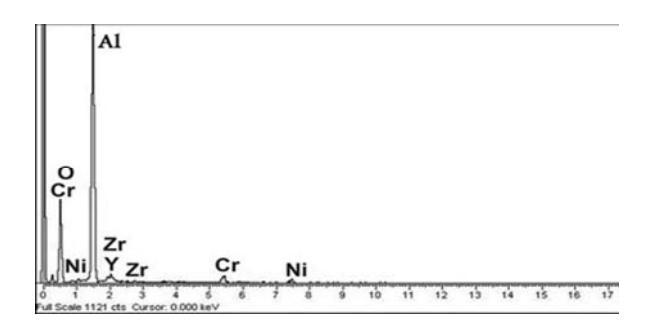
Fig. 5 EDS analysis from TGO at point A in Fig. 4.

The examination of TGO by EDS indicated the high percentage of Al and O (Fig. 5) and less amount of Ni

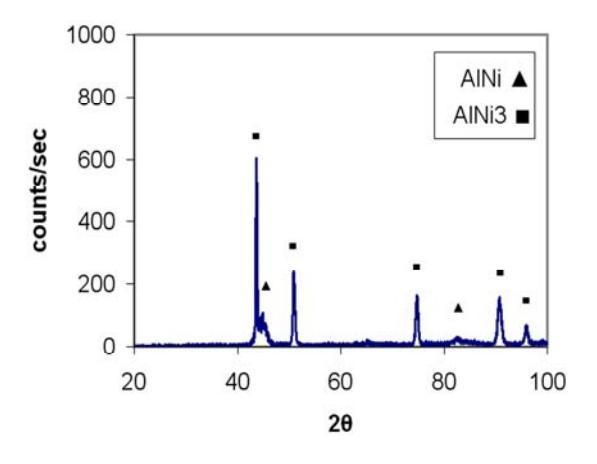
Fig. 6 XRD pattern from the surface of the as-sprayed bond coat.

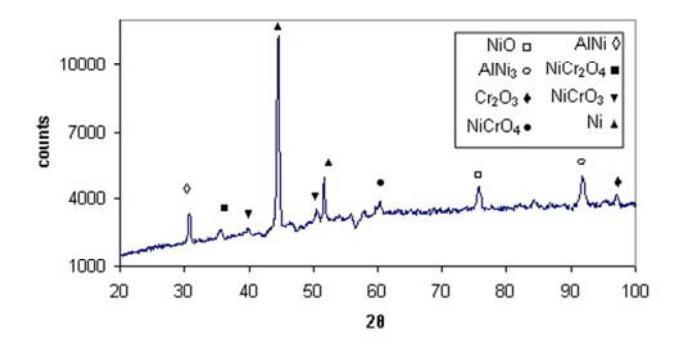
Fig. 7 Micro XRD patterns from the cross section of bond coat after oxidation at 1100 °C for 100 h.

at 1100 °C for 100 h. The oxide phases in bond coat are: $NiCr_2O_4$, $NiCrO_3$, $NiCrO_4$, Cr_2O_3 , and NiO.

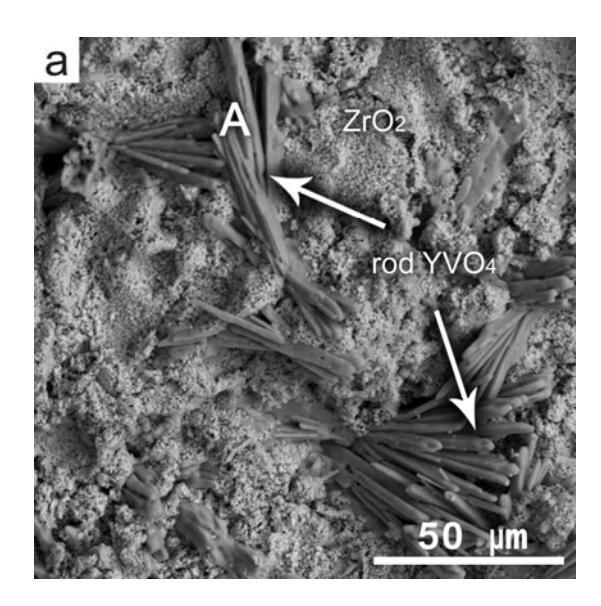
Fig. 8 SEM micrograph from YVO_4 crystals on the surface of coating after hot corrosion.

Figure 8 shows the SEM surface morphology from the coating after 40 h of hot corrosion testing. YSZ coating after hot corrosion revealed a porous surface and many rod crystals, which deposited on the surface. EDS analysis from the surface (**Fig. 9**) demonstrated that the crystals were composed of yttrium, vanadium and oxygen, and they were identified by XRD analysis to be YVO_4 .

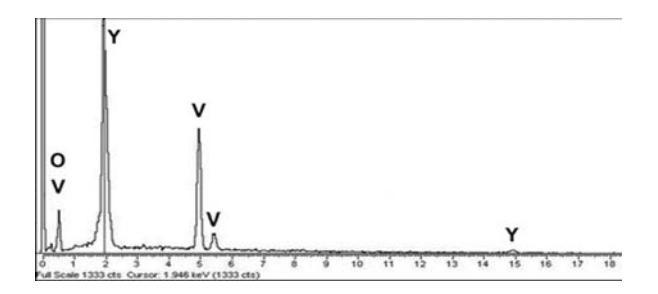
Fig. 9 EDS spectrum from rod crystals at point A in Fig. 8.

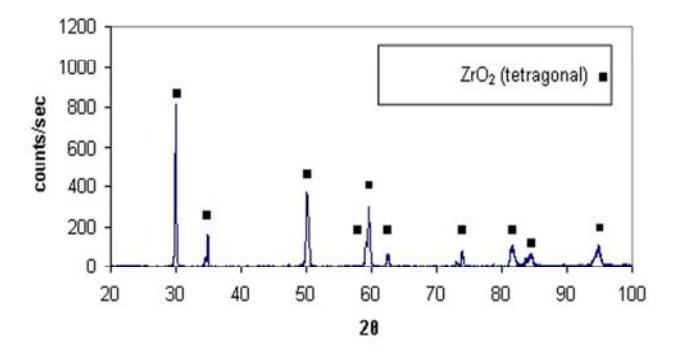
Fig. 10 XRD patterns from the surface of the as sprayed YSZ.

XRD analysis was performed on the surface of the coating before and after hot corrosion testing. **Figure 10** illustrates the XRD patterns of as sprayed YSZ. **Figure 11** shows the XRD patterns from the coating after hot corrosion testing.

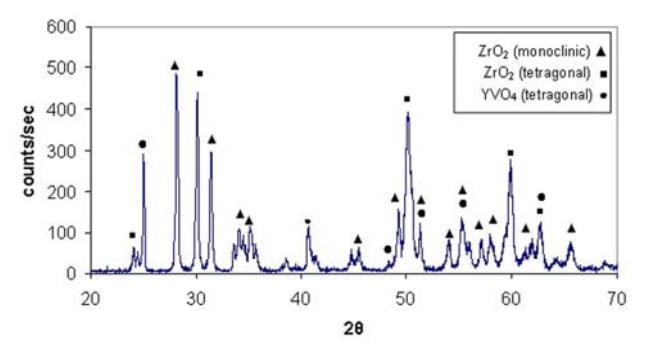
Fig. 11. XRD patterns from the surface of the YSZ coating after hot corrosion.

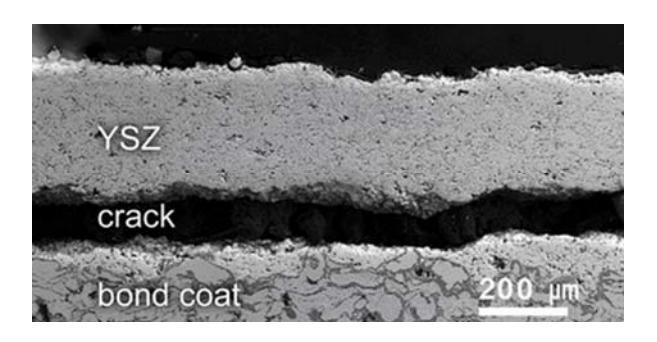
Fig. 12 SEM image showing the cross section of the coating after hot corrosion test.

Monoclinic ZrO_2 and YVO_4 were formed in the coating after exposure to molten salt at 1050 °C for 40 h. The cross section of the coating after hot corrosion testing is exhibited in **Fig. 12**. The wide crack in YSZ coating (Fig.12) is the result of formation of the monoclinic ZrO_2 and YVO_4 crystals.
