# RESEARCH AND ASSESSMENT OF LANDSLIDE ALONG HIGHWAY NO.12 IN THE NORTHWEST VIETNAM.

**Chu Van Ngoi, Luong Thi Thu Hoai**

## **Abstract**

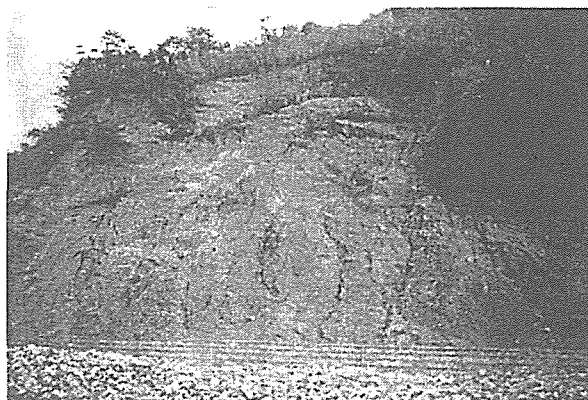
**Foto1.1.** Landslide in Huoi Leng Commune  
(350m of length, 150m of high with many terras )

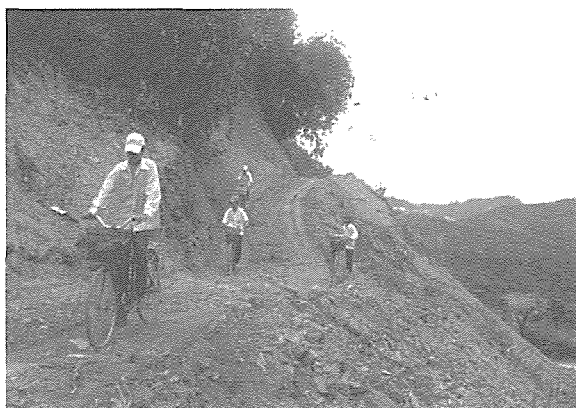
**Photo 3.1.** Picture taken in research place No.4

After straightening, the new part of highway has high and steep slope (45°). This slope composed of broken rocks, breccia and loose soil, somewhere are exposed springs. Geotechnical measures are not still applied for new slope, thus potential of landslide is very high.

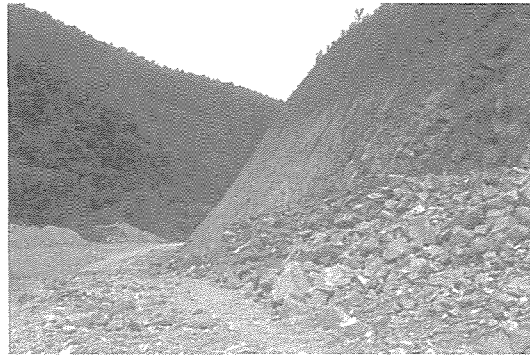
The research place belongs to the curve part located on the right of Highway from Dien Bien to Laichau. Here the curve part is straightened. The new slope composed of two parts: the first part from Highway surface to 6m of height, characterized by sediment layers compressed, broken and intensively weathered; the second one over 6m of height composed of old alluvial, weathered with red brown colour.

**Photo 3.2.** A new steep slope on the right side of Highway No.12

The steep slope consists of different lithocompositions, intensively broken rocks and loose soil, bearing high potential of landslide in rainy season. Thus this place is dangerous for transport.

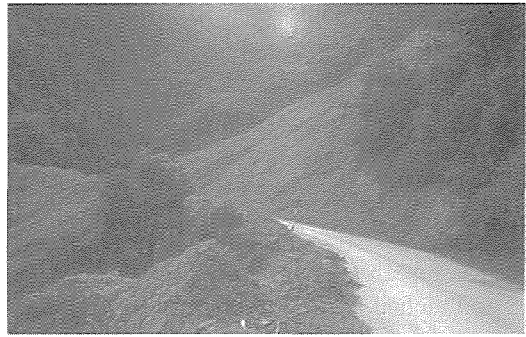
**Photo 3.6.** Major landslide block on Ma Thi Ho pass

From Dien Bien side to peak of pass slope steep is over 700, rocks presented coal bearing clayers follated and broken with exposed springs. Thus potential of landslide is very high (Photo 3.5). From peak of pass to Lai Chau, there was a big block of positive slope landslide (Photo 3.6).

Ma Thi Ho is the more dangerous place that here slope is very high and steep, highway surface is narrow with negative slope steep and deep. Besides that, the slope composed of broken, follated rocks and loose soil.

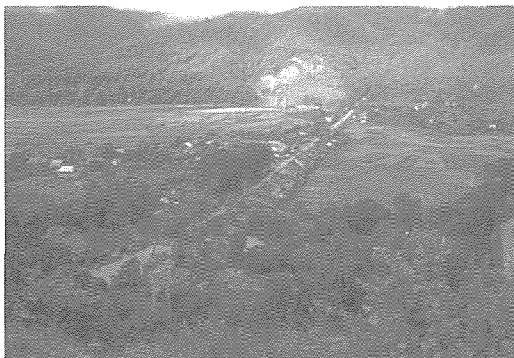
**Photo 3.7.** Landslide block on the west side of Nam Lay valley

The whole Town located in Dien Bien – Lai Chau fault zone. By cross –section from West to East relief has following feature: From bottom of valley to slope at the west side highness of relief increases and slope form has terrace structure. It is result if vertical block movement; From bottom of valley to slope at the East side, the relief is high mountains with many high and steep scarps.

In this area the geological formations were intensively deformed, sheared and broken. Here flash flooding usually was to occurrence and seriously damaged Town.

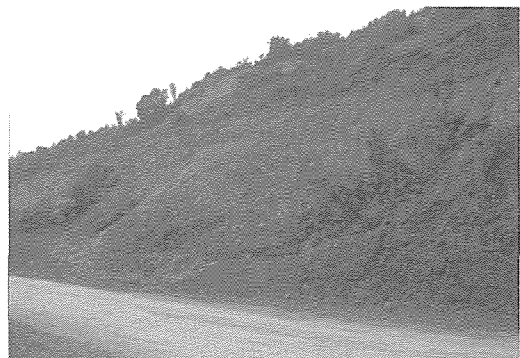
**Photo 3.8.** Landslide block composited form shattered rock
