RESEARCH AND ASSESSMENT OF LANDSLIDE ALONG HIGHWAY NO.12 IN THE NORTHWEST VIETNAM.

Chu Van Ngoi, Luong Thi Thu Hoai

Hanoi University of Science, VNU, 334 Nguyen Trai, Thanh Xuan, Hanoi

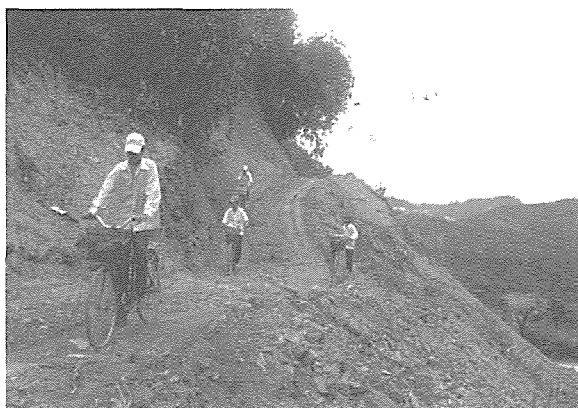
Photo 3.1. Picture taken in research place No.4

After straightening, the new part of highway has high and steep slope (45°). This slope composed of broken rocks, breccia and loose soil, somewhere are exposed springs. Geotechnic measures are not still applied for new slope, thus potential of landslide is very high.

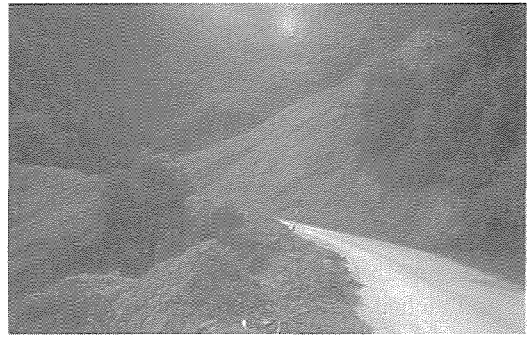
Photo 3.6. Major landslide block on Ma Thi Ho pass

From Dien Bien side to peak of pass slope steep is over 700, rocks presented coal bearing clayers follated and broken with exposed springs. Thus potential of landslide is very high (Photo 3.5). From peak of pass to Lai Chau, there was a big block of positive slope landslide (Photo 3.6).

Ma Thi Ho is the more dangerous place that here slope is very high and steep, highway surface is narrow with negative slope steep and deep. Besides that, the slope composed of broken, follated rocks and loose soil.

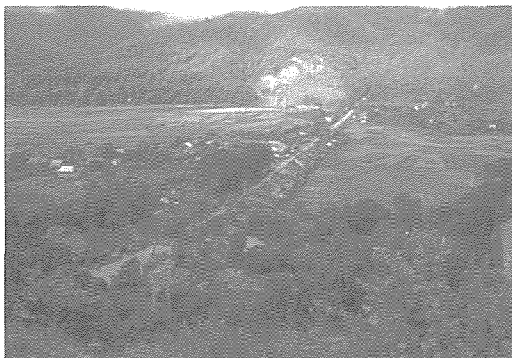
Photo 3.7. Landslide block on the west side of Nam Lay valley

The whole Town located in Dien Bien – Lai Chau fault zone. By cross –section from West to East relief has following feature: From bottom of valley to slope at the west side highness of relief increases and slope form has terrace structure. It is result if vertical block movement; From bottom of valley to slope at the East side, the relief is high mountains with many high and steep scarps.
