# RESEARCH AND ASSESSMENT OF LANDSLIDE ALONG HIGHWAY NO.12 IN THE NORTHWEST VIETNAM.

**Chu Van Nghi, Luong Thi Thu Hoai**

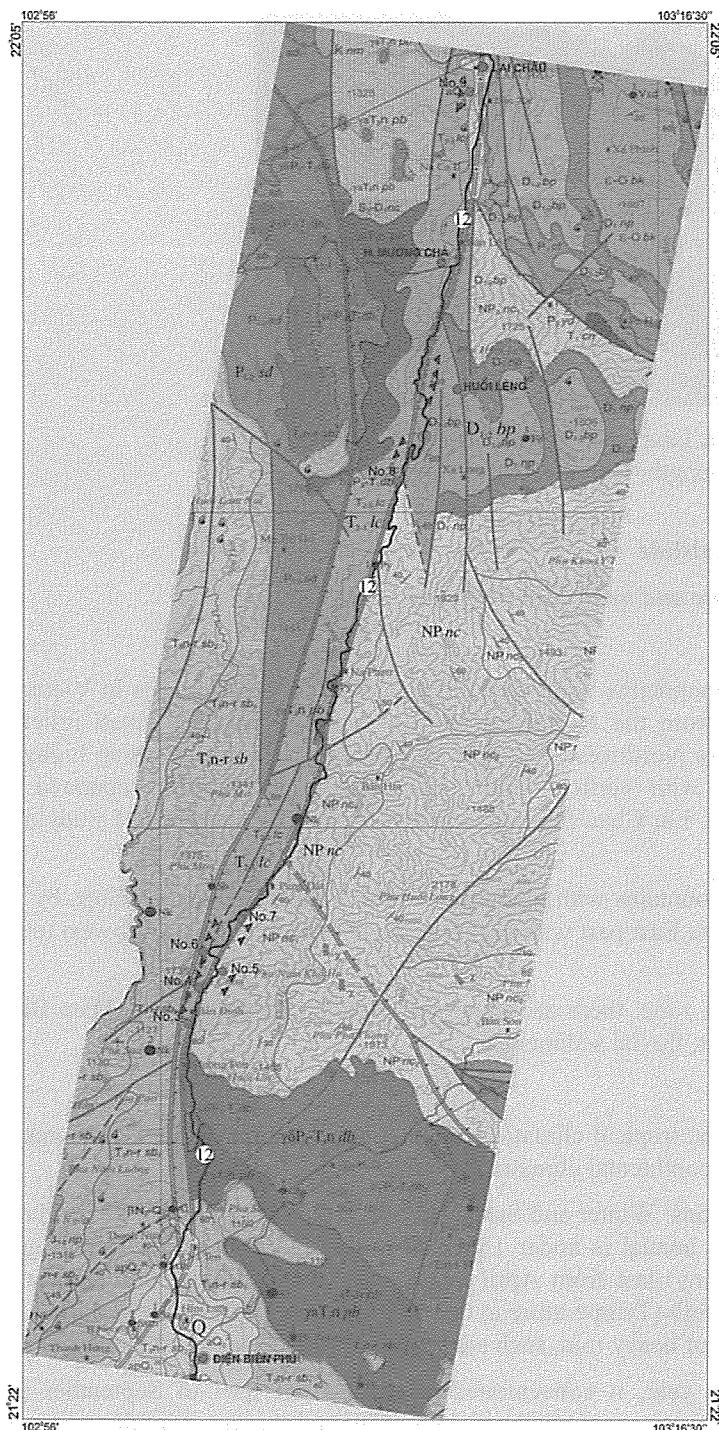
**Figure1.1.** Geological map along highway No12

On the highway, serious landslides are concentrated in some parts, such as Ma Thi Ho pass, Huoi Leng commune and Lai Chau Town (Figure 1.1), Which are black points for transport activities.

## 2.2. Geological structure a log highway No12 (Figure 1.1)

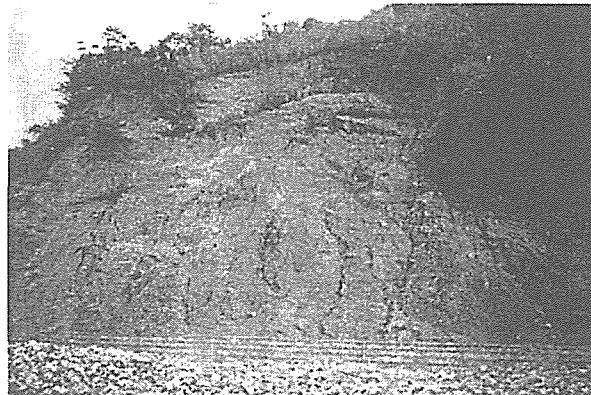
**Foto1.1.** Landslide in Huoi Leng Commune  
(350m of length, 150m of high with many terras )

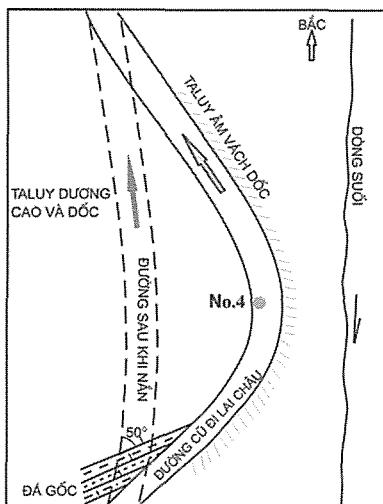
Photo 3.1. Picture taken in research place No.4

After straightening, the new part of highway has high and steep slope (450). This slope composed of broken rocks, brecia and loose soil, somewhere are exposed springs. Geotechnic measures are not still applied for new slope, thus potential of landslide is very high.

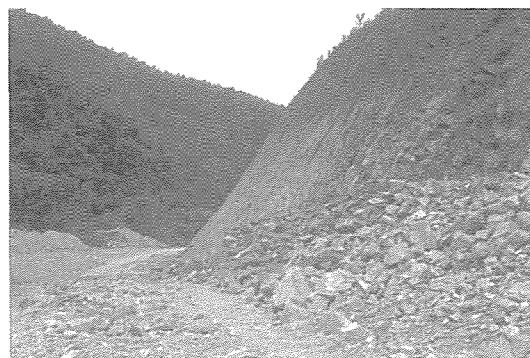
**Photo 3.2.** A new steep slope on the right side of Highway No.12

The steep slope consist of different lithocompositions, intensively broken rocks and loose soil, bearing high potential of landslide in rainy season. Thus this place is dangerous for transport.

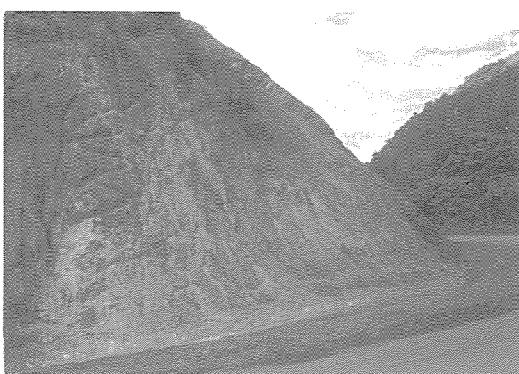
The research place is on the left of highway in the peak of MaThiHo pass. Ma Thi Ho pass characterized complexly geological structure. Geological formations (siltstone, coal beary shale) were strong compressed, they are broken, microfolded and penetrated by dykes.

**Photo 3.3.** Veins of marl cut mudstone, coal-claystone

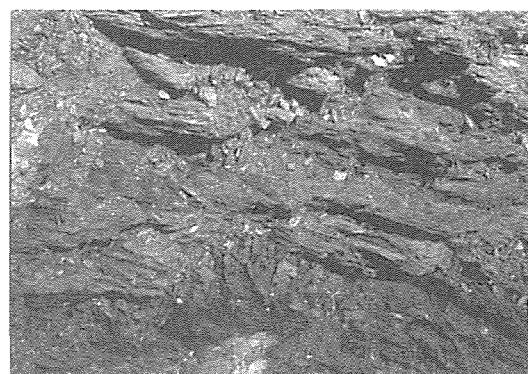
**Photo 3.4.** Folded coal-claystone of Lai Chau formation

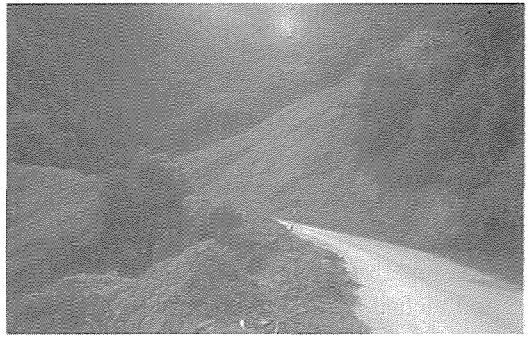
**Photo 3.6.** Major landslide block on Ma Thi Ho pass

From Dien Bien side to peak of pass slope steep is over 700, rocks presented coal bearing clayers foliated and broken with exposed springs. Thus potential of landslide is very high (Photo 3.5). From peak of pass to Lai Chau, there was a big block of positive slope landslide (Photo 3.6).

Ma Thi Ho is the more dangerous place that here slope is very high and steep, highway surface is narrow with negative slope steep and deep. Besides that, the slope composed of broken, foliated rocks and loose soil.

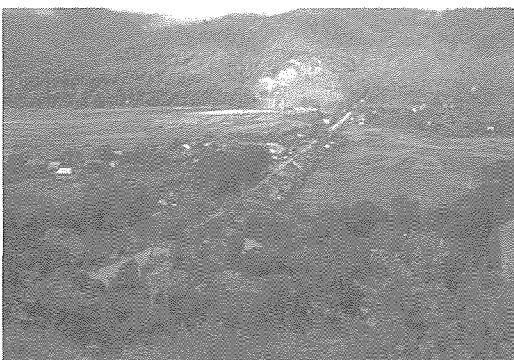
**Photo 3.7.** Landslide block on the west side of Nam Lay valley

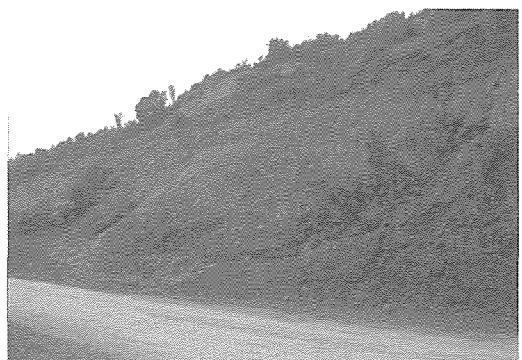
**Photo 3.8.** Landslide block composed from shattered rock

In this area the geological formations were intensively deformed, sheared and broken. Here flash flooding usually was to occurrence and seriously damaged Town.
