# **SCANNING TUNNELING MICROSCOPY OF SEMICONDUCTOR SURFACES**

by  
Ichiro TANAKA

DISSERTATION IN PHYSICS

THE OSAKA UNIVERSITY  
GRADUATE SCHOOL OF SCIENCE  
TOYONAKA, OSAKA

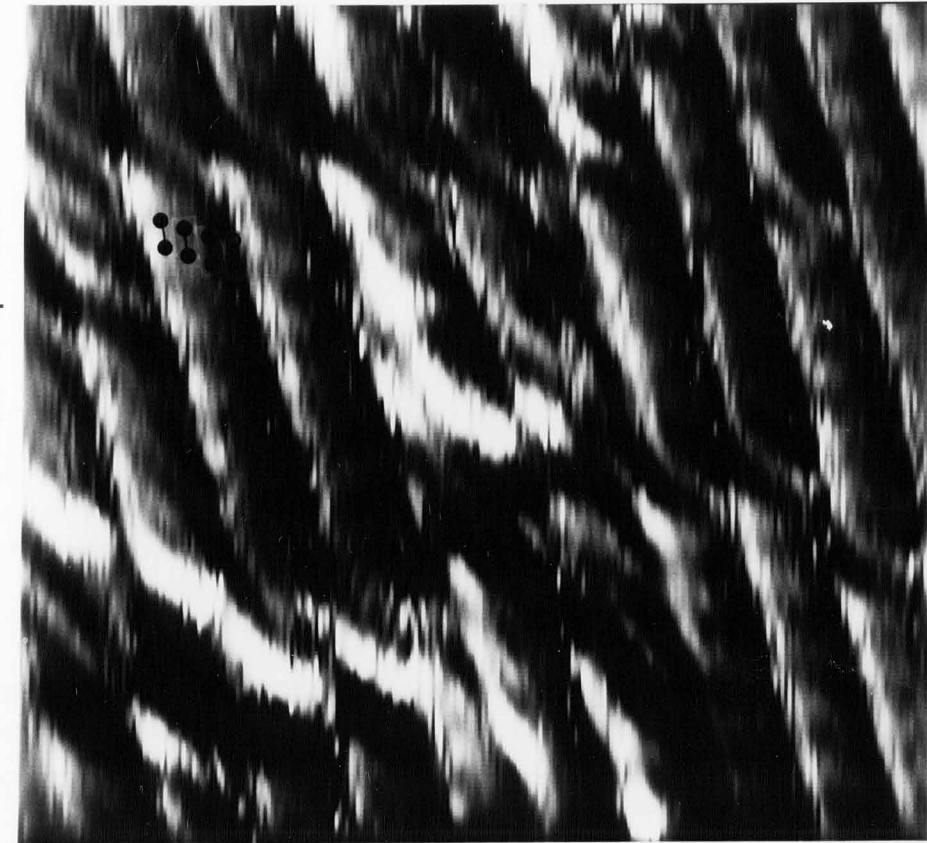
Fig. 3-5. (a) STM image and (b) ball-and-stick model of the MBE-grown GaAs (001) surface which was cooled to 570°C in the arsenic flux having 2x4 symmetry. This STM image is distorted by thermal drift.
