Frequency dependence of images in scanning laser source technique for a plate

Takahiro Hayashi, Morimasa Murase, Tsunaji Kitayama

Toyota Central R&D Labs., Inc., Nagakute, Aichi, 480-1192, Japan

Abstract

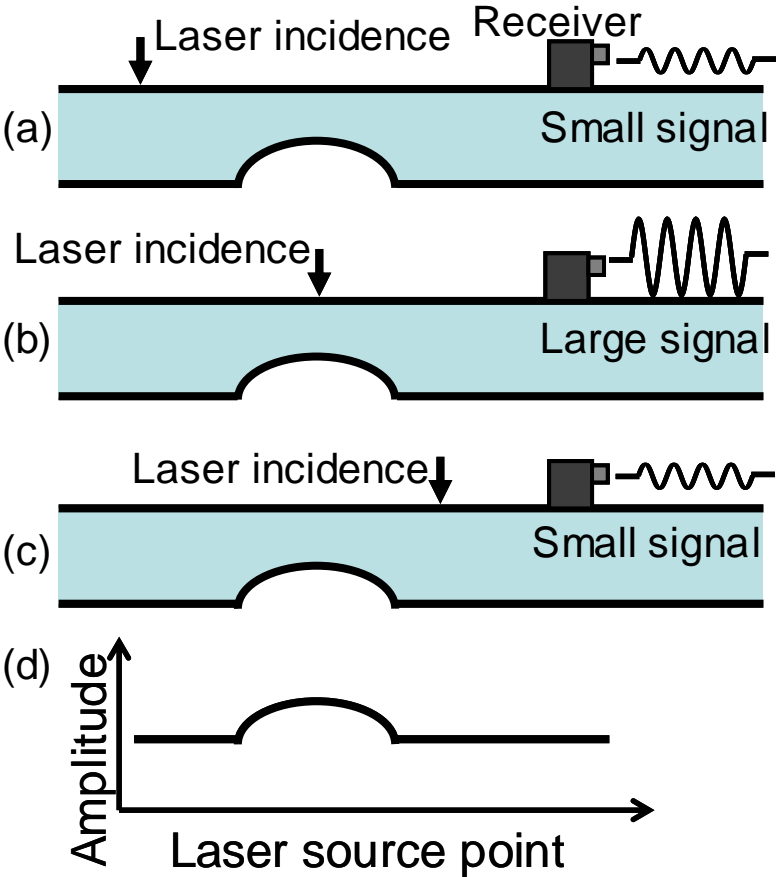
Figure 1

Schematic figures representing the relationship between location of laser incidence and amplitude of receiving signals.

Characteristics of A0 mode of Lamb waves are utilized in the defect imaging technique with the SLS for a plate. Fig.1 is a schematic figure of signals received at the fixed transducer when laser beam is emitted onto the surface of a plate with a rounded defect. Large signals are detected when the laser beam is emitted on the thin defected region (Fig.1(b)), while detected signals become small when laser beam is on the thick intact regions (Fig.1 (a), (c)). As a result, an amplitude distribution can be obtained by scanning the laser source as shown in Fig.1 (d). These phenomena appear when reflection is small at a defect, and our previous paper^[6] demonstrated that thickness distribution images can be obtained when A0 mode of Lamb waves from the SLS is detected in the low frequency region below the A1 cut-off frequency for a shallow rounded defect.

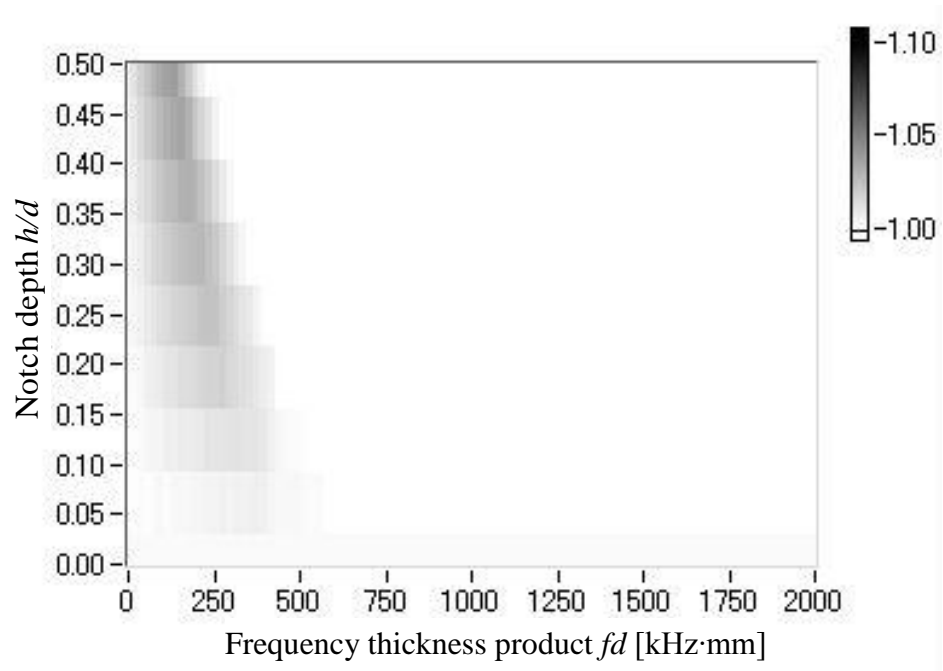
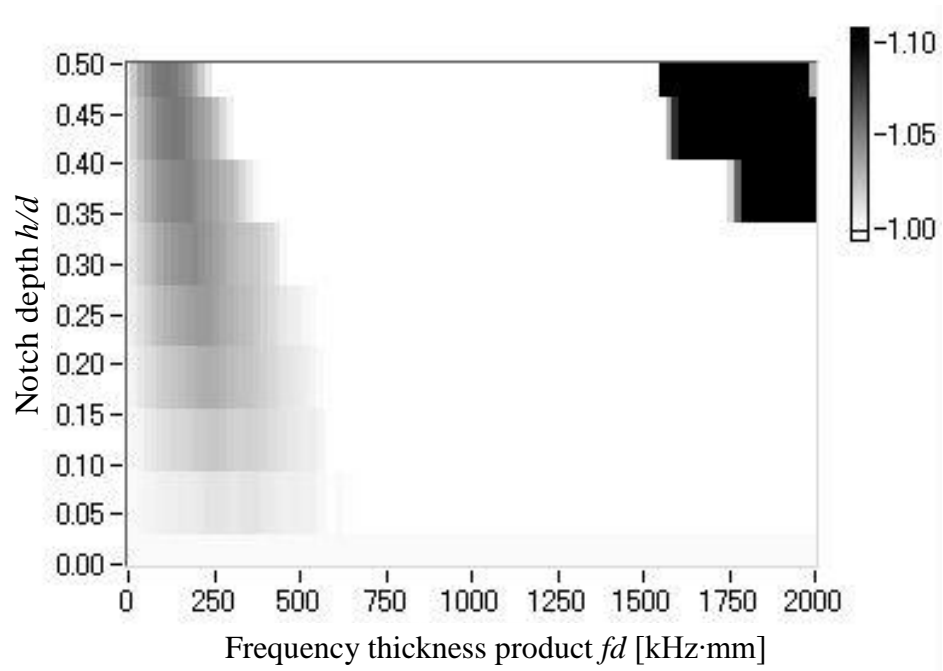
Figure 7

Frequency dependence of the imaging performance index A/B .

(a) $w/d=0.25$

(b) $w/d=0.5$

Fig.7 shows distributions of the imaging index A/B for the widths of $w/d=0.25$ and 0.5 in the graph of frequency fd versus depth h/d . The values at $h/d=0.5$ in Fig.7 (b) correspond to the amplitude distributions in Fig.5. In both figures, imaging index A/B indicates more than 1 (gray) in the low frequency range below $fd=200$ kHz·mm, which means that large amplitudes are observed inside the notch region as shown in Fig.5 (a) and (b). On the other hand, imaging index A/B is below 1 (white) in the frequency range of $fd=500$ - 1400 kHz·mm because largest amplitudes appear outside the notch region as seen in Fig.5 (c) and (d).

Very large A/B values are seen at the right upper corner of Fig.7 (b), which may be caused by resonance in the notch region. However, considering the fact that the A/B is below 1 for shallow notches $h/d < 0.35$ or for narrow notches $w/d=0.25$ (Fig.7(a)) in the frequency range of $fd > 1500$ kHz·mm, defect images are strongly affected by notch depth and width in the frequency range, which implies that this imaging technique cannot be applied to unknown defects in this high frequency range $fd > 1500$ kHz·mm.
