# Remote defect imaging for plate-like structures based on the scanning laser source technique

Takahiro Hayashi, Atsuya Maeda and Shogo Nakao

**Abstract.** In defect imaging with a scanning laser source technique, the use of a fixed receiver realizes stable measurements of flexural waves generated by laser at multiple rastering points. This study discussed the defect imaging by remote measurements using a laser Doppler vibrometer as a receiver. Narrow-band burst waves were generated by modulating laser pulse trains of a fiber laser to enhance signal to noise ratio in frequency domain. Averaging three images obtained at three different frequencies suppressed spurious distributions due to resonance. The experimental system equipped with these newly-devised means enabled us to visualize defects and adhesive objects in plate-like structures such as a plate with complex geometries and a branch pipe.

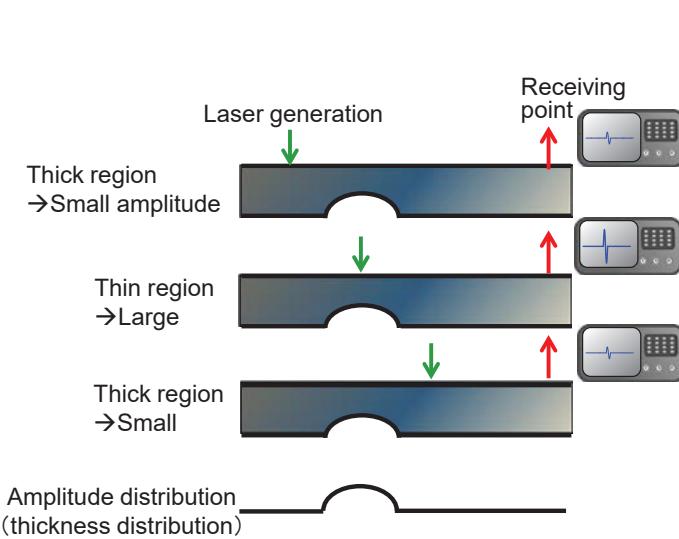
**FIGURE 1.** Principle of energy enhancement

Figure 1 shows variations of flexural waves generated by laser in a plate with a gently-sloping wall-thinning. When a laser source is located at an intact range, flexural waves generated in the plate are small and the signals detected at a certain point of the plate are also small. While for laser incidence on the defect region, flexural waves are generated larger and the signals detected at the same point also become larger. This energy variation is caused by the characteristic that flexural wave energy varies with a plate thickness at the laser source. Authors experimentally verified that images of defects in a plate can be obtained by rastering a laser source over the plate surface [5].

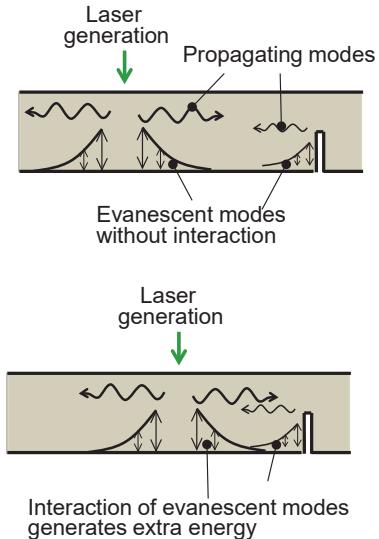
**FIGURE 2.** Evanescent modes around a notch type defect and a laser source

It was also theoretically and experimentally verified that flexural wave energy generates larger for a laser source in the vicinity of a notch type defect in a plate [7, 8]. Authors proved using a semi-analytical finite element method that the energy enhancement in the vicinity of the notch type defect is caused by the interactions of evanescent modes generated by the laser emission and reflection [7]. The evanescent modes decrease exponentially with the distance from the sources (in this case, the laser source and the notch) and the dominant distance is significantly short compared with the wavelength of the flexural propagating wave. Therefore, the energy enhancement due to the interaction of the evanescent modes occurs only when the laser source is located very close to the notch type defect. Specifically, when a laser source is rastered over a plate surface and flexural waves generated from the laser source are detected for all rastering points, the distribution of the signal amplitude corresponds to the defect image. Because the resolution of the image becomes much smaller than wavelength of the flexural wave (A0 mode of Lamb wave), we can use low frequency range of kHz order that has not been utilized in ultrasonic inspection, which enables us to use a wide variety of vibration measurement means.

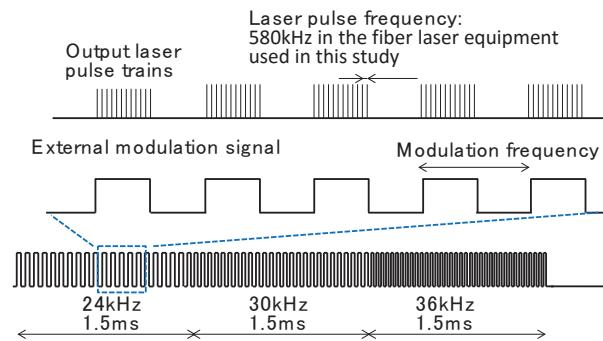
**FIGURE 3.** Modulation signal and output laser pulse trains

Figure 3 is a schematic figure of output laser pulses and modulation signals used in this study. Laser pulses were output at the repetition rate of 580 kHz modulated by the rectangular signals of 24 kHz, 30 kHz, and 36 kHz. Elastic waves containing the three frequency components were generated at each source point by the use of the modulation signals connecting these three rectangular signals in a series, as shown at the bottom of Fig. 3. After receiving the waveforms, Fourier spectra of them were taken and peaks at the three frequency bands were plotted on the 2D map, and then these images were averaged. Reference [10] described how this technique, called Frequency Image Averaging (FIA), works well to reduce spurious images caused by resonance. Modulation signals used in this study were set to 1.5 ms duration for each frequency component.

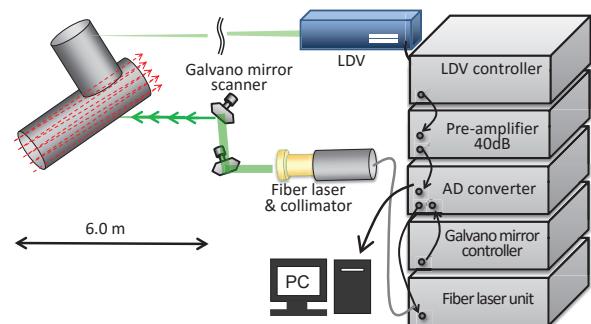
**FIGURE 4.** Experimental set-up

Figure 4 is the experimental set-up used in this study. Galvano mirror scanners moved laser beam to the rastering points and the flexural vibration generated for each laser irradiation point were detected by a laser Doppler vibrometer. The detected signals were transferred to a personal computer after being amplified at 60 dB and digitized. Then, fast Fourier transform was performed and the FFT peaks were plotted in a two dimensional map. Although the distance between the experimental system and the specimens were set to about 6.0 m due to the limitation of the laboratory space, serious problems cannot be found in longer-distance operation.

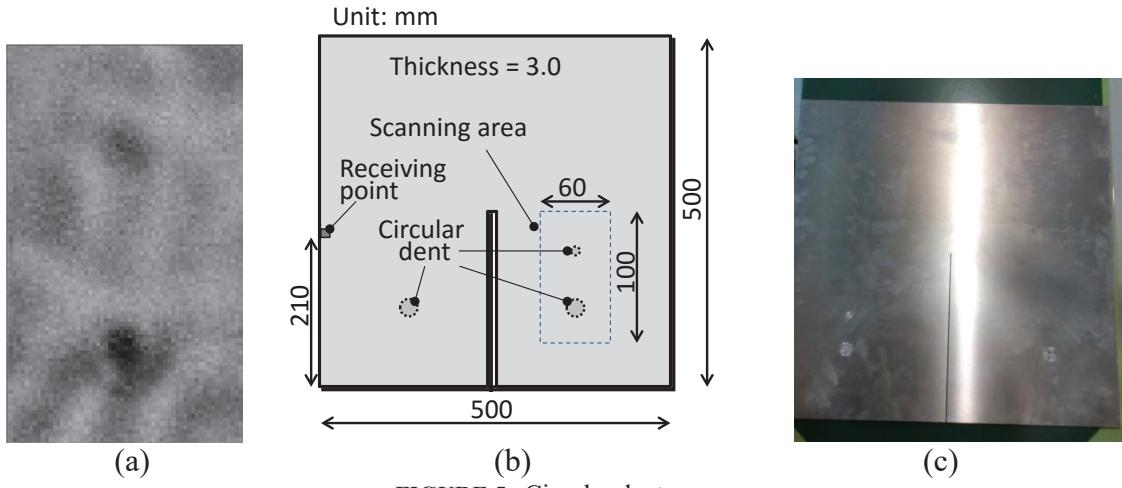
FIGURE 5. Circular dent case

Figure 5 (a) is an image obtained for the artificial circular dents in an aluminum alloy plate as shown in Fig. 5 (b) and (c). The specimen was 3.0 mm thick, having two circular dents of 1.5 mm in depth and 10 mm and 20 mm in diameter on the back surface as artificial defects. The laser for generating elastic wave was rastered over the area of 60 mm  $\times$  100 mm behind the two dents (a dashed square in Fig. 5 (b)) at 1.0 mm increment. The elastic waves were detected at the point shown in the figure. Between the elastic wave source by the laser and the detection point, a through notch was made to block the direct transmission wave in order to confirm the validities of the imaging technique even for such complex structures [8]. The dark spots appear at the appropriate positions, showing that the defect imaging is working well.

Signatures of dent, adhesives, and a wall-thinning were appropriately visualized for an aluminum plate with circular dents, a T-shaped steel plate with magnets on the back surface, and a branch pipe with an artificial wall-thinning. However, it should be noted that resonance patterns were observed at the same time.

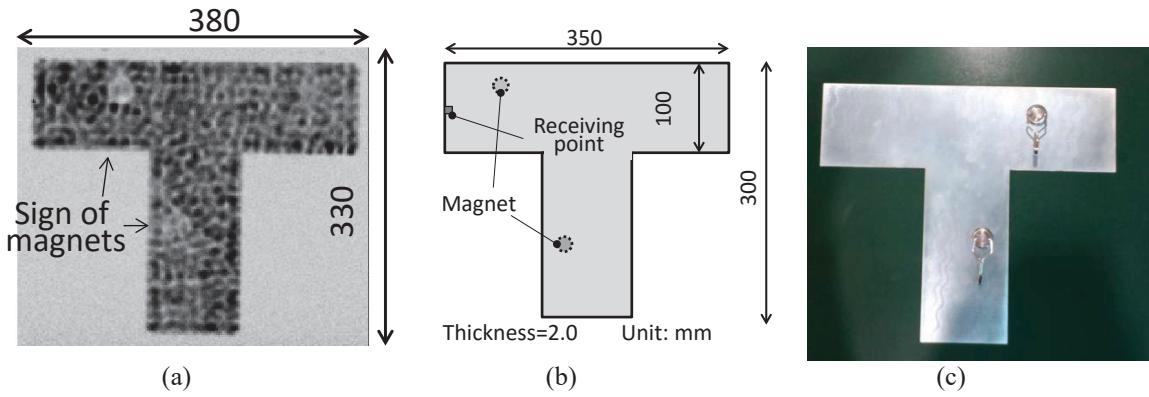
FIGURE 6. A T-shaped steel plate attached with magnets

Next, an image was obtained for a T-shaped steel plate attached with two magnets as shown in Fig. 6 (a) by the same imaging process. Figures 6 (b) and (c) are dimensions of the steel plate and a photo taken from the back surface. Laser beam for generating elastic wave was rastered at 2 mm increments over the area of 380 mm  $\times$  330 mm covering full range of the plate. Intensity becomes small at the area that the magnets adhered to, which is caused by the fact that energy of flexural vibration becomes small due to the increase of apparent bending stiffness at the magnet areas. The other patterns were caused by mixture of multiple resonance patterns. This result shows that the imaging technique has a potential to detect scales in a pipe.

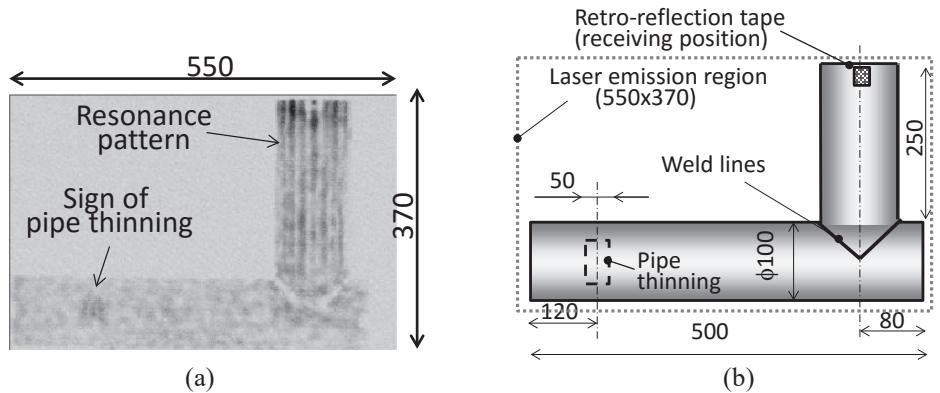
FIGURE 7. Branch pipe

The last case study shows a branch pipe with an inner wall-thinning (Fig. 7 (a)). Two aluminum pipes of 100 mm diameter and 3.0 mm thickness were welded as shown in Fig. 7 (b), and a wall-thinning of the maximum depth of 1.5 mm was made on the inner surface of the dashed rectangular line. Laser was rastered over the range of 550 mm  $\times$  370 mm at 2 mm increment, and flexural vibrations were detected at the upper edge of the branch pipe. A large intensity region can be obtained at the position of the wall-thinning, which indicates that the imaging technique performed appropriately. The striped patterns close to the receiving position also appeared clearly, which indicates resonance patterns of circumferentially propagating waves.

These results show that remote defect imaging was possible for such plate-like structures with complex geometries. However, we may need to use a'priori information such as possible defect shape and locations for more accurate defect detection because resonance patterns were sometimes largely superposed with defect images.
