Weldability of Fe-36%Ni Alloy (Report IV)[†]

— Dynamic Observation of Reheat Hot Cracking in Weld Metal by Means of Hot Stage Microscope —

Yue-Chang ZHANG*, Hiroji NAKAGAWA** and Fukuhisa MATSUDA***

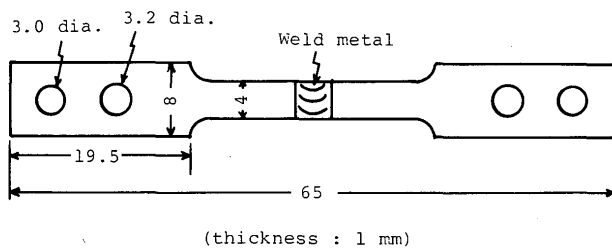
Fig. 1 Specimen configuration for hot stage microscope.

The Fe-36%Ni alloy used has the chemical composition shown in Table 1, and has 3 mm in thickness. GTA welding was done without filler metal under the following conditions with Ar back shielding; welding current of 100 A (DCEN), arc voltage of 11–13 V and welding speed of 100 mm/min. Consequently, the bead width obtained was about 5–6 mm on top and back surfaces. After the welding, the specimen was machined to the configuration shown in Fig. 1 for the observation in hot stage microscope.

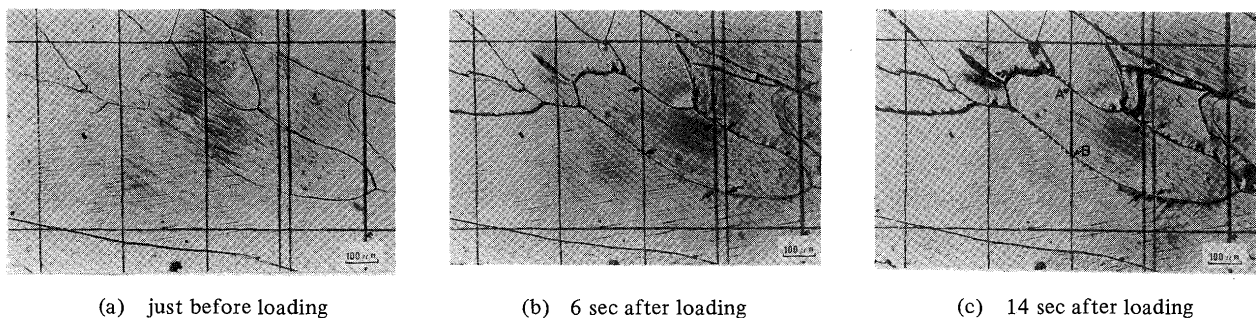
As an example of the dynamic observation, Fig. 2 shows the deformation behavior in the weld metal of the specimen tested at 850°C, where the rectangular straight lines are the scratches made to observe the grain-boundary sliding. The load was applied to the upper and the lower directions. Figure 2(a) gives the appearance just before the loading, and grain-boundaries are observed clearly together with solidification substructure. During the cooling after welding, almost all the grain-boundaries migrated a little from the original positions formed at the weld solidification. During heating before the loading, further progress of the grain-boundary migration was hardly observed. Just after the loading, grain-boundaries became clear and grain-boundary sliding started to occur at two or three grain-boundaries. Figure 2(b) gives the appearance at 6 sec after the loading, and grain-boundary sliding is shown by arrows. All the grain-boundaries in Fig. 2(b) is clear than those in Fig. 2(a), which means that strain was concentrated to the grain-boundaries. Also grain-boundary migration and folding due to the strain concentration within grain by grain-boundary sliding are

Fig. 2 Dynamic observation of deformation behavior prior to cracking at 850°C (arrows show grain-boundary sliding).

observed. At 14 sec after the loading, in Fig. 2(c), the grain-boundary sliding, the strain concentration to the grain-boundaries, the folding and the grain-boundary migration became noticeable. Also slip bands are observed partly. The detailed appearance around marks A and B in Fig. 2(c) is magnified in Fig. 3. After such gradual progress of the grain-boundary sliding, cracks occurred.

Similar phenomena were observed in the specimen of testing temperature 880, 800 and 700°C, though the maximum distance of grain-boundary sliding had a tendency to decrease together with the drop of the testing temperature.

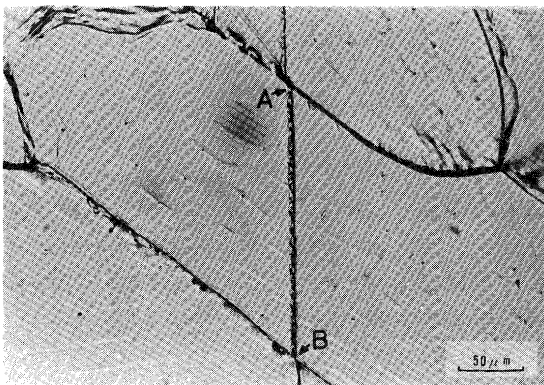
Fig. 3 Magnified view of A and B parts in Fig. 2 (c).

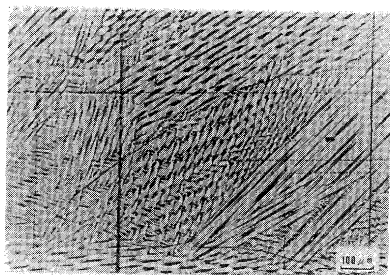
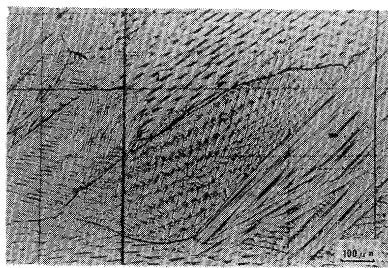
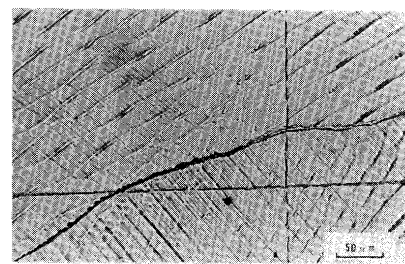
(a) just before loading.

(b) 20 sec after loading.

(c) magnified view of upper parts in (b).

Fig. 4 Dynamic observation of deformation behavior at 600°C.

Dynamic observation for the specimen tested at 600°C is shown in Fig. 4. Many slip bands and strain concentration to grain-boundaries were observed well, and they developed a little together with the time lapse, but grain-boundary sliding was hardly observed. Consequently, no cracking was observed. Also grain-boundary migration was hardly observed.

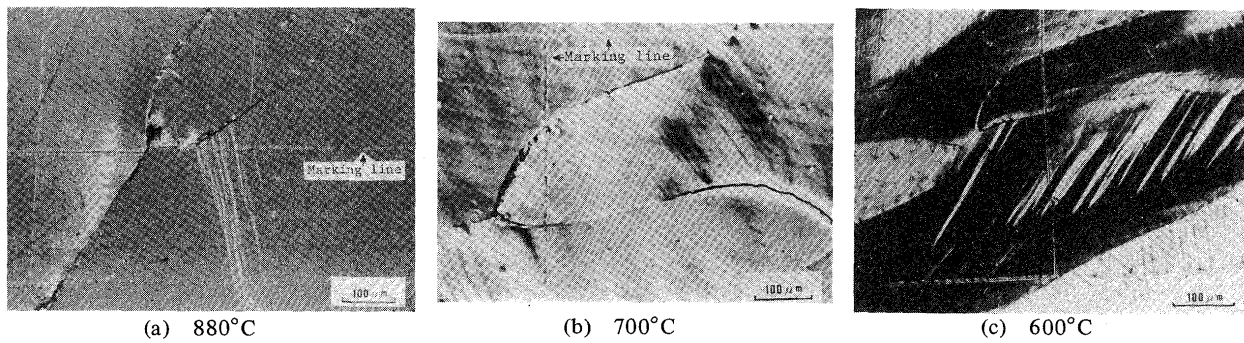
Fig. 5 Comparison of slip bands among different temperature, photographed by Nomarski differential interference microscope.

As well known, if grain-boundary sliding is related to hot ductility, the ratio of the displacement of grain-boundary sliding to total strain or strain within grains is very important. As already mentioned in 3.1, the grain-boundary sliding had a tendency to decrease together with the drop of the testing temperature. Conventional optical microscope, however, is not sensitive enough to distinguish the small difference in slip bands within grains. Figures 5(a), (b) and (c), photographed by Nomarski differential interference microscope, show the clear difference of slip bands among the specimens tested 880, 700 and 600°C respectively. Thus it is well understood that the degree of slip bands, namely the strain within grains increased together with the drop of the testing temperature.

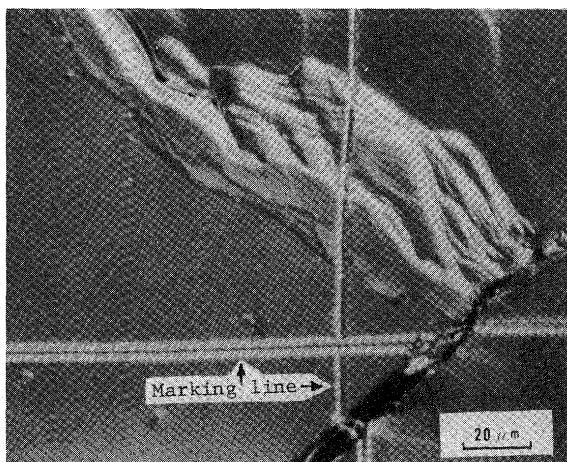
Fig. 6 Effect of grain-boundary migration on grain-boundary sliding.

It seemed noticeable in this study that not only grain-boundary sliding but also grain-boundary migration were significant factors relating the ductility trough, although of course they have opposite effects. Namely, any crack was not observed at the grain-boundaries which were active in the grain-boundary migration. This can be explained by the fact that there was little grain-boundary sliding at such grain-boundary as shown in Fig. 6. The number of grain-boundaries which migrated during the loading increased together with the rise of the testing temperature, the tendency of which is nearly the same as that in the hot ductility test shown in the next paper⁸⁾. Furthermore, the migrating distance was comparatively large in the specimens tested at 850 and 880°C.

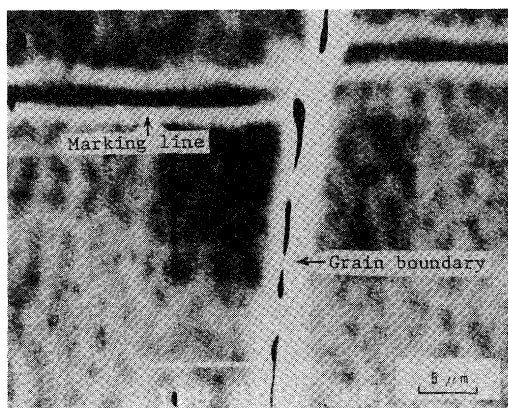
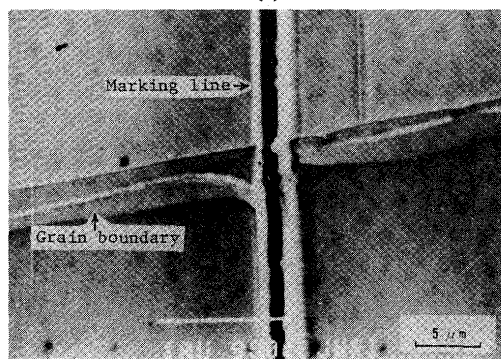
Figure 7 shows examples of grain boundaries observed on the surface of specimen. In Fig. 7(a) cavities are formed at the grain-boundary where grain-boundary sliding occurred. In Fig. 7(b), however, neither grain-boundary sliding nor cavity is seen. In the specimen tested at 600°C, only small cavities were observed accompanied by very

Fig. 7 Correlation between grain-boundary sliding and cavity formation at grain-boundary.

The results in Figs. 7 and 8 confirm that the grain-boundary sliding and its resultant cavity formation and coalescence take part in the ductility trough. Therefore, it is supposed that the sliding displacement at the grain-boundary making cavities, S_{gbc} , reflects the characteristic of temperature dependency of the hot ductility. Table 2 shows the results measured, and means that S_{gbc} had the minimum value at 800°C. The minimum ductility of the same material evaluated by the hot ductility test in the previous paper¹⁾ occurred at about 800–900°C. Both agree nearly with each other, but the difference is considered to be due to very slow strain rate in this study, judging the dependency of Zener-Hollomon parameter¹⁰⁾ on strain rate.

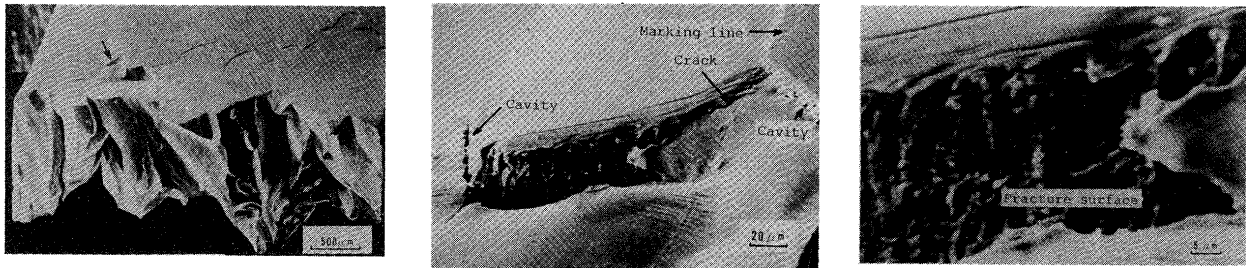
(a) low magnification.

(b) magnified view of arrow part in (a).

(c) magnified view of cracked surface in (b).

Fig. 8 Correlation between grain-boundary sliding or step, cavities and microcrack.

small displacement of grain-boundary sliding on very rare occasions. Then, the specimen tilted by about 45 degree was observed by SEM to study both the specimen surface and cracked or fractured surface simultaneously, and the examples are shown in Fig. 8. General view in (a) shows that many small steps corresponding to grain-boundary sliding were formed. Its arrow part is magnified in (b), and means that cavities were formed at low steps, and crack was formed at high step. The cracked surface in (b) is magnified in (c), and it is noticed that the unit size of unevenness on the wavy cracked surface was similar to the size of cavities shown in Fig. 7(a). This problem will be discussed in detail in the next paper⁹⁾.
