Weldability of Fe-36%Ni Alloy (Report IV)[†]

— Dynamic Observation of Reheat Hot Cracking in Weld Metal by Means of Hot Stage Microscope —

Yue-Chang ZHANG*, Hiroji NAKAGAWA** and Fukuhisa MATSUDA***

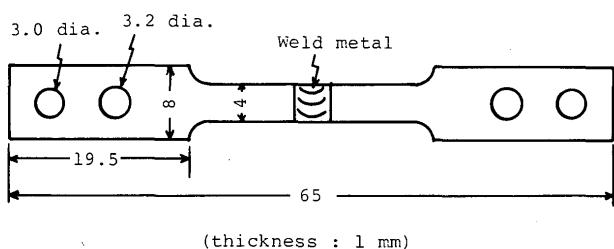
Fig. 1 Specimen configuration for hot stage microscope.

The Fe-36%Ni alloy used has the chemical composition shown in Table 1, and has 3 mm in thickness. GTA welding was done without filler metal under the following conditions with Ar back shielding; welding current of 100A (DCEN), arc voltage of 11–13V and welding speed of 100 mm/min. Consequently, the bead width obtained was about 5–6 mm on top and back surfaces. After the welding, the specimen was machined to the configuration shown in Fig. 1 for the observation in hot stage microscope.

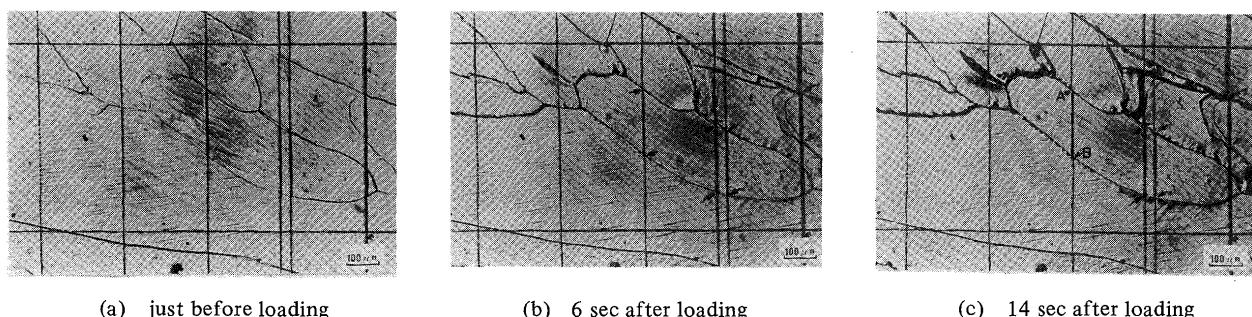
As an example of the dynamic observation, Fig. 2 shows the deformation behavior in the weld metal of the specimen tested at 850°C, where the rectangular straight lines are the scratches made to observe the grain-boundary sliding. The load was applied to the upper and the lower directions. Figure 2(a) gives the appearance just before the loading, and grain-boundaries are observed clearly together with solidification substructure. During the cooling after welding, almost all the grain-boundaries migrated a little from the original positions formed at the weld solidification. During heating before the loading, further progress of the grain-boundary migration was hardly observed. Just after the loading, grain-boundaries became clear and grain-boundary sliding started to occur at two or three grain-boundaries. Figure 2(b) gives the appearance at 6 sec after the loading, and grain-boundary sliding is shown by arrows. All the grain-boundaries in Fig. 2(b) is clear than those in Fig. 2(a), which means that strain was concentrated to the grain-boundaries. Also grain-boundary migration and folding due to the strain concentration within grain by grain-boundary sliding are

Fig. 2 Dynamic observation of deformation behavior prior to cracking at 850°C
(arrows show grain-boundary sliding).

observed. At 14 sec after the loading, in Fig. 2(c), the grain-boundary sliding, the strain concentration to the grain-boundaries, the folding and the grain-boundary migration became noticeable. Also slip bands are observed partly. The detailed appearance around marks A and B in Fig. 2(c) is magnified in Fig. 3. After such gradual progress of the grain-boundary sliding, cracks occurred.

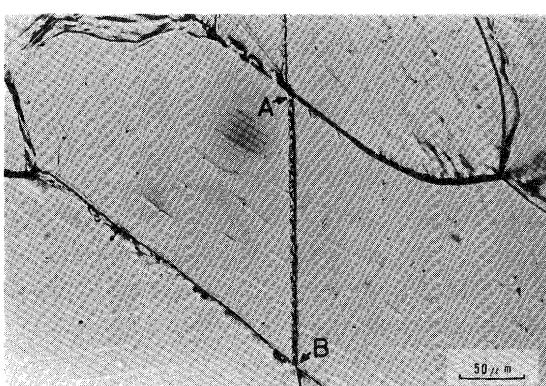
Fig. 3 Magnified view of A and B parts in Fig. 2 (c).

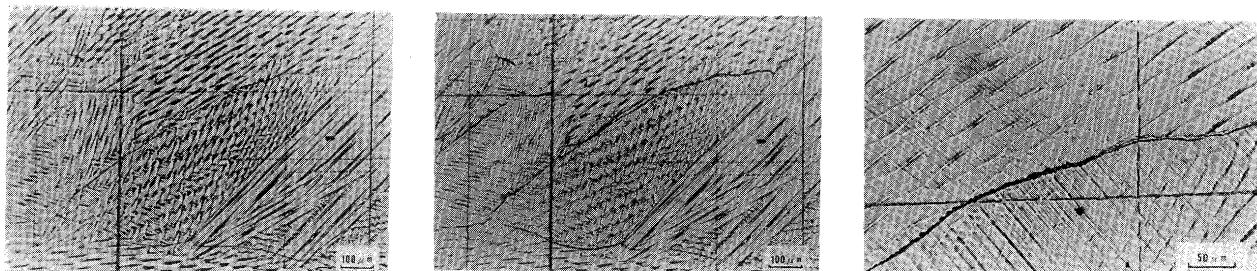
Dynamic observation for the specimen tested at 600°C is shown in Fig. 4. Many slip bands and strain concentration to grain-boundaries were observed well, and they developed a little together with the time lapse, but grain-boundary sliding was hardly observed. Consequently, no cracking was observed. Also grain-boundary migration was hardly observed.

Fig. 4 Dynamic observation of deformation behavior at 600°C.

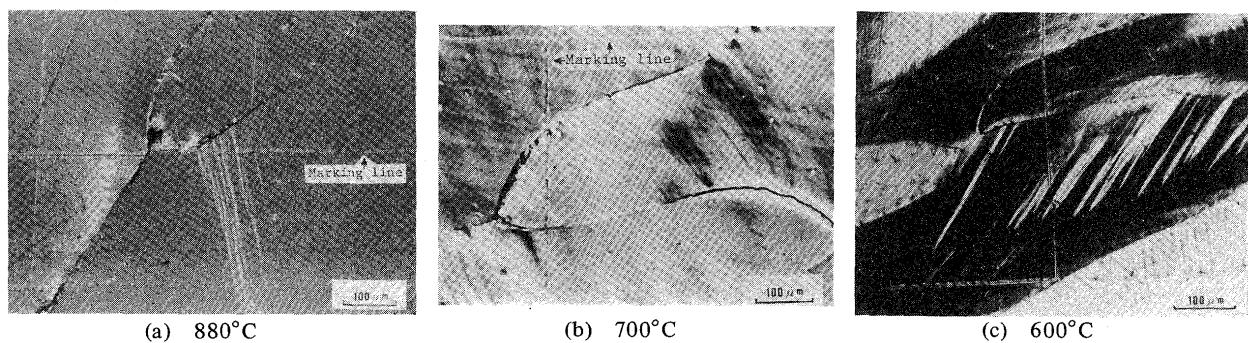
Fig. 5 Comparison of slip bands among different temperature, photographed by Nomarski differential interference microscope.

As well known, if grain-boundary sliding is related to hot ductility, the ratio of the displacement of grain-boundary sliding to total strain or strain within grains is very important. As already mentioned in 3.1, the grain-boundary sliding had a tendency to decrease together with the drop of the testing temperature. Conventional optical microscope, however, is not sensitive enough to distinguish the small difference in slip bands within grains. Figures 5(a), (b) and (c), photographed by Nomarski differential interference microscope, show the clear difference of slip bands among the specimens tested 880, 700 and 600°C respectively. Thus it is well understood that the degree of slip bands, namely the strain within grains increased together with the drop of the testing temperature.

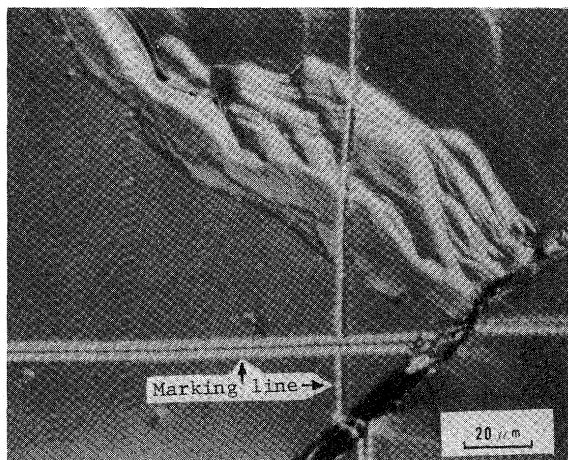
Fig. 6 Effect of grain-boundary migration on grain-boundary sliding.

It seemed noticeable in this study that not only grain-boundary sliding but also grain-boundary migration were significant factors relating the ductility trough, although of course they have opposite effects. Namely, any crack was not observed at the grain-boundaries which were active in the grain-boundary migration. This can be explained by the fact that there was little grain-boundary sliding at such grain-boundary as shown in Fig. 6. The number of grain-boundaries which migrated during the loading increased together with the rise of the testing temperature, the tendency of which is nearly the same as that in the hot ductility test shown in the next paper⁸⁾. Furthermore, the migrating distance was comparatively large in the specimens tested at 850 and 880°C.

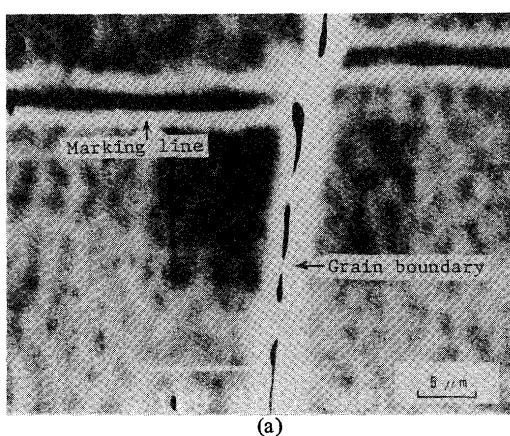
Figure 7 shows examples of grain boundaries observed on the surface of specimen. In Fig. 7(a) cavities are formed at the grain-boundary where grain-boundary sliding occurred. In Fig. 7(b), however, neither grain-boundary sliding nor cavity is seen. In the specimen tested at 600°C, only small cavities were observed accompanied by very

Fig. 7 Correlation between grain-boundary sliding and cavity formation at grain-boundary.

The results in Figs. 7 and 8 confirm that the grain-boundary sliding and its resultant cavity formation and coalescence take part in the ductility trough. Therefore, it is supposed that the sliding displacement at the grain-boundary making cavities, S_{gbc} , reflects the characteristic of temperature dependency of the hot ductility. Table 2 shows the results measured, and means that S_{gbc} had the minimum value at 800°C. The minimum ductility of the same material evaluated by the hot ductility test in the previous paper¹⁾ occurred at about 800–900°C. Both agree nearly with each other, but the difference is considered to be due to very slow strain rate in this study, judging the dependency of Zener-Hollomon parameter¹⁰ on strain rate.

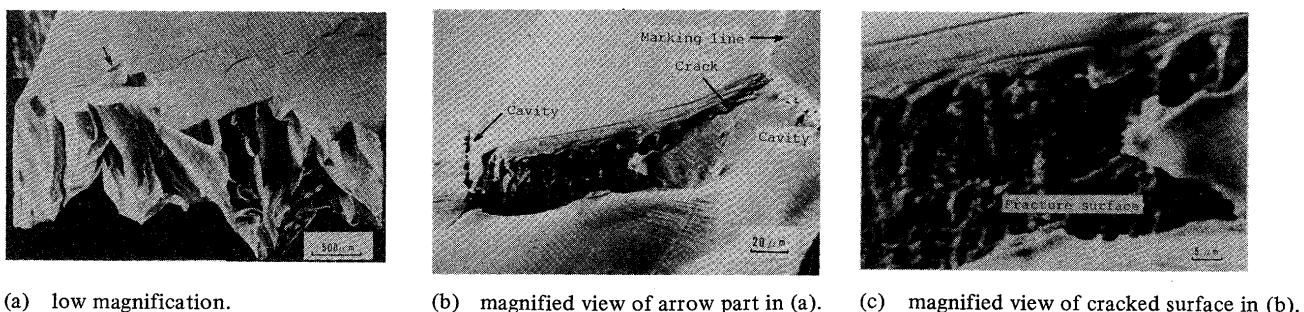
small displacement of grain-boundary sliding on very rare occasions. Then, the specimen tilted by about 45 degree was observed by SEM to study both the specimen surface and cracked or fractured surface simultaneously, and the examples are shown in Fig. 8. General view in (a) shows that many small steps corresponding to grain-boundary sliding were formed. Its arrow part is magnified in (b), and means that cavities were formed at low steps, and crack was formed at high step. The cracked surface in (b) is magnified in (c), and it is noticed that the unit size of unevenness on the wavy cracked surface was similar to the size of cavities shown in Fig. 7(a). This problem will be discussed in detail in the next paper⁹.

(a) low magnification. (b) magnified view of arrow part in (a). (c) magnified view of cracked surface in (b).

Fig. 8 Correlation between grain-boundary sliding or step, cavities and microcrack.
