Weldability of Fe-36%Ni Alloy (Report IV)[†]

— Dynamic Observation of Reheat Hot Cracking in Weld Metal by Means of Hot Stage Microscope —

Yue-Chang ZHANG*, Hiroji NAKAGAWA** and Fukuhisa MATSUDA***

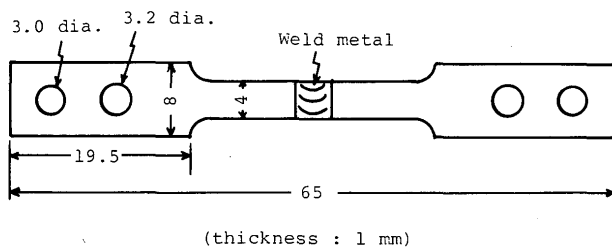
Fig. 1 Specimen configuration for hot stage microscope.

The Fe-36%Ni alloy used has the chemical composition shown in Table 1, and has 3 mm in thickness. GTA welding was done without filler metal under the following conditions with Ar back shielding; welding current of 100 A (DCEN), arc voltage of 11–13 V and welding speed of 100 mm/min. Consequently, the bead width obtained was about 5–6 mm on top and back surfaces. After the welding, the specimen was machined to the configuration shown in Fig. 1 for the observation in hot stage microscope.

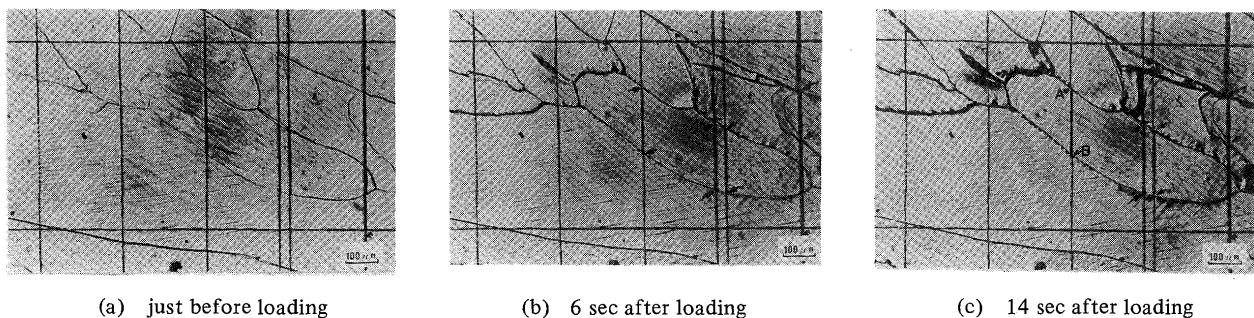
As an example of the dynamic observation, Fig. 2 shows the deformation behavior in the weld metal of the specimen tested at 850°C, where the rectangular straight lines are the scratches made to observe the grain-boundary sliding. The load was applied to the upper and the lower directions. Figure 2(a) gives the appearance just before the loading, and grain-boundaries are observed clearly together with solidification substructure. During the cooling after welding, almost all the grain-boundaries migrated a little from the original positions formed at the weld solidification. During heating before the loading, further progress of the grain-boundary migration was hardly observed. Just after the loading, grain-boundaries became clear and grain-boundary sliding started to occur at two or three grain-boundaries. Figure 2(b) gives the appearance at 6 sec after the loading, and grain-boundary sliding is shown by arrows. All the grain-boundaries in Fig. 2(b) is clear than those in Fig. 2(a), which means that strain was concentrated to the grain-boundaries. Also grain-boundary migration and folding due to the strain concentration within grain by grain-boundary sliding are

Fig. 2 Dynamic observation of deformation behavior prior to cracking at 850°C (arrows show grain-boundary sliding).

observed. At 14 sec after the loading, in Fig. 2(c), the grain-boundary sliding, the strain concentration to the grain-boundaries, the folding and the grain-boundary migration became noticeable. Also slip bands are observed partly. The detailed appearance around marks A and B in Fig. 2(c) is magnified in Fig. 3. After such gradual progress of the grain-boundary sliding, cracks occurred.

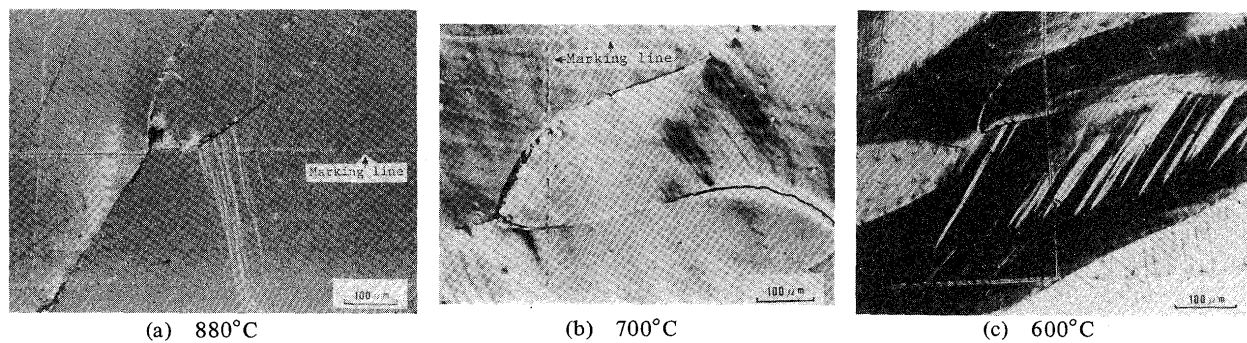
Fig. 5 Comparison of slip bands among different temperature, photographed by Nomarski differential interference microscope.

As well known, if grain-boundary sliding is related to hot ductility, the ratio of the displacement of grain-boundary sliding to total strain or strain within grains is very important. As already mentioned in 3.1, the grain-boundary sliding had a tendency to decrease together with the drop of the testing temperature. Conventional optical microscope, however, is not sensitive enough to distinguish the small difference in slip bands within grains. Figures 5(a), (b) and (c), photographed by Nomarski differential interference microscope, show the clear difference of slip bands among the specimens tested 880, 700 and 600°C respectively. Thus it is well understood that the degree of slip bands, namely the strain within grains increased together with the drop of the testing temperature.

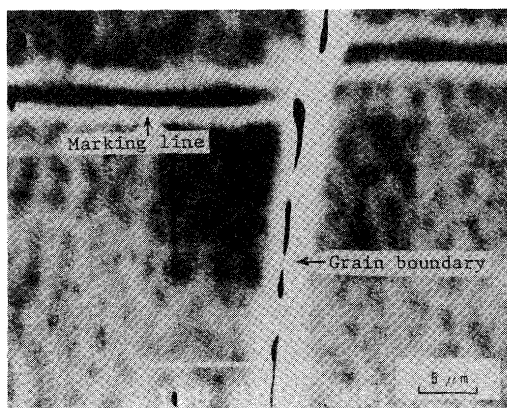
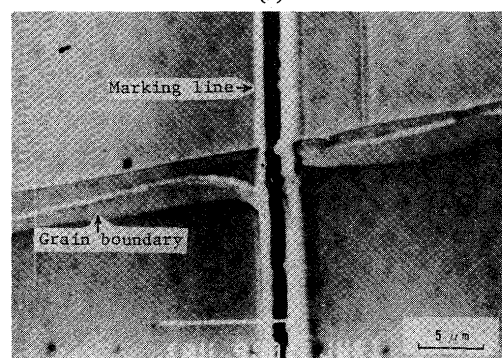
Figure 7 shows examples of grain boundaries observed on the surface of specimen. In Fig. 7(a) cavities are formed at the grain-boundary where grain-boundary sliding occurred. In Fig. 7(b), however, neither grain-boundary sliding nor cavity is seen. In the specimen tested at 600°C, only small cavities were observed accompanied by very

Fig. 7 Correlation between grain-boundary sliding and cavity formation at grain-boundary.

The results in Figs. 7 and 8 confirm that the grain-boundary sliding and its resultant cavity formation and coalescence take part in the ductility trough. Therefore, it is supposed that the sliding displacement at the grain-boundary making cavities, S_{gbc} , reflects the characteristic of temperature dependency of the hot ductility. Table 2 shows the results measured, and means that S_{gbc} had the minimum value at 800°C. The minimum ductility of the same material evaluated by the hot ductility test in the previous paper¹⁾ occurred at about 800–900°C. Both agree nearly with each other, but the difference is considered to be due to very slow strain rate in this study, judging the dependency of Zener-Hollomon parameter¹⁰⁾ on strain rate.

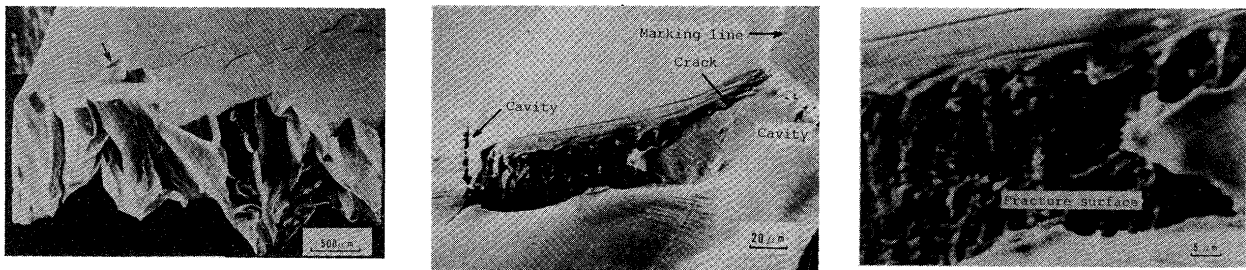
small displacement of grain-boundary sliding on very rare occasions. Then, the specimen tilted by about 45 degree was observed by SEM to study both the specimen surface and cracked or fractured surface simultaneously, and the examples are shown in Fig. 8. General view in (a) shows that many small steps corresponding to grain-boundary sliding were formed. Its arrow part is magnified in (b), and means that cavities were formed at low steps, and crack was formed at high step. The cracked surface in (b) is magnified in (c), and it is noticed that the unit size of unevenness on the wavy cracked surface was similar to the size of cavities shown in Fig. 7(a). This problem will be discussed in detail in the next paper⁹⁾.

(a) low magnification.

(b) magnified view of arrow part in (a).

(c) magnified view of cracked surface in (b).

Fig. 8 Correlation between grain-boundary sliding or step, cavities and microcrack.
