# On the Fillet Weld Cracking of 50 kg/mm<sup>2</sup> Grade High Strength Steels<sup>†</sup>

## —On the Heel-Crack—

Hiroshi KIHARA\*, Michio INAGAKI\*\*, Kazuo HORIKAWA\*\*\* and Yoshikazu KURIYAMA\*\*\*\*

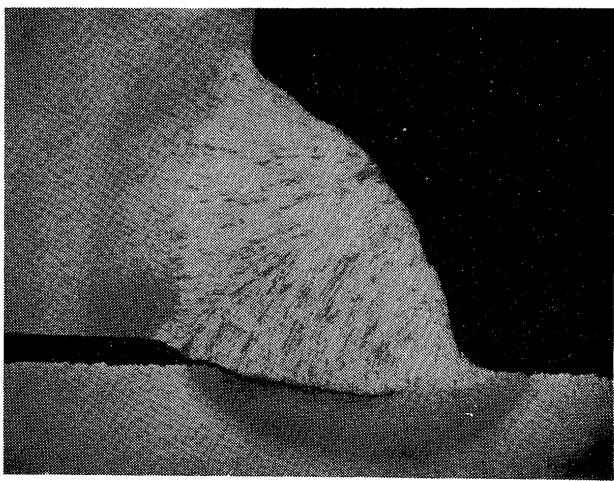
Photo. 1 Typical Example of Heel-Crack.

This type of crack was a relatively shallow longitudinal crack along the weld bead and it was less than 2 or 3 mm in the depth. Cracks propagated along the fusion line in the heat affected zone, and it appears that the crack was initiated by the pulling apart of the welded plates. One of the characteristic features of this crack was that the crack was found when the plates, which are less than 12 mm, were welded. Effects of hydrogen cannot be discounted, as it is possibly related to the initiation of the crack, because the crack was found in the fillet weld even when ilmenite or low hydrogen type electrodes were used in welding.

Root cracks, toe-cracks and underbead cracks known as crack defects are found in fillet weld. A new type of defect called "heel-crack", which is something different from root cracks, was found in the opposite side of the toe as shown in Photo. 1.

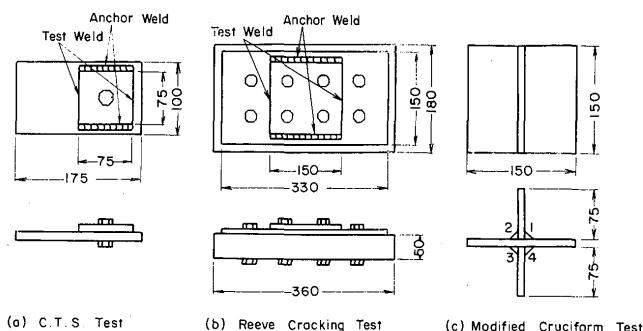
Fig. 1. Fillet Weld Cracking Test Assembly.

A test method must be established for reproducing heel-cracks. For this purpose, fillet weld cracking tests, C. T. S. tests, Reeve crack tests and cruciform fillet weld cracking tests were used. The dimensions of the test specimens are shown in **Fig. 1**.

In Reeve crack tests, as shown in **Fig. 1 (b)**, the test piece was tightly bolted to a 50 mm thick restraining plate, so that the restraint is greater than in C.T.S. test. For this reason, the cracks in Reeve crack test

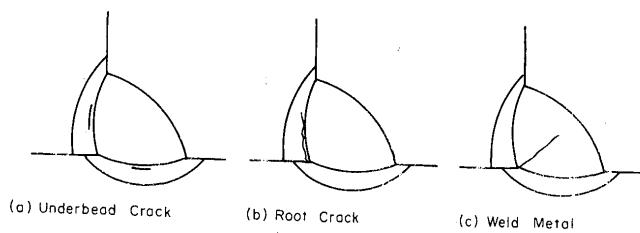
Fig. 2. Crack Shape in C. T. S. Test.

C. T. S. test was carried out on 12 mm 50 kg/mm<sup>2</sup> grade high strength steel under various conditions. **Table 1** shows the chemical composition of the plate. **Fig. 2** gives (a) underbead crack; (b) root crack in the upper plate; and (c) weld metal crack. There were no heel-cracks.

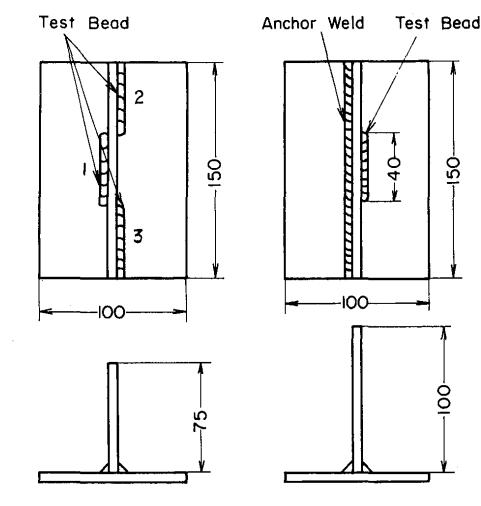
Fig. 3. Tee Joint Weld Cracking Specimen.

As it is difficult to reproduce heel-cracks by the conventional fillet weld cracking tests, test pieces, having a geometrically similar shape and with the actual welding joint in which heel-cracks were observed, were made as shown in **Fig. 3**. Tests were made by placing three short beads intermittently on the T-type 12 mm plate test piece (Table 1). Welded specimens were left for 24 hours after welding and checked for cracks. Heel-cracks were observed in each bead. However, in a Tee joint cracking test in which restraint beads were placed on the opposite side of test beads before the test bead was placed no heel-crack appeared as shown in **Fig. 3 (b)**, even though the test was made with T-type test plate.

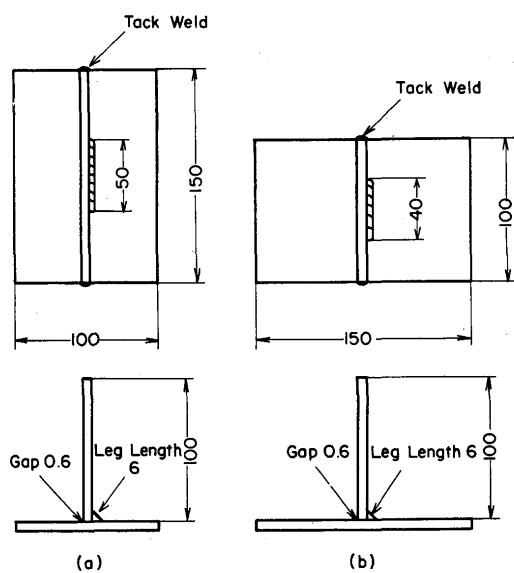
Fig. 4. Standard Non-restraint T type Cracking Test.

cracking test piece (called T-type test piece in this report) was developed to which vertical plate and horizontal plate was tack welded at both ends and then test bead was placed as shown in **Fig. 4**. There was no difference in the cracking tendency between (a) placing the test bead in the longitudinal direction of the test piece and (b) placing the test bead in the cross-sectional direction, but both had a larger cracking tendency than the staggered fillet weld cracking test, and were considered to be appropriate for standard test pieces for investigation of heel-cracks. The results of various preliminary tests showed that the increase of the weld bead length of fillet weld tended to off-set heel-cracks. Therefore, the welding standard for heel-crack test pieces was determined as 40 to 50 mm for bead length with fillet weld leg size of 6 mm.

For investigating the effect of the welding electrode upon the heel-crack, the standard test piece, **Fig. 4(b)**, was made using 12 mm thick plate, **Table 1**. The degree of cracking was investigated at various preheating temperature using low hydrogen type and ilmenite type electrodes. As is shown in **Fig. 15**, the degree of cracking decreased as the pre-heating temperature was raised, and the pre-heating temperature for preventing the heel-cracks was 125°C in all cases. But there was a difference between the two types of electrodes in the degree of cracking for 75°C and 100°C in the pre-heating temperature. This may be due to the fact that there is a difference between the low hydrogen type electrode and the ilmenite type electrode not only in hydrogen content but also in the yield stress and its cross-sectional shape of the fillet weld, which combine in a complicated manner to influence the heel-cracking tendency.

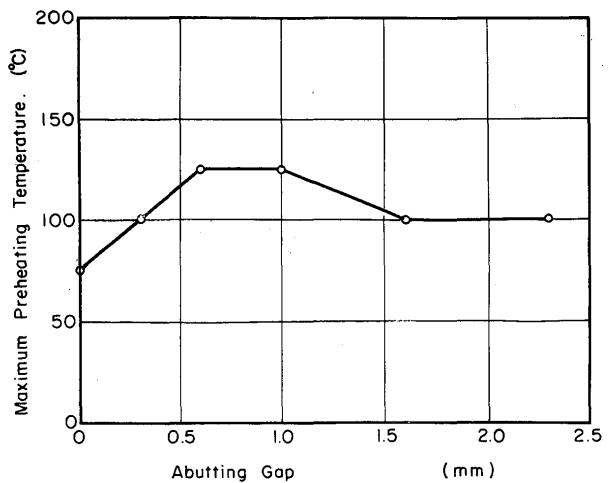
Fig. 5. Maximum Preheating Temperature to Prevent Heel-Cracking Against Abutting Gap.

In order to investigate the relation between the abutting gap with the horizontal plate and vertical plate and the heel-crack, the pre-heating temperature for preventing the heel-cracks to various abutting gaps was studied using a 12 mm test plate, **Table 1**, and test piece, **Fig. 4 (b)**. The results of the experiment in **Fig. 5** show that the pre-heating temperature for

preventing heel-cracks was high and that the cracking tendency at 0.6 to 1.0 mm at abutting gap was greater. Therefore 0.6 mm was assessed as the standard abutting gap. Low hydrogen type electrodes were used in the following experiments unless otherwise specified.

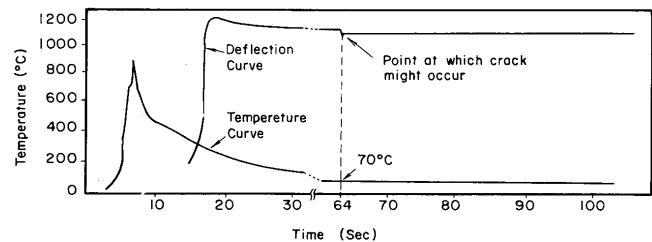
Fig. 7. Example of Time-Temperature and Time-Deflection Measurement.

Mechanical measurements traced the deflection of the vertical plate due to the thermal shrinkage by a strain gauge as shown in **Fig. 6**. This measuring system is capable of detecting as deflection of 40  $\mu$  at the minimum (0.04° in terms of angle). This measuring system simultaneously records the time-deflection curve and the time-temperature curve, and the crack is detected by the discontinuing line on the time-deflection curve as shown in **Fig. 7**. The maximum temperature on the time-temperature curve is about 900°C, but this does not detect the thermal cycle of the heel in the fillet weld. The discontinued point on the

time-deflection curve, which may correspond to cracking, was observed at 70°C. There may be no temperature difference in the relatively low temperature range between the detecting spot and the heel in the fillet weld.

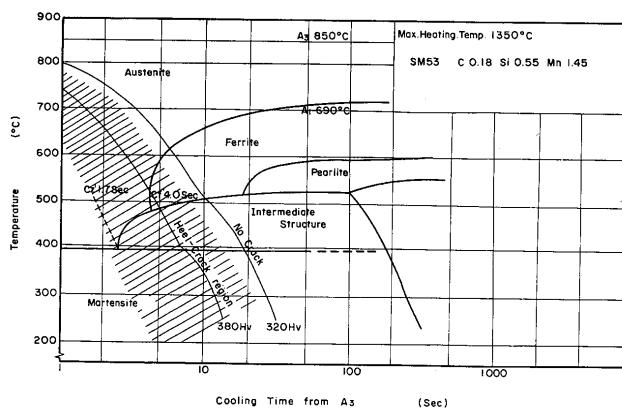
Fig. 8. Cooling Curve in Relation to Heel-Cracking.

The weld thermal cycle on which the heel-crack was observed, was recorded and plotted in SH-CCT diagram (Continuous Cooling Transformation Diagram of Synthetic Heat Affected Zone) as shown in **Fig. 8.** Although there is a slight difference in the thickness of the plates, the heel-crack was observed in the cooling process that passed at the top of the ferrite area. The micro-photograph near the heel-crack is shown in **Photo. 2.** In this case, the maximum hardness was 380 Hv. The heel-crack was not observed when the cooling curve was deviated to the longer time side on the SH-CCT diagram with maximum hardness

320 Hv. From these facts, it may be concluded that there is a certain hardness limit which governs heel-cracking.

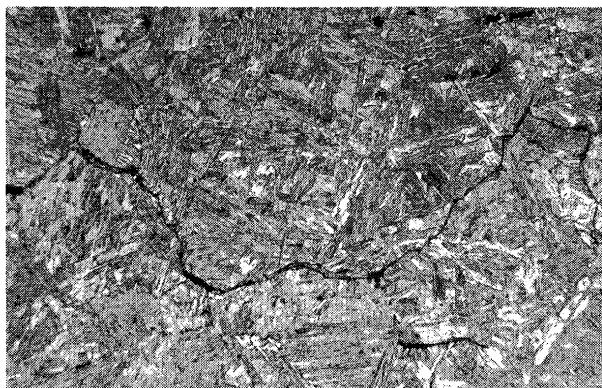
Photo.2 Microstructure Adjacent to Heel-Crack.

(magnification:  $\times 320$ )

these tests but there was a case in which the crack propagated along the gain boundary as shown in **Photo. 2**. Thus non-metallic inclusions may not be related to the initiation of cracking.

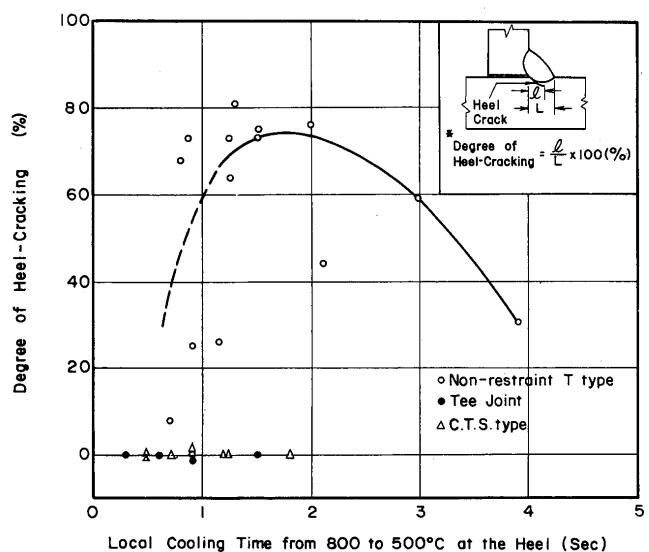
Fig. 9. Relation between Cooling Time from 800 to 500°C and Heel-Cracking.

It has been established that the micro-structure of the heat affected zone is closely related to the cooling time between 800°C and 500°C in the cooling process of the descending course of the weld thermal cycle. Inagaki et al<sup>1)</sup> reported that under certain assumptions, the cooling time from 800°C to 500°C is proportional to the square of the width of the partial solid solution range in the heat affected zone, where the length of the range is called the characteristic distance. The relation between the local cooling time of the heel in the fillet weld and the degree of the heel-crack was estimated after determining the characteristic distance as shown in **Fig. 9.** If the microstructure was the dominant factor for the crack, the crack would be observed in all the test pieces. In non-restraint T-type weld test pieces, heel-cracking was observed but no crack was observed in restraint type and C. T. S. type weld test pieces. Therefore it is suggested that crack sensitivity is not entirely dependent on the micro-structure, and that the dynamic factors (see the section on restraint) should also be investigated. The longer the cooling time from 800°C to 500°C, the lesser the heel-crack in non-restraint T-type weld test piece.

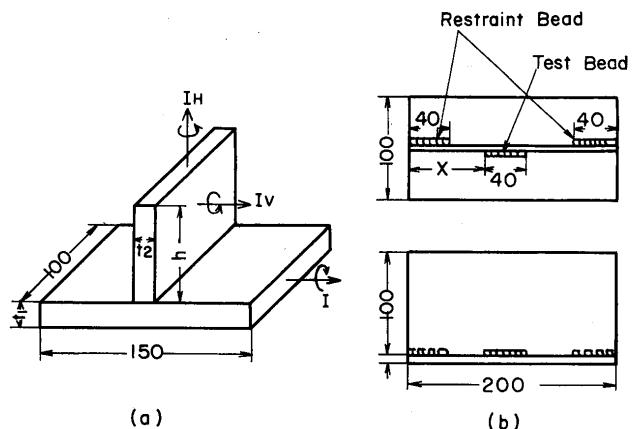
Fig. 10. Dimension of Test Piece.

vertical plate has a large effect upon heel-cracking. The fillet weld cracking tendency was investigated by varying the dimensions of the vertical plate and the horizontal plate, choosing appropriate values for rigidity to lateral bending ( $I_H$ ), rigidity of longitudinal bending ( $I_V$ ) of the vertical plate, and rigidity of the horizontal plate ( $I$ ). **Fig. 10 (a)** shows the dimensions of the test pieces and **Table 5** indicates the value of the moment of inertia under varying conditions. The 30 mm plate in **Table 1** was used for this experiment, and the standard bead length and leg size were respectively 40 mm and 6 mm. In the crack inspection after

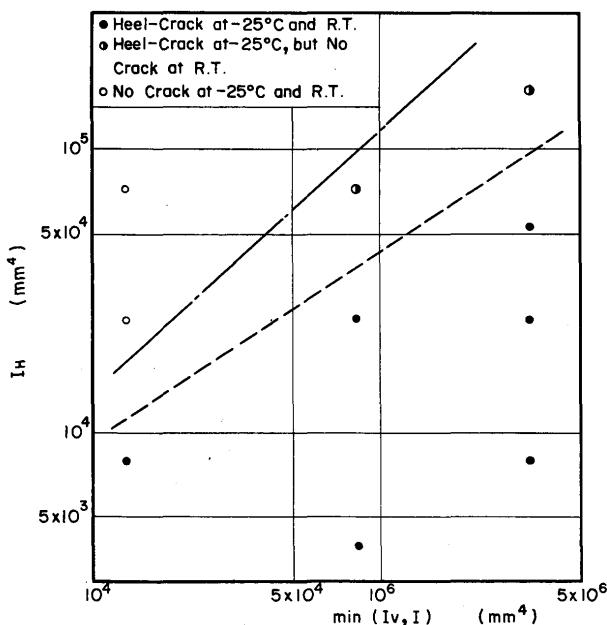
Fig. 11. Relation between Geometrical Moment of Inertia and Heel Cracking.

completion of welding the test pieces were left for 20 hours to air cool and cross-sectional part of bead was checked for cracks. **Fig. 11** shows the results of the experiment.

$I_H$  representing the rigidity of lateral bending, namely the thickness of the vertical plate was small when a heel-crack was observed. The cracking tendency was increased, when the test pieces were pre-cooled at  $-25^{\circ}\text{C}$ . When  $I_H$  became smaller relative to  $I$  or  $I_v$  neither heel-crack nor other cracks were found in the vertical plate.

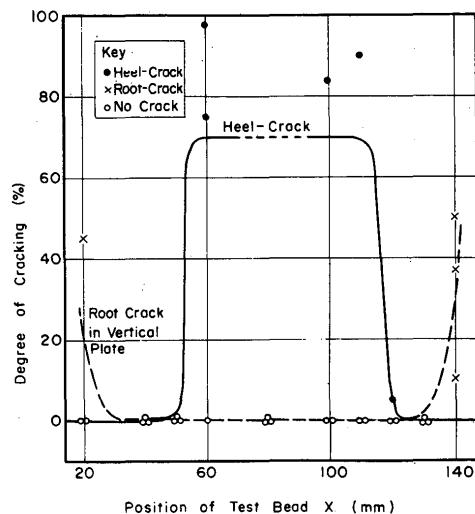
Fig. 12. Degree of Crack vs. Position of Test Bead.

In the experiment above, the rigidity of lateral bending reached limit at the maximum 30 mm thick plate. Thus 12 mm plate was used (Table 1), and the relative position of the test bead was changed to the two restraint beads on the edge of the opposite side of the test bead as shown in **Fig. 10 (b)**. It was possible to reproduce a large rigidity of lateral bending by changing the rigidity of the vertical plate by placing the test bead closer to the restraint beads. Welding conditions and crack inspection were the same as in the experiment above. The results are shown in **Fig. 12**. When the restraint beads are placed on the opposite side to the test bead (which corresponds to the large  $I_H$ )  $X=20$  mm, 140 mm a root crack was observed in the vertical plate. When the relative distance between the test bead and the restraint beads was increased ( $I_H$  was decreased) to make  $X=60$  to 120 mm, a heel-crack was observed, but in the transient range ( $X=30$  mm, 130 mm) where the crack shape varied from a heel-crack to a root crack in the vertical plate, no crack was observed.

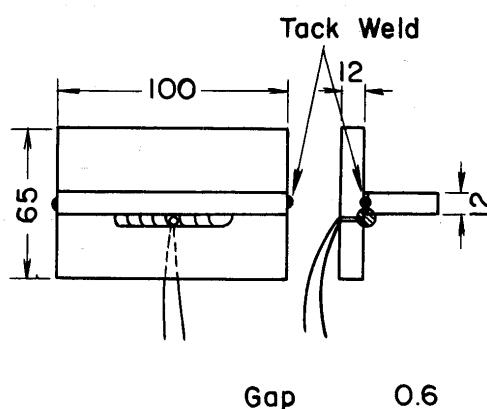
Fig. 13. Dimension of Specimen.

As already described in section 2-2, the heel-crack is one of the low temperature cracks which occurs below  $100^{\circ}\text{C}$ , which indicates that hydrogen may have some relation to the crack. The following experiment was conducted to check this. The martensite transformation in the heat affected zone by the weld thermal cycle is nearly completed by  $200^{\circ}\text{C}$ , and changing the cooling rate below  $200^{\circ}\text{C}$  of the temperature in the heat affected zone means changing the evolution of diffusible hydrogen into the heat affected zone without micro-structural change. Using 12 mm thick plate, **Table 1**, a small T-type test piece was made, as shown in **Fig. 13**, to improve the thermal response. The heel-crack tendency was investigated by changing the cooling rate of the test piece when the temperature

For the measurement of the cooling curve, a thermocouple was set at the center of the bead length under the bead area of the horizontal plate. Heat-resistant cement was used to cover the measuring spot for preventing intrusion of alcohol.

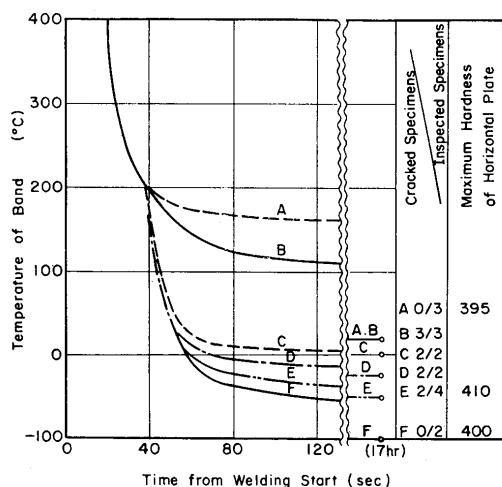
Fig. 14. Relation between Cooling Rate below 200°C and Heel Cracking.

The results of the experiment are shown in **Fig. 14**. There is no difference in the maximum hardness by the various cooling rates, and it appears doubtful that the micro-structural change was caused by the cooling method of (A), (B) ---- (F). Nevertheless, as there is a difference in the heel-cracking tendency, it may be regarded as the effect of hydrogen. In other words, if the cooling rate is small (operation A), hydrogen will

be evolved, and if the cooling rate is large and the test piece is kept at low temperature (Operation F), hydrogen evolution will be fixed and no heel-crack will be observed. It is possible to conclude from the results of the experiment that the heel-crack is one of the low temperature cracks due to hydrogen.

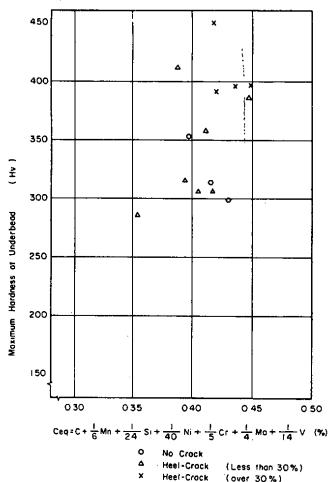
Fig. 16. Relation between Carbon Equivalent, Maximum Hardness at Underbead and Heel-Cracking.

- (1) The heel-crack is not peculiar to SM53C, but it is common to 50 kg/mm<sup>2</sup> grade high strength steels. Semi-killed steels seem less sensitive to the heel-cracks than killed steels.
- (2) Heel-cracking tendency increases with higher carbon equivalent and underbead hardness (See **Fig. 16**).

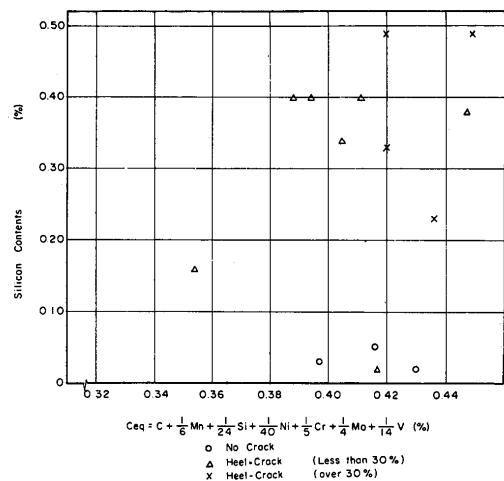
Fig. 17. Relation between Carbon Equivalent, Silicon Contents and Heel-Cracking.

There is some difference in the cracking tendency between killed steels and semi-killed steels. The only distinct difference between these two types of steels is the Si content. The chemical compositions of the surface layer where the heel-crack is less, and the center of the plate were investigated, but there was no difference, between them as shown in Table 8. As it was impossible to obtain positive conclusions on the difference, research is being continued.

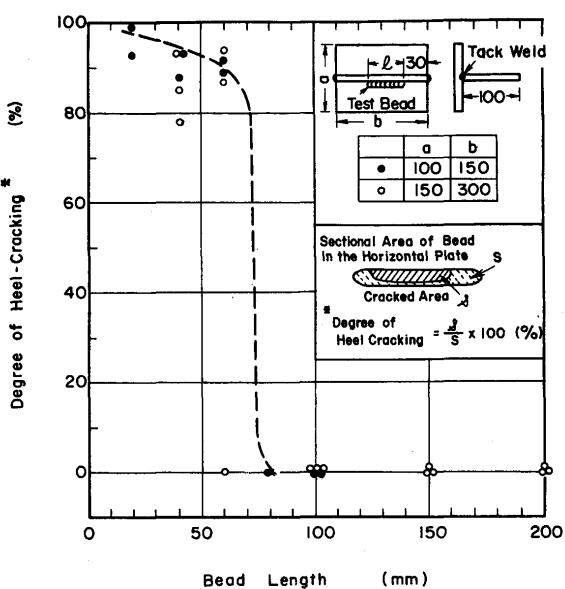
Fig. 18. Effect of Bead Length on Heel-Cracking.

In the experiments, the bead length was kept constant 40 to 50 mm. For the purpose of investigating the effect of the bead length on the heel-cracking tendency, an experiment was conducted by changing the bead length from 20 to 200 mm using 12 mm thick plate. The test pieces used are shown in Fig. 4 (a) and the dimension of the horizontal plate is 150×300 mm. The test pieces were pre-cooled at -25°C. The test results are shown in Fig. 18. No heel-crack was observed when the bead length is longer than 80 mm.

The maximum hardness of the underbead along the bead direction did not show any change as long as 100 mm and the maximum hardness at the center was more than 405 Hv. Consequently it is difficult to say that the increase in the bead length resulted the less hardening effect of the heat affected zone and decreased the heel-cracking. A thermocouple was welded on the crater to measure the cooling rate in welding. The cooling time from 100°C to 50°C for 100, 80, 60, 40 mm bead length were respectively 53, 48, 32 and 20 seconds. The effect of the bead length is to change the cooling process in the low temperature range so as to activate the evolution of diffusible hydrogen which affects the crack initiation.

The long bead is also effective for preventing heel-cracks, see section 2-7.
